# **Coastal Construction:**

## *Designing the Building Envelope*

# 11 Designing the Building Envelope

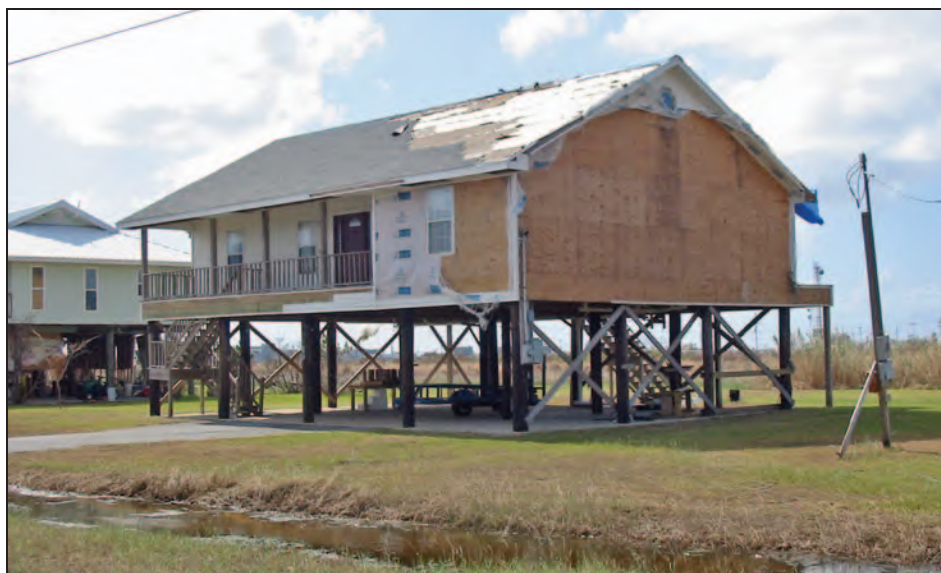
**Figure 11-1.**  
Good structural system performance but the loss of shingles, underlayment, siding, housewrap, and soffits resulted in significant interior water damage. Estimated wind speed: 125 mph.<sup>3</sup> Hurricane Katrina (Louisiana, 2005)

The predominant cause of damage to buildings and their contents during high-wind events has been shown to be breaching of the building envelope, as shown in Figure 11-1, and subsequent water infiltration. Breaching includes catastrophic failure (e.g., loss of the roof covering or windows) and is often followed by wind-driven water infiltration through small openings at doors, windows, and walls. The loss of roof and wall coverings and soffits on the house in Figure 11-1 resulted in significant interior water damage. Recommendations for avoiding breaching are provided in this chapter.

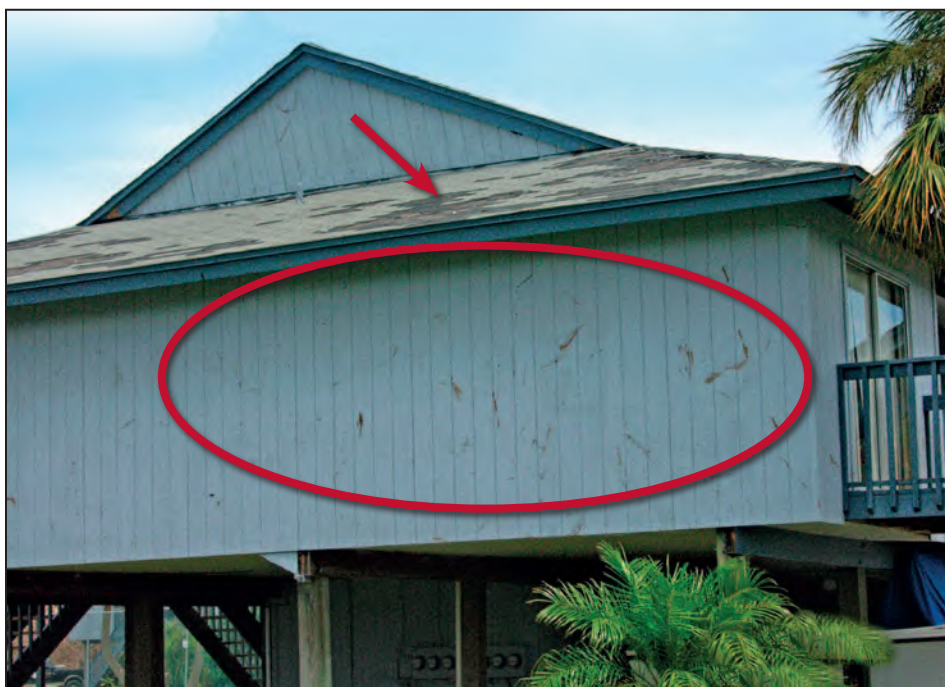
**Figure 11-2.** Numerous wind-borne debris scars on the wall of this house and several missing asphalt shingles. Estimated wind speed: 140 to 150 mph. Hurricane Charley (Florida, 2004)

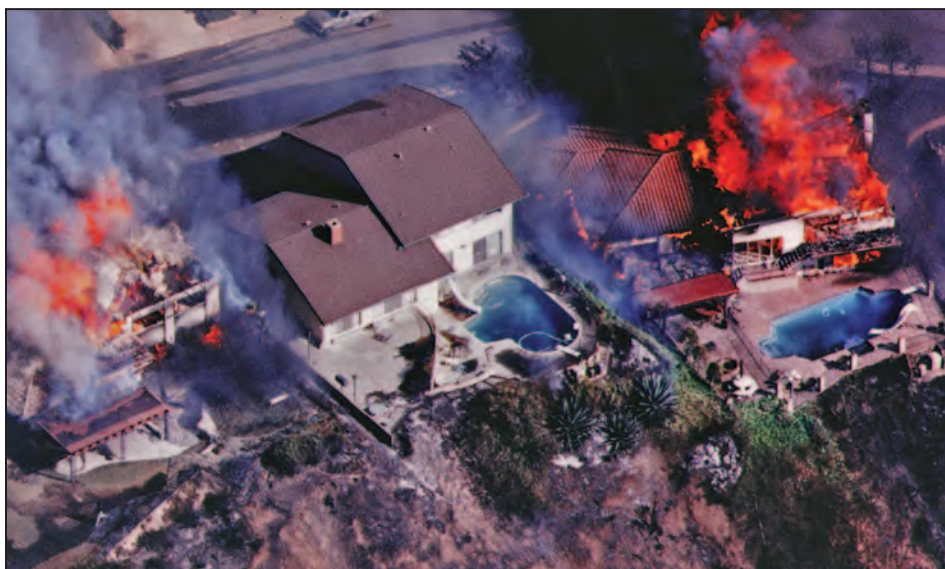
**Figure 11-3.** House that survived a wildfire due in part to fire-resistant walls and roof while surrounding houses were destroyed  
SOURCE: DECRA ROOFING SYSTEMS, USED WITH PERMISSION

A building's susceptibility to wildfire depends largely on the presence of nearby vegetation and the characteristics of the building envelope, as illustrated in Figure 11-3. See FEMA P-737, *Home Builder's Guide to Construction in Wildfire Zones* (FEMA 2008), for guidance on materials and construction techniques to reduce risks associated with wildfire.

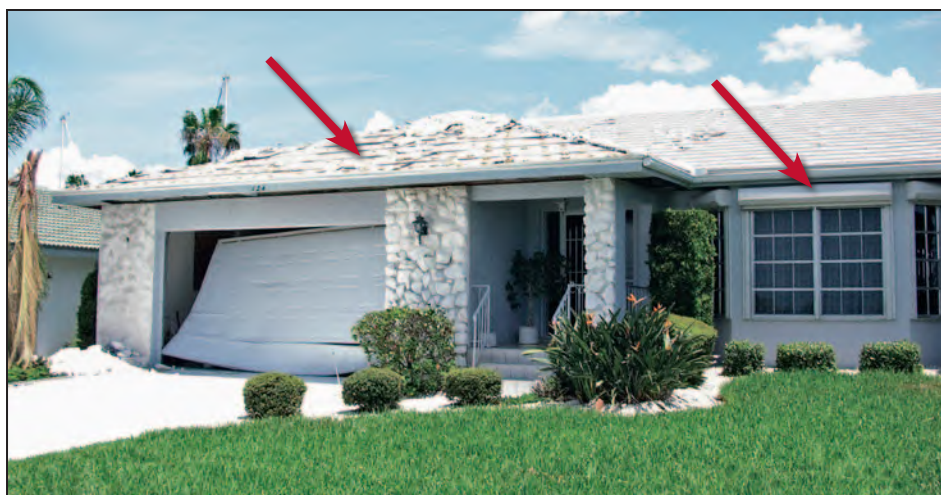
**Figure 11-6.**  
Garage door blown from its track as a result of positive pressure. Note the damage to the adhesive-set tiles (left arrow; see Section 11.5.4.1). This house was equipped with roll-up shutters (right arrow; see Section 11.3.1.2). Estimated wind speed: 140 to 160 mph. Hurricane Charley (Florida, 2004)

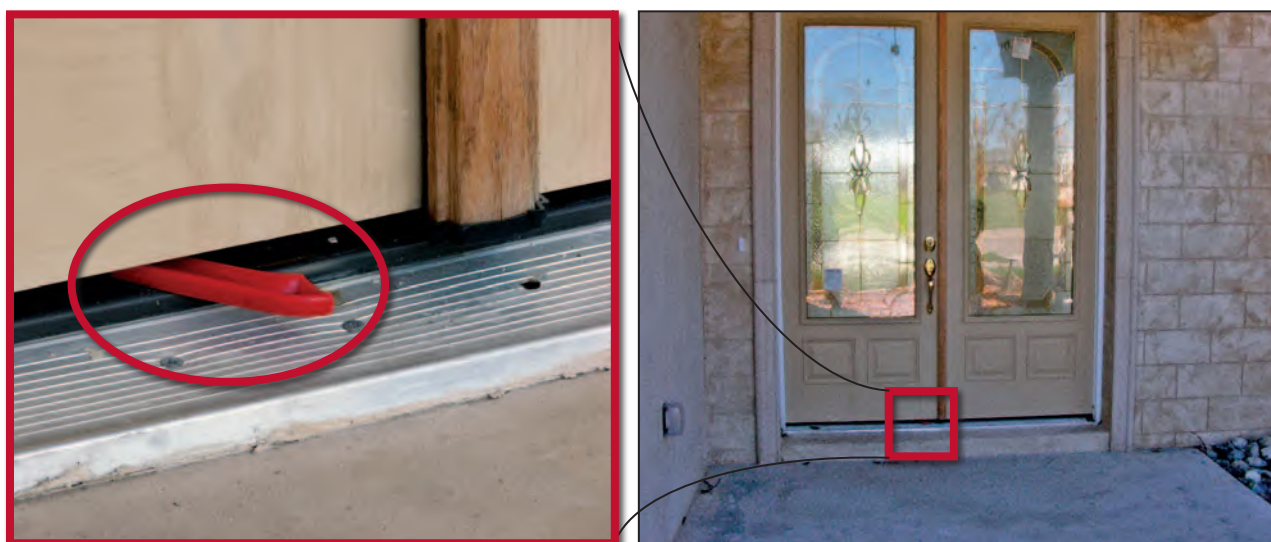
Figure 11-7.

A 3/8-inch gap between the threshold and door (illustrated by the spatula handle), which allowed wind-driven rain to enter the house. Estimated wind speed: 140 to 160 mph. Hurricane Charley (Florida, 2004)

Figure 11-7 shows a pair of doors that successfully resisted winds that were estimated at between 140 and 160 mph. However, as shown in the inset, a gap of about 3/8 inch between the threshold and the bottom of the door allowed a significant amount of water to be blown into the house. The weatherstripping and thresholds shown in Fact Sheet 6.1 in FEMA P-499 can minimize water entry.

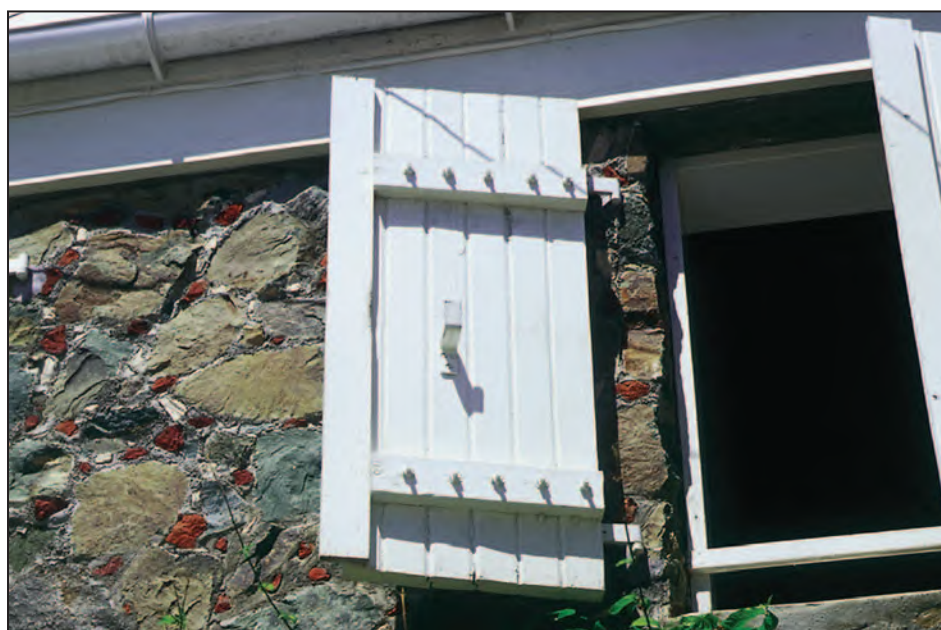
**Figure 11-9.**  
Very old building  
with robust shutters  
constructed of  
2x4 lumber, bolted  
connections, and heavy  
metal hinges. Hurricane  
Marilyn (U.S. Virgin  
Islands, 1995)

In windstorms other than hurricanes and tornadoes, the probability of a window or skylight being struck by debris is extremely low, but in hurricane-prone regions, the probability is higher. Although the debris issue was recognized decades ago, as illustrated by Figure 11-9, wind-borne debris protection was not incorporated into U.S. codes and standards until the 1990s. In order to minimize interior damage, the IBC and IRC, through ASCE 7, prescribe that exterior glazing in wind-borne debris regions be impact-resistant (i.e., laminated glass or polycarbonate) or protected with an impact-resistant covering (shutters). ASCE 7 refers to ASTM E1996 for missile (debris) loads and to ASTM E1886 for the test method to be used to demonstrate compliance with the ASTM E1996 load criteria. Regardless of whether the glazing is laminated glass, polycarbonate, or protected by shutters, glazing is required to meet the positive and negative design air pressures.

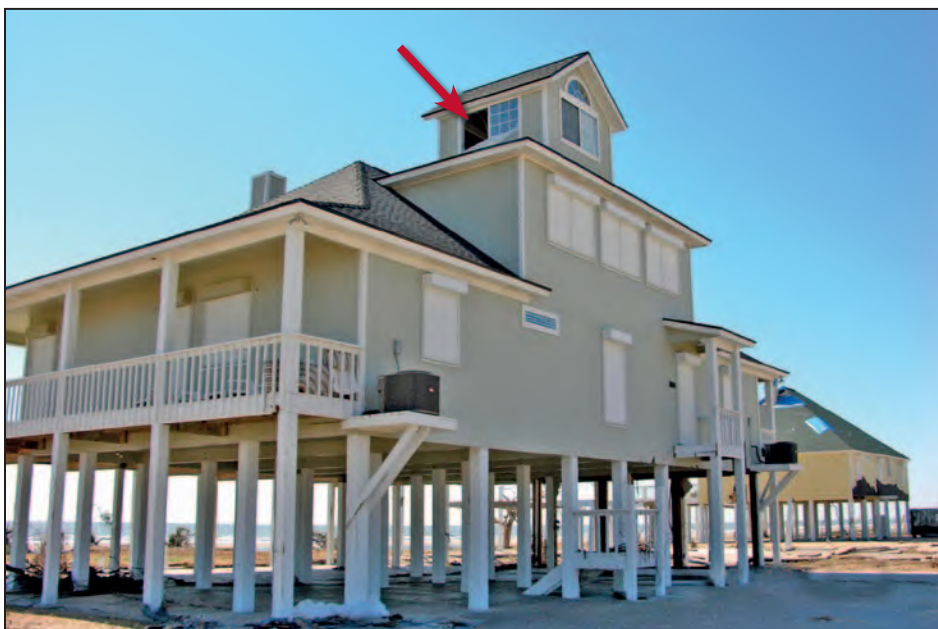
**Figure 11-10.**  
Unprotected cupola  
window that was broken.  
Estimated wind speed:  
110 mph. Hurricane Ike  
(Texas, 2008)

Because hurricane winds can approach from any direction, when debris protection is specified, it is important to specify that all exterior glazing be protected, including glazing that faces open water. At the house shown in Figure 11-10, all of the windows were protected with roll-up shutters except for those in the cupola. One of the cupola windows was broken. Although the window opening was relatively small, a substantial amount of interior water damage likely occurred.

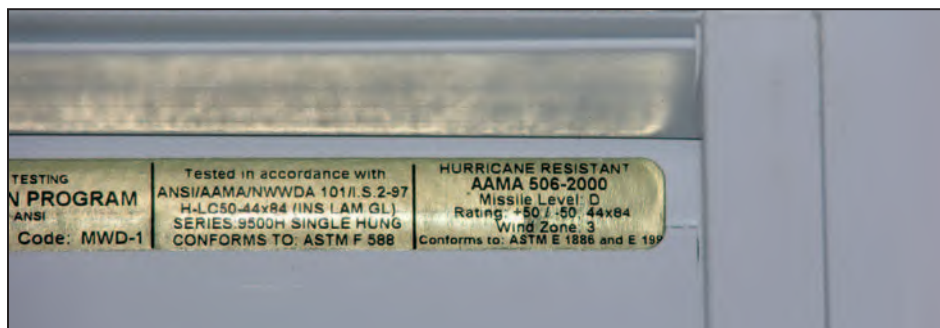
**Figure 11-11.**  
Design pressure and impact-resistance information in a permanent window label. Hurricane Ike (Texas, 2008)

The FBC requires exterior windows and sliding glass doors to have a permanent label or marking, indicating information such as the positive and negative design pressure rating and impact-resistant rating (if applicable). Impact-resistant shutters are also required to be labeled. Figure 11-11 is an example of a permanent label on a window assembly. This label provides the positive and negative design pressure rating, test missile rating,

and test standards that were used to evaluate the pressure and impact resistance. Without a label, ascertaining whether a window or shutter has sufficient strength to meet pressure and wind-borne debris loads is difficult (see Figure 11-12). It is therefore recommended that design professionals specify that windows and shutters have permanently mounted labels that contain the type of information shown in Figure 11-11.

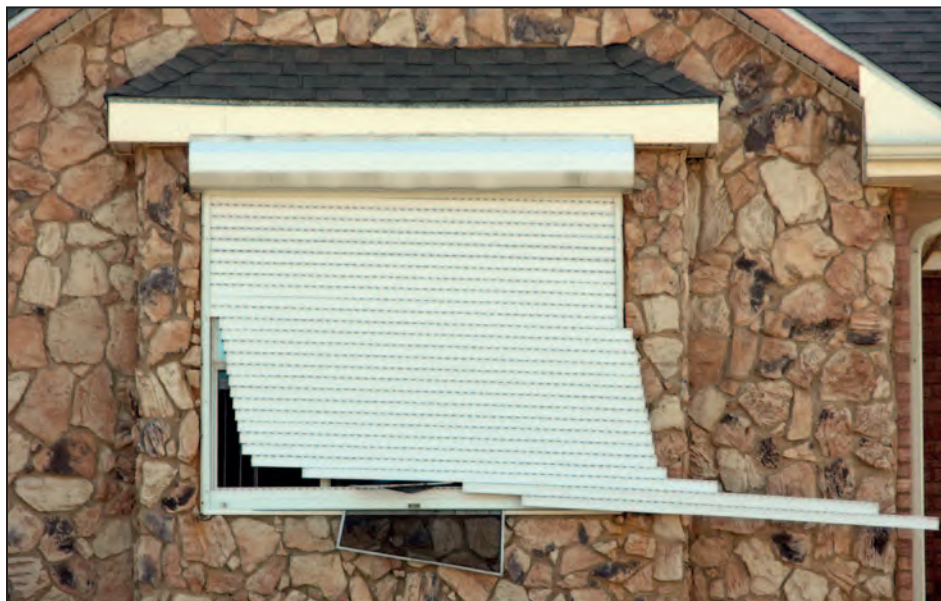
**Figure 11-12.**  
Roll-up shutter slats that detached from the tracks. The lack of a label makes it unclear whether the shutter was tested in accordance with a recognized method. Estimated wind speed: 110 mph. Hurricane Katrina (Louisiana, 2005)

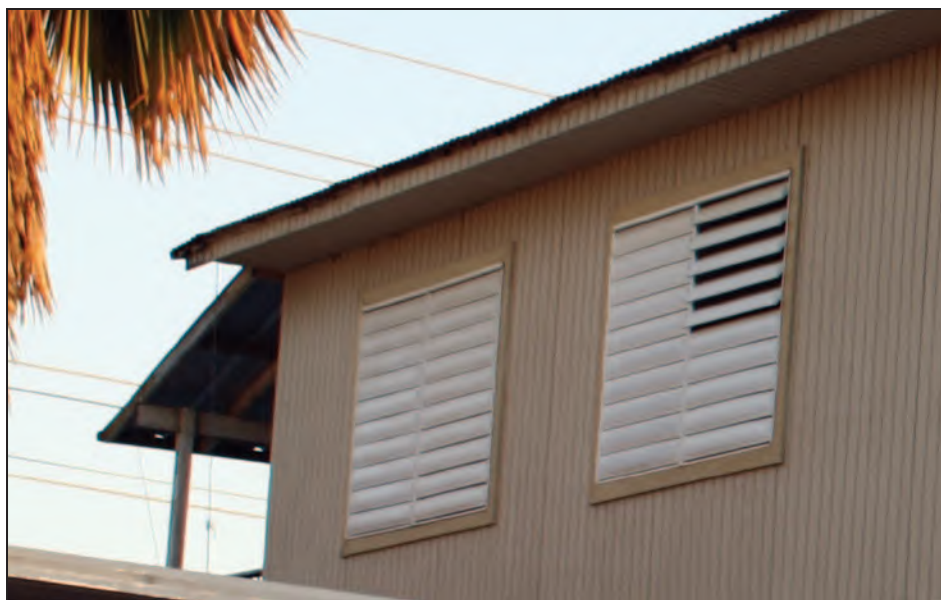
Figure 11-14.  
House in Puerto Rico with  
metal jalousie louvers

In tropical climates such as Puerto Rico, some houses have metal jalousie louvers in lieu of glazed window openings (see Figure 11-14). Metal жалousies have the appearance of a debris-resistant shutter, but they typically offer little debris resistance. Neither the UBC nor IRC require openings equipped with metal жалousie louvers to be debris resistant because glazing does not occur. However, the louvers are required to meet the design wind pressure.

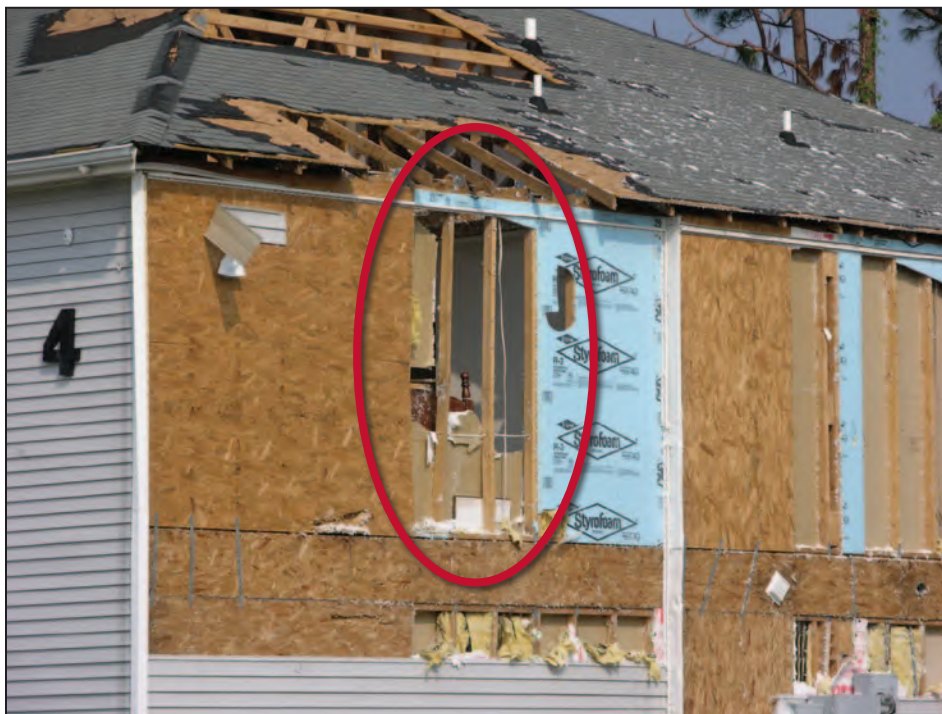
Figure 11-15. Blown-off vinyl siding and foam sheathing; some blow-off of interior gypsum board (circle). Estimated wind speed: 130 mph. Hurricane Katrina (Mississippi, 2006)

other siding or panel materials (see Figure 11-15). Problems with aluminum and fiber cement siding have also occurred (see Figure 11-16).

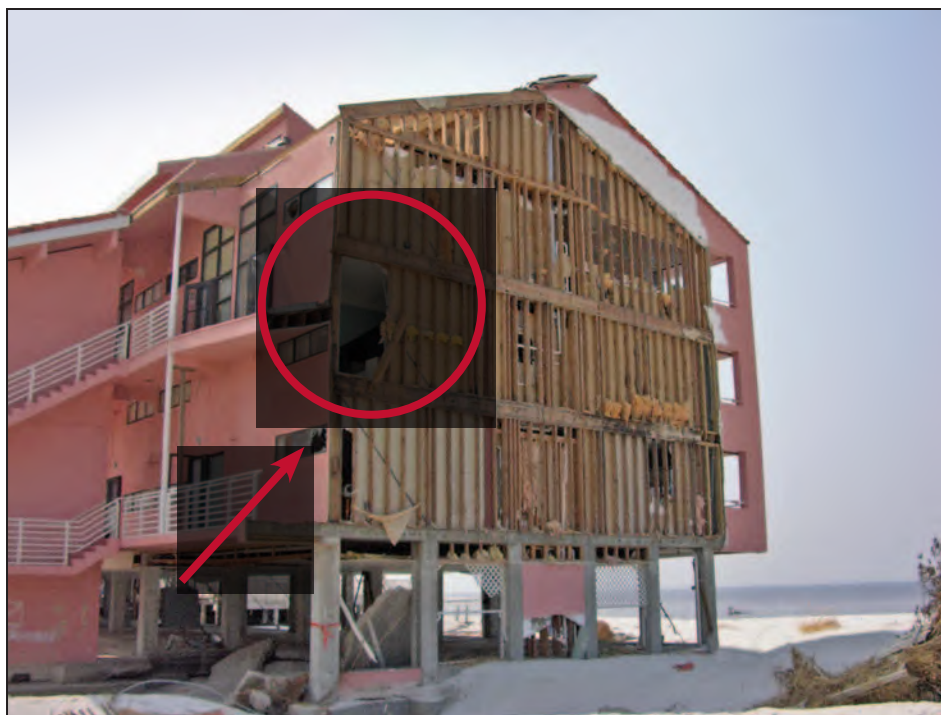
**Figure 11-19.** Blown-off EIFS, resulting in extensive interior water damage; detachment of the gypsum board or stud blow off (circle); two windows broken by debris (arrow). Estimated wind speed: 105 to 115 mph. Hurricane Ivan (Florida, 2004)

At the residence shown in Figure 11-19, the synthetic stucco was installed over molded expanded polystyrene (MEPS) insulation that was adhered to gypsum board that was mechanically attached to wood studs. Essentially all of the gypsum board blew off (the boards typically pulled over the fasteners). The failure was initiated by detachment of the gypsum board or by stud blow off. Some of the gypsum board on the interior side of the studs was also blown off. Also, two windows were broken by debris.

Several of the studs shown in Figure 11-19 were severely rotted, indicating long-term moisture intrusion behind the MEPS insulation. The residence shown in Figure 11-19 had a barrier EIFS design, rather than the newer drainable EIFS design (for another example of a barrier EIFS design, see Figure 11-21). EIFS should be designed with a drainage system that allows for dissipation of water leaks.

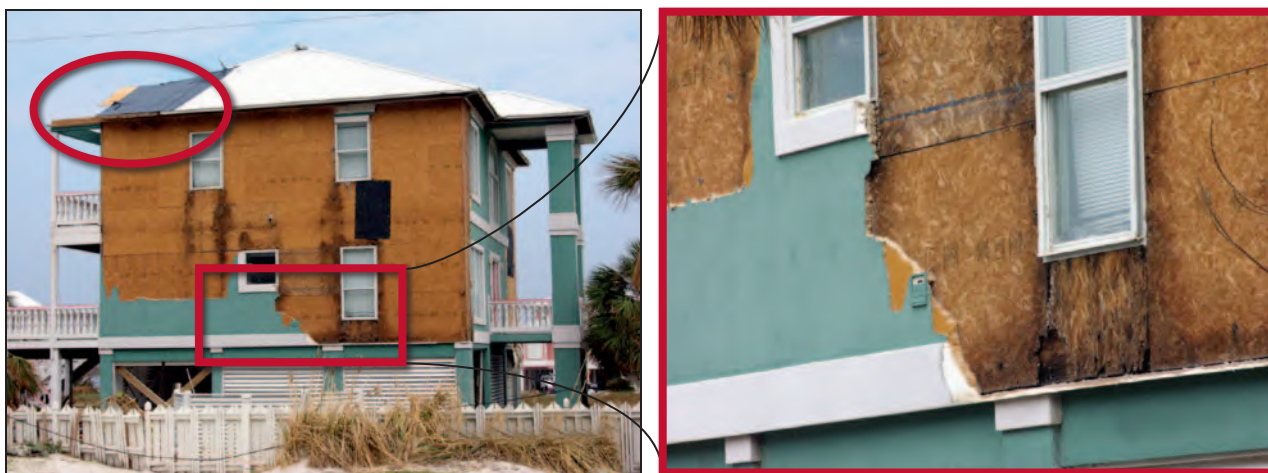
Figure 11-21.  
EIFS with a barrier design: blown-off roof decking (top circle); severely rotted OSB due to leakage at windows (inset). Hurricane Ivan (2004)

Water infiltration at wall openings and wall transitions due to poor flashing design and/or installation is a common problem in many coastal homes (see Figure 11-21). In areas that experience frequent wind-driven rain and areas susceptible to high winds, enhanced flashing details and attention to their execution are recommended. Enhancements include flashings that have extra-long flanges, use of sealant, and use of self-adhering modified bitumen tape.

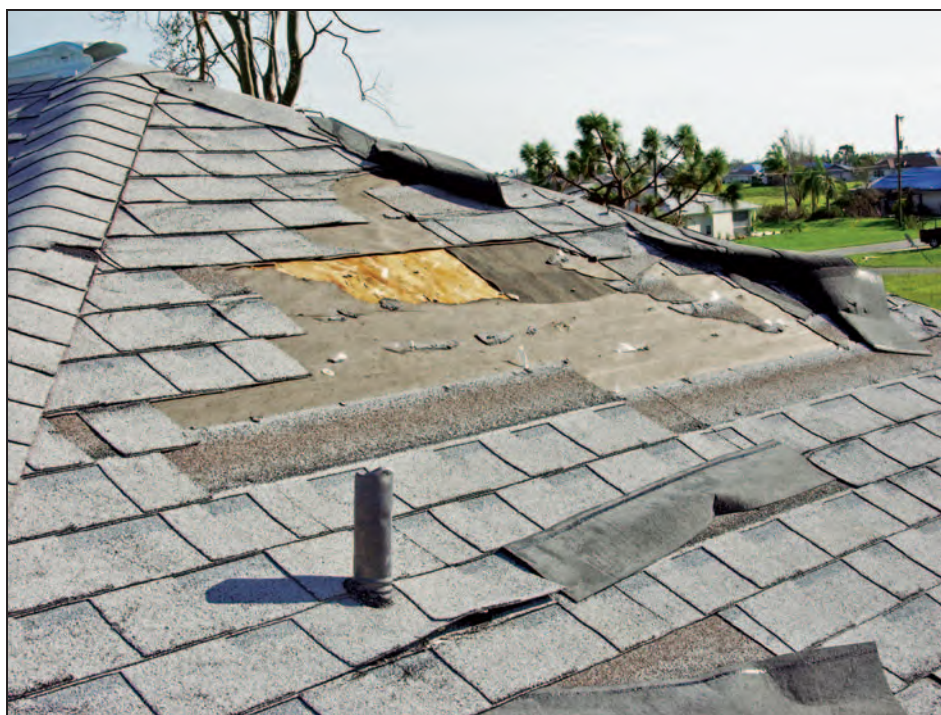
Figure 11-24.  
Small area of sheathing  
that was exposed  
after loss of a few  
shingles and some  
underlayment. Estimated  
wind speed: 140 to 160  
mph. Hurricane Charley  
(Florida, 2004)

If shingles blow off, water infiltration damage can be avoided if the underlayment remains attached and is adequately sealed at penetrations. Figures 11-24 and 11-25 show houses with underlayment that was not effective in avoiding water leakage. Reliable

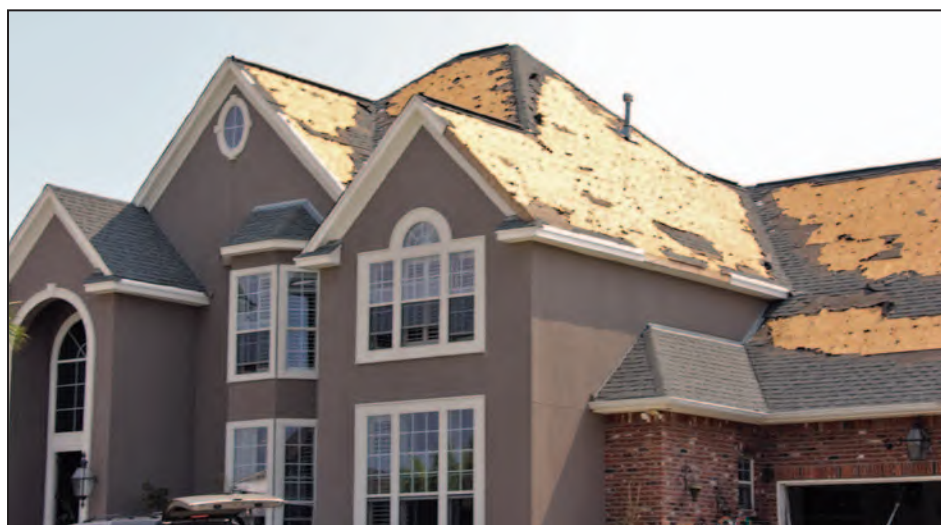
Figure 11-25.  
Typical underlayment  
attachment;  
underlayment blow-off is  
common if the shingles  
are blown off, as shown.  
Estimated wind speed:  
115 mph. Hurricane  
Katrina (Louisiana, 2005)

- **Enhanced Underlayment Option 3.** Option 3 is the typical underlayment scheme (i.e., a single layer of #15 felt tacked to the sheathing, as shown in Figure 11-25) with the added enhancement of self-adhering modified bitumen tape. This option provides limited protection against water infiltration if the shingles blow off. However, this option provides more protection than the typical underlayment scheme. Option 3 is illustrated in Fact Sheet 7.2 in FEMA P-499.

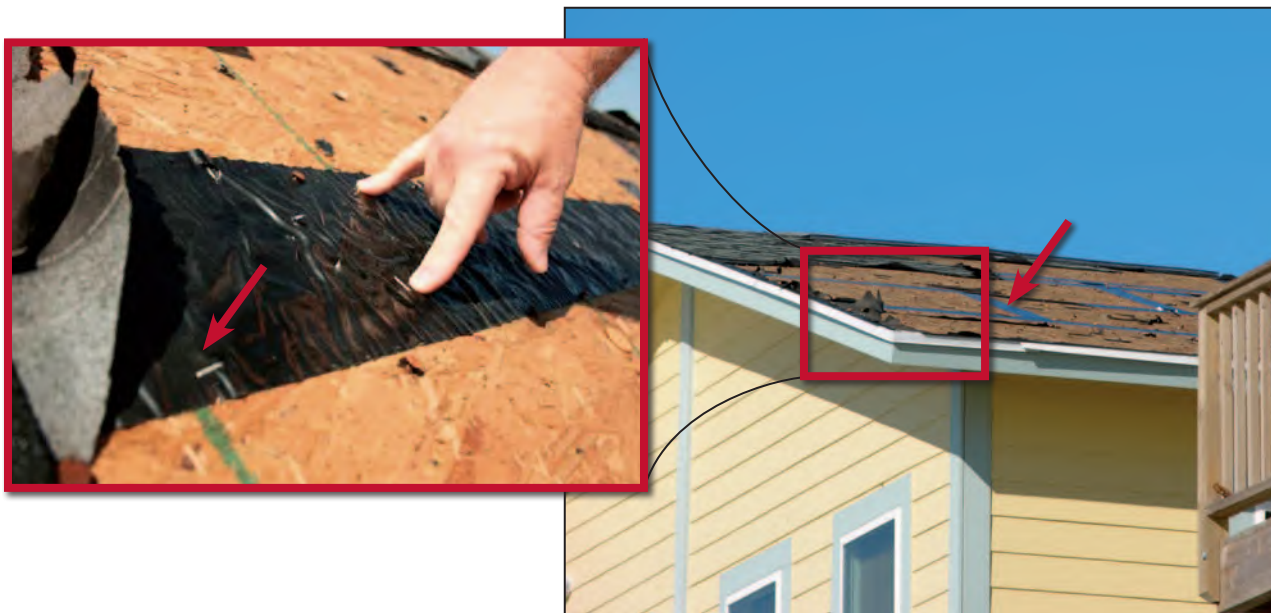
Figure 11-28.

House that used enhanced underlayment Option 3 with taped sheathing joints (arrow). The self-adhering modified bitumen tape (inset) was stapled because of bonding problems. Estimated wind speed: 110 mph. Hurricane Ike (Texas, 2008)

Figure 11-28 shows a house that used Option 3. The self-adhering modified bitumen tape at the sheathing joints was intended to be a third line of defense against water leakage (with the shingles the first line and the felt the second line). However, as shown in the inset at Figure 11-28, the tape did not provide a watertight seal. A post-storm investigation revealed application problems with the tape. Staples (arrow, inset) were used to attach the tape because bonding problems were experienced during application. Apparently, the applicator did not realize the tape was intended to prevent water from leaking through the sheathing joints. With the tape in an unbonded and wrinkled condition, it was incapable of fulfilling its intended purpose.

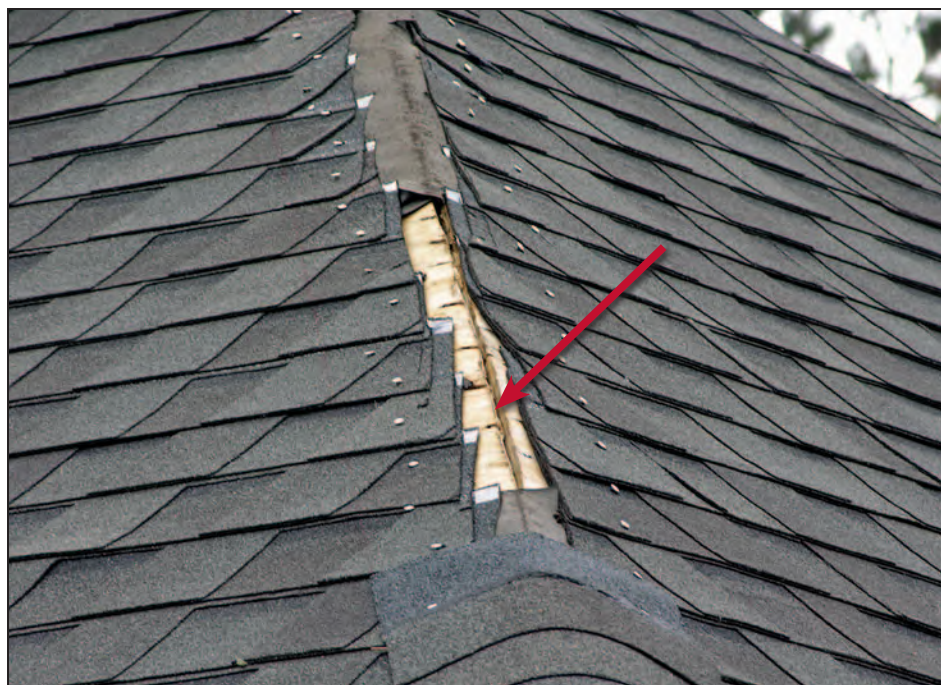
Figure 11-29.  
Underlayment that was  
not lapped over the hip;  
water entry possible  
at the sheathing joint  
(arrow). Estimated  
wind speed: 130 mph.  
Hurricane Katrina  
(Mississippi, 2005)

In addition to taping the sheathing joints in the field of the roof, the hip and ridge lines should also be taped unless there is a continuous ridge vent, and the underlayment should be lapped over the hip and ridge. By doing so, leakage will be avoided if the hip or ridge shingles blow off (see Figure 11-29). See Section 11.6 for recommendations regarding leakage avoidance at ridge vents.

Shingle blow-off is commonly initiated at eaves (see Figure 11-30) and rakes (see Figure 11-31). Blow-off of ridge and hip shingles, as shown in Figure 11-29, is also common. For another example of blow-off of ridge

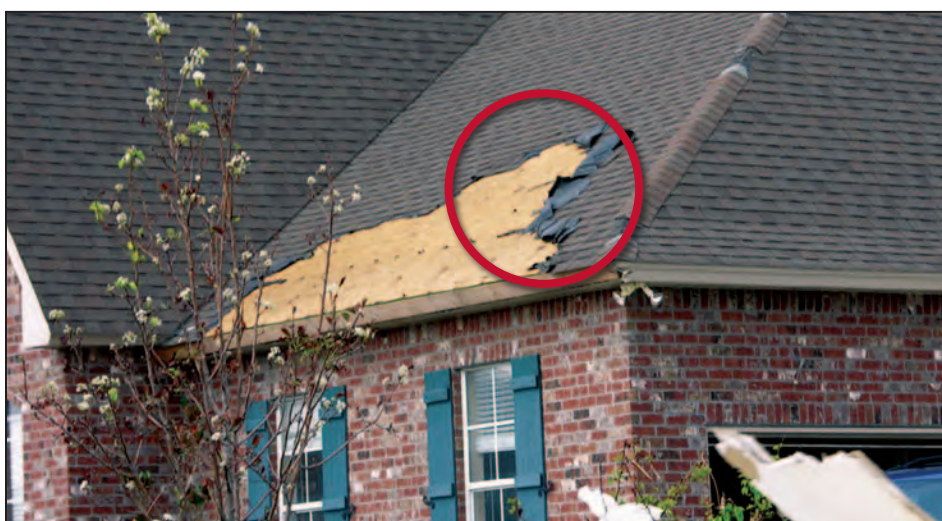
Figure 11-30.  
Loss of shingles and underlayment along the eave and loss of a few hip shingles. Estimated wind speed: 115 mph. Hurricane Katrina (Louisiana, 2005)

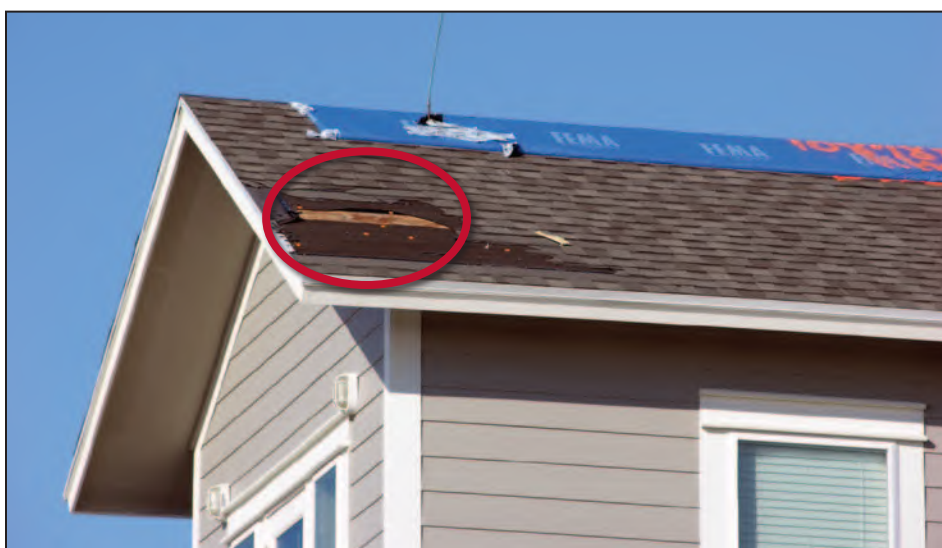
Figure 11-31.  
Loss of shingles and underlayment along the rake. Estimated wind speed: 110 mph. Hurricane Ike (Texas, 2008)

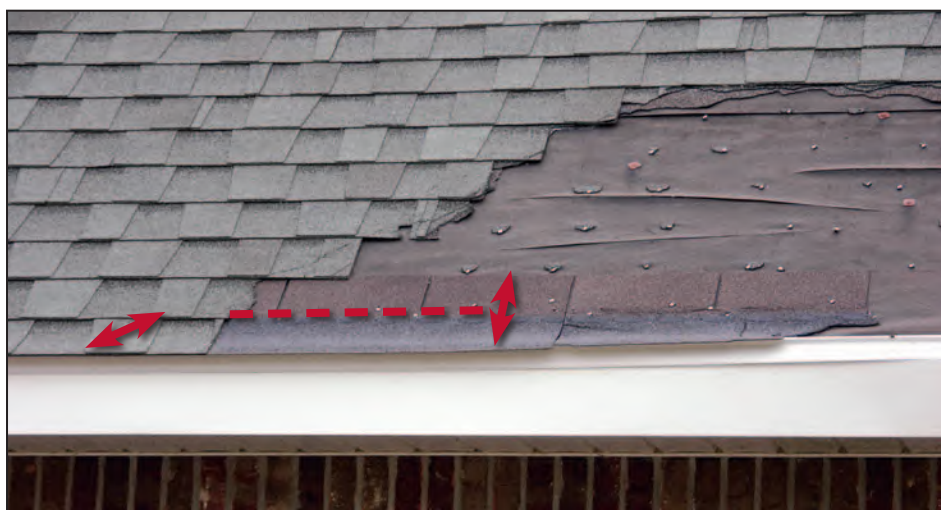
**Figure 11-32.**  
Incorrect installation of the starter course (incorrectly rotated starter, right arrow, resulted in self-seal adhesive not near the eave, dashed line). Estimated wind speed: 130 mph. Hurricane Katrina (Mississippi, 2005)

Storm damage investigations have shown that when eave damage occurs, the starter strip was typically incorrectly installed, as shown in Figure 11-32. Rather than cutting off the tabs of the starter, the starter was rotated 180 degrees (right arrow). The exposed portion of the first course of shingles (left arrow) was unbounded because the self-seal adhesive (dashed line) on the starter was not near the eave. Even when the starter is correctly installed (as shown on shingle bundle wrappers), the first course may not bond to the starter because of substrate variation. Fact Sheet 7.3 in FEMA P-499 provides information about enhanced attachment along the eave, including special recommendations regarding nailing, use of asphalt roof cement, and overhang of the shingle at the eave.

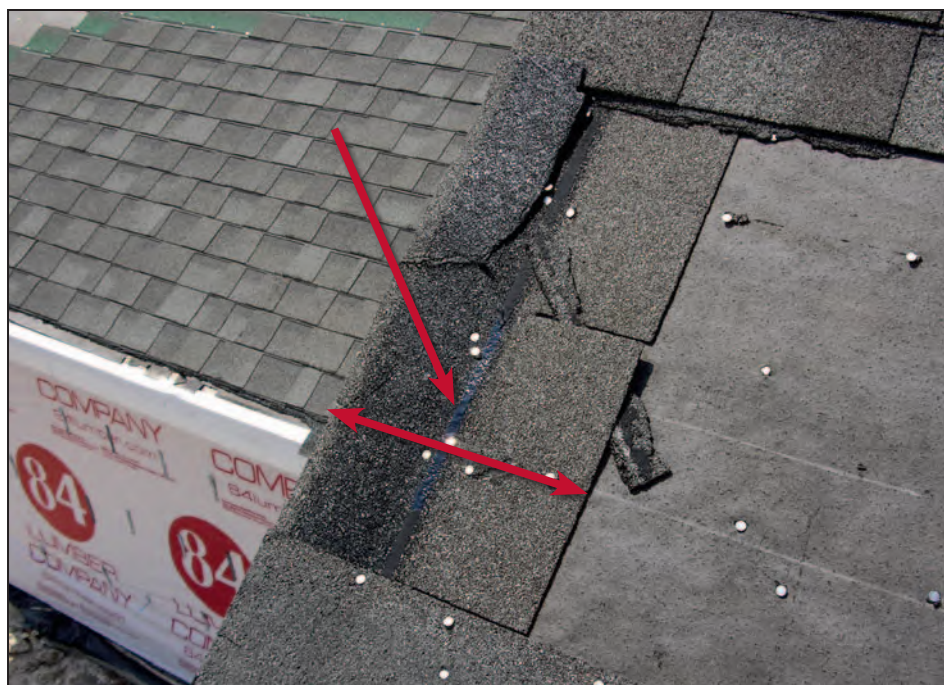
Figure 11-34.  
A bleeder strip (double-arrow) that was used at a rake blow-off; lack of contact between the tab of the overlying shingle and the bleeder's self-seal adhesive (upper arrow). Estimated wind speed: 125 mph. Hurricane Katrina (Mississippi, 2005)

Storm damage investigations have shown that on several damaged roofs, bleeder strips had been installed. Bleeder strips are shingles that are applied along the rake, similar to the starter course at the eave, as shown at Figure 11-34. A bleeder provides an extended straight edge that can be used as a guide for terminating the rake shingles. At first glance, it might be believed that a bleeder enhances wind resistance along the rake. However, a bleeder does not significantly enhance resistance because the concealed portion of the overlying rake shingle is the only portion that makes contact with the self-seal adhesive on the bleeder. As can be seen in Figure 11-34, the tab does not make contact with the bleeder. Hence, if the tab lifts, the shingle is placed in peel mode, which can easily break the bond with the bleeder. Also, if the tabs are not cut from the bleeder and the cut edge is placed along the rake edge, the bleeder's adhesive is too far inward to be of value.

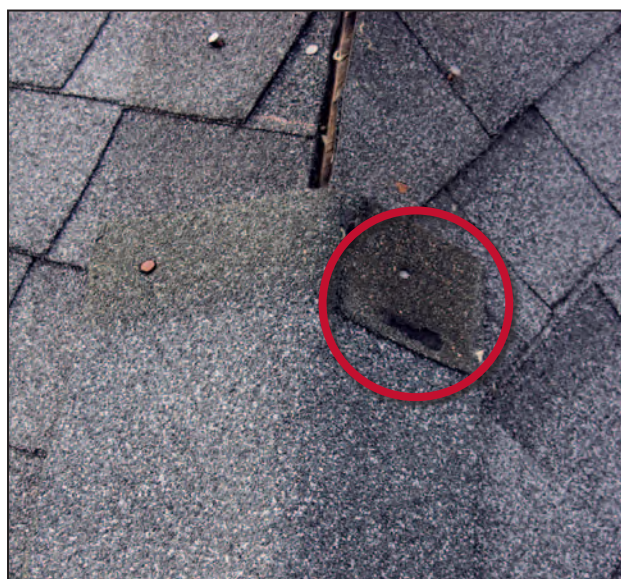
Figure 11-35.  
Inadequate sealing of the self-sealing adhesive at a hip as a result of the typical hip installation procedure. Estimated wind speed: 105 mph. Hurricane Katrina (Mississippi, 2005)

and hip shingles, see Figure 11-35. Fact Sheet 7.3 in FEMA P-499 provides enhanced eave, rake, and hip/ridge information that can be used to avoid failure in these areas.

Storm damage investigations have shown that when hip and ridge shingles are blown off, there was a lack of bonding of the self-seal adhesive. Sometimes some bonding occurred, but frequently none of the adhesive had bonded. At the hip shown in Figure 11-35, the self-seal adhesive made contact only at a small area on the right side of the hip (circle). Also, at this hip, the nails were above, rather than below, the adhesive line. Lack of bonding of the hip and ridge shingles is common and is caused by substrate irregularity along the hip/ridge line. Fact Sheet 7.3 in FEMA P-499 provides recommendations regarding the use of asphalt roof cement to ensure bonding in order to enhance the attachment of hip and ridge shingles.

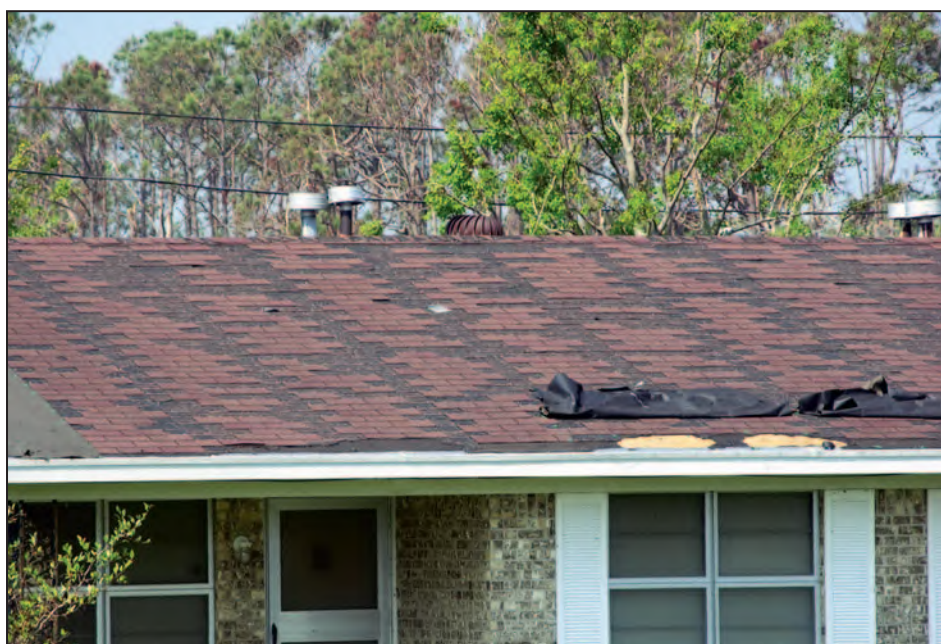
**Figure 11-38.**  
Shingles that unzipped at the band lines because the raking method was used to install them. Estimated wind speed: 135 mph. Hurricane Katrina (Mississippi, 2005)

Shingle damage is also sometimes caused by installing shingles via the raking method. With this method, shingles are installed from eave to ridge in bands about 6 feet wide. Where the bands join one another, at every other course, a shingle from the previous row needs to be lifted up to install the end nail of the new band shingle. Sometimes installers do not install the end nail, and when that happens, the shingles are vulnerable to unzipping at the band lines, as shown in Figure 11-38. Raking is not recommended by the National Roofing Contractors Association or the Asphalt Roofing Manufacturers Association.

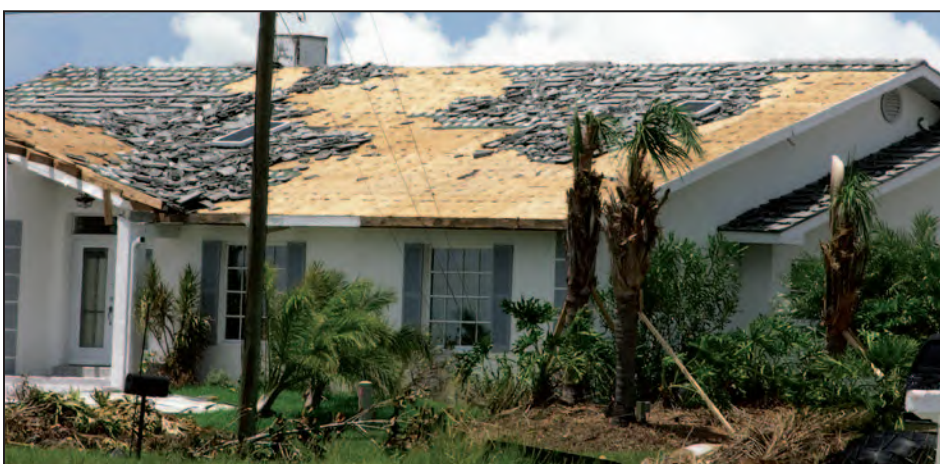
Figure 11-40.  
Large area of blown-off underlayment on a mortar-set tile roof. The atypical loss of waterproofing tile underlayment resulted in substantial water leakage into the house. Estimated wind speed: 140 to 160 mph. Hurricane Charley (Florida, 2004)

Figure 11-39 illustrates the type of damage that has often occurred during moderately high winds. Blow-off of hip, ridge, or eave tiles is caused by inadequate attachment. Damage to field tiles is typically caused by wind-borne debris (which is often tile debris from the eaves and hips/ridges). Many tile roofs occur over waterproof (rather than water-shedding) underlayment. Waterproof underlayments have typically been well-attached and therefore have not normally blown off after tile blow-off. Hence, many residences with tile roofs have experienced significant tile damage, but little, if any water infiltration from the roof. Figure 11-40 shows an atypical underlayment blow-off, which resulted in substantial water leakage into the house.

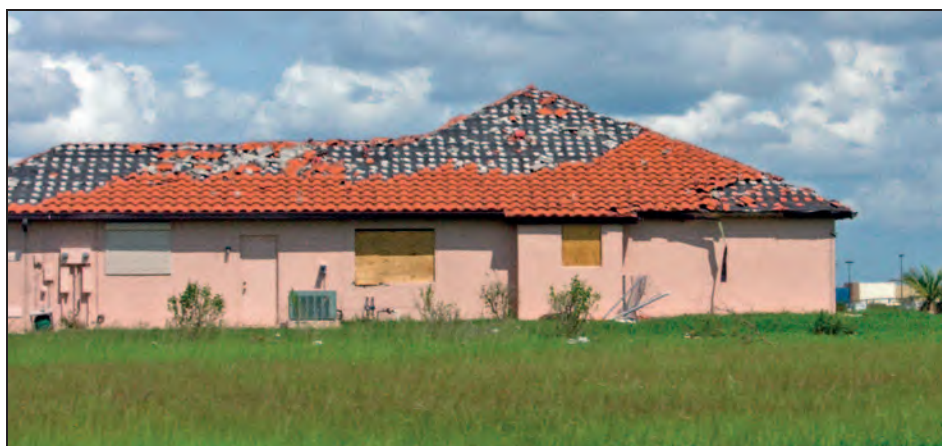
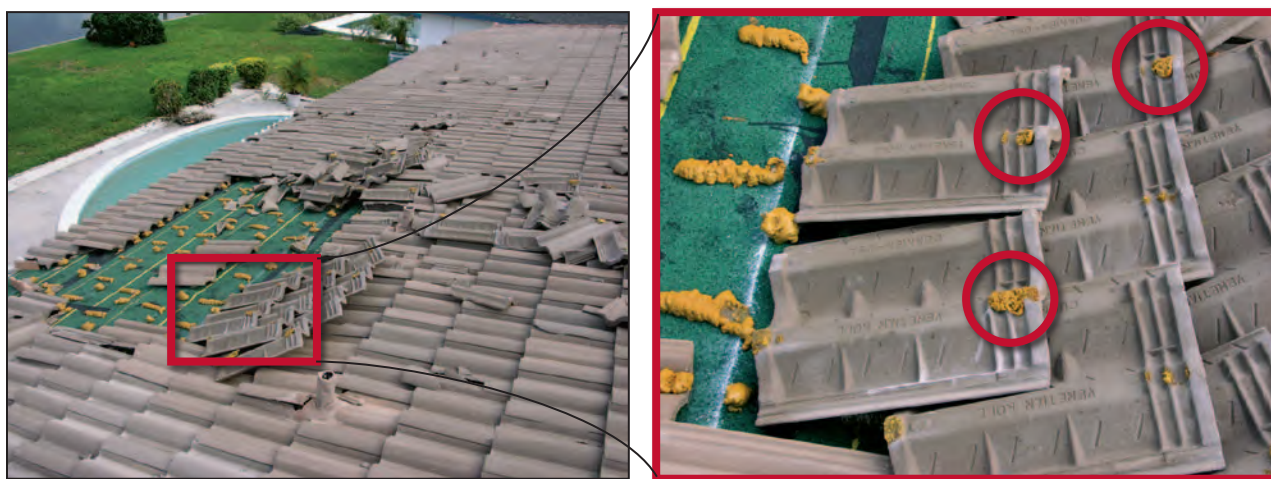
Figure 11-43.  
Blown-off adhesive-set tile. Note the very small contact area of the foam at the tile heads (left side of the tiles) and very small contact at the nose (circles). Estimated wind speed: 140 to 160 mph. Hurricane Charley (Florida, 2004)

Damage investigations have revealed that mortar-set systems often provide limited wind resistance (Figure 11-42).<sup>17</sup> As a result of widespread poor performance of mortar-set systems during Hurricane Andrew (1992), adhesive-set systems were developed. Hurricane Charley (2004) offered the first opportunity to evaluate the field performance of this new attachment method during very high winds (see Figures 11-43 and 11-44).

Figure 11-43 shows a house with adhesive-set tile. There were significant installation problems with the foam paddies, including insufficient contact area between the patty and the tile. As can be seen in Figure 11-43, most of the foam failed to make contact with the tile. Some of the foam also debonded from the mineral surface cap sheet underlayment (see Figure 11-44).

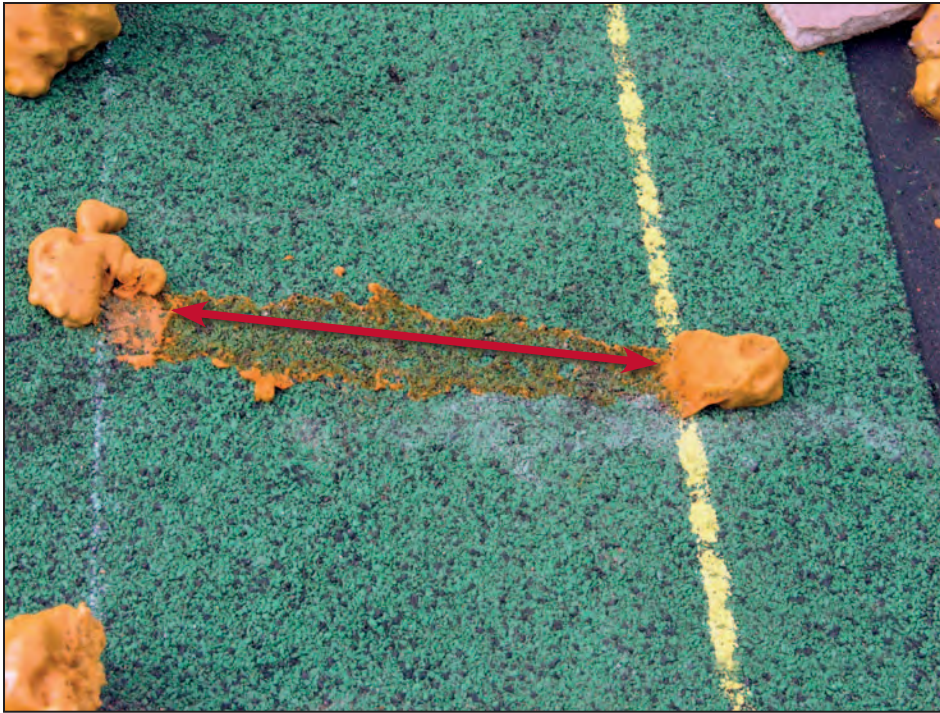
Figure 11-44.  
Adhesive that debonded  
from the cap sheet

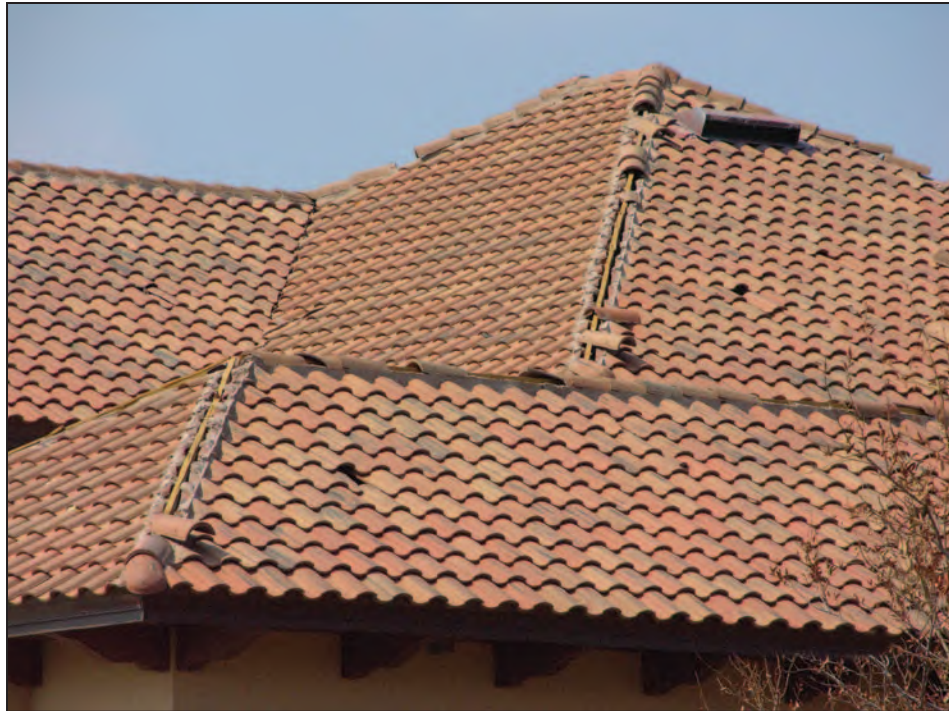
Figure 11-47.  
Damage to field tiles  
caused by tiles from  
another area of the  
roof, including a hip  
tile (circle). Estimated  
wind speed: 140 to 160  
mph. Hurricane Charley  
(Florida, 2004)

Because of the brittle nature of tile, tile is often damaged by wind-borne debris, including tile from nearby buildings or tile from the same building (see Figure 11-47).

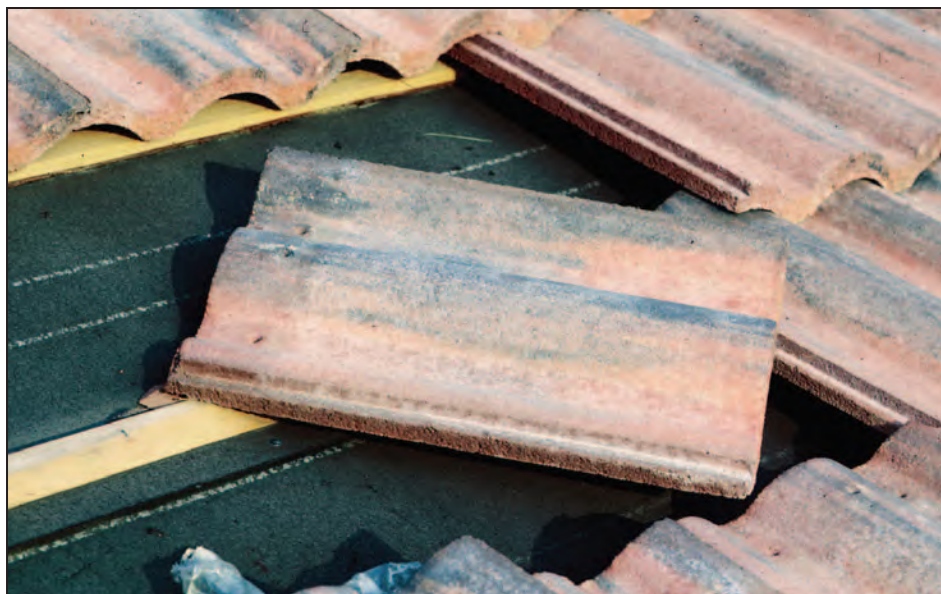
Figure 11-49.  
Area of the roof where  
tiles were not nailed to  
batten strips. Northridge  
Earthquake (California,  
1994)

- If tiles are laid on battens, supplemental mechanical attachment is recommended. When tiles are only loose laid on battens, they can be shaken off, as shown in Figure 11-49 where most of the tiles on the roof were nailed to batten strips. However, in one area, several tiles were not nailed. Because of the lack of nails, the tiles were shaken off the battens.

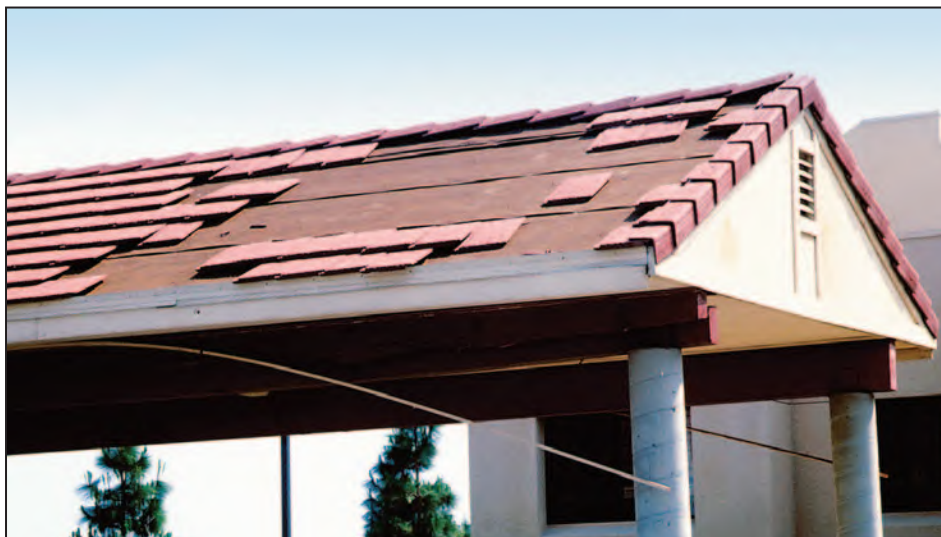
Figure 11-50.  
Tiles that were nailed  
to thin wood sheathing.  
Northridge Earthquake  
(California, 1994)

- Tiles nailed only at the head may or may not perform well. If they are attached with a smooth-shank nail into a thin plywood or OSB sheathing, pullout can occur. Figure 11-50 shows tiles that were nailed to thin wood sheathing. During the earthquake, the nose of the tiles bounced and pulled out the nails. Specifying ring-shank or screw-shank nails or screws is recommended, but even with these types of fasteners, the nose of the tile can bounce, causing enlargement of the nail hole by repeated pounding. To overcome this problem, wind clips near the nose of the tile or a bead of adhesive between the tiles at the headlap should be specified.
