# **Coastal Construction:**

## *Designing the Building Envelope*

# 11 Designing the Building Envelope

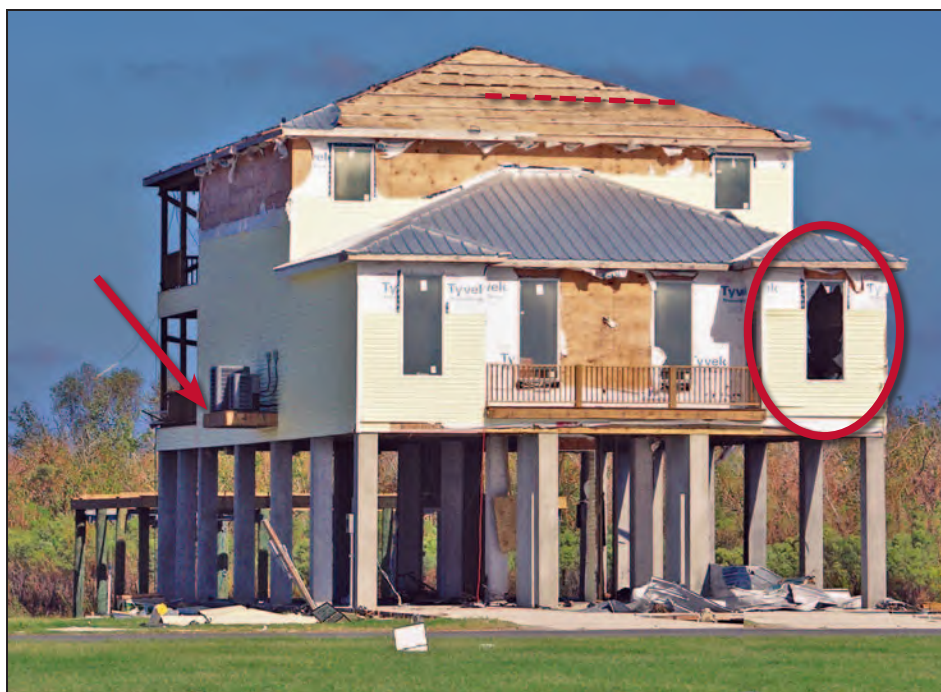
Figure 11-52.  
Blow-off of one of the  
nailers (dashed line on  
roof) caused panels  
to progressively fail;  
cantilevered condenser  
platform (arrow);  
broken window (circle).  
Estimated wind speed:  
130 mph. Hurricane  
Katrina (Louisiana, 2005)

Figure 11-52 illustrates the importance of load path. The metal roof panels were screwed to wood nailers that were attached to the roof deck. The panels were well attached to the nailers. However, one of the nailers was inadequately attached. This nailer lifted and caused a progressive lifting and peeling of the metal panels. Note the cantilevered condenser platform (arrow), a good practice, and the broken window (circle).

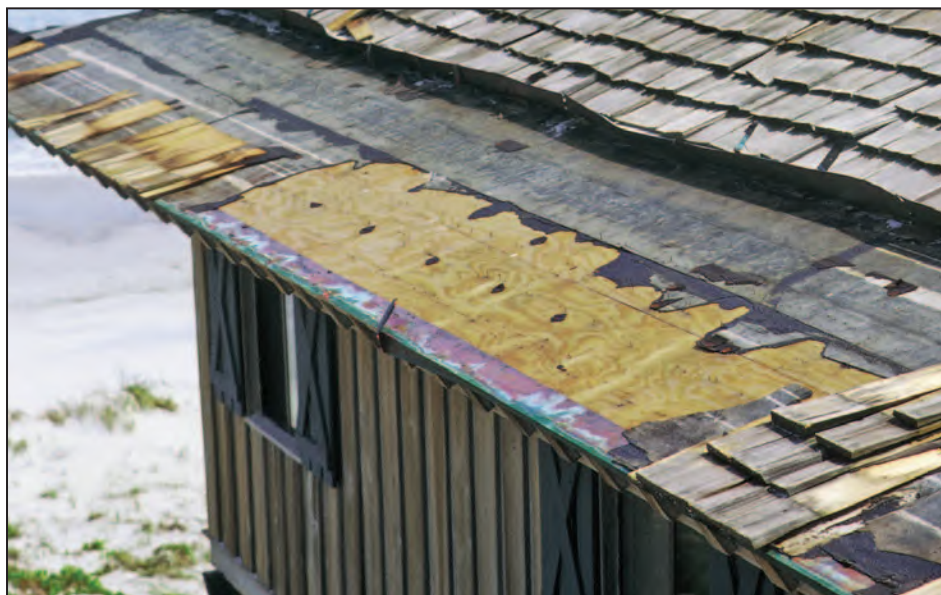
**Figure 11-54.**  
Loss of wood shingles  
due to fastener corrosion.  
Hurricane Bertha (North  
Carolina, 1996)

For enhanced durability, preservative-treated wood is recommended for shingle or shake roofs on coastal buildings. Stainless steel fasteners are recommended for roofs within 3,000 feet of an ocean shoreline (including sounds and back bays). See Figure 11-54 for an example of shingle loss due to corrosion of the nails.
