Pipe defects

Sarajevo 2022

Prepared by: DSc Dževad Hadžihafizović

Manufacturing: ERW Pipe Defects

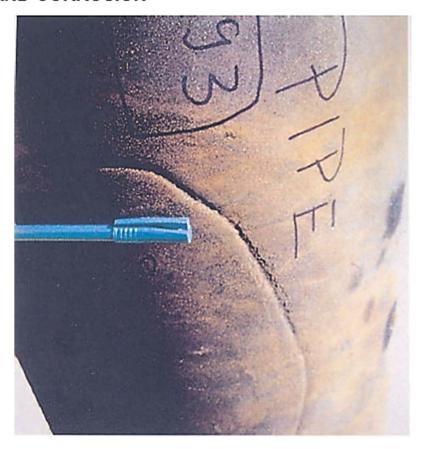
DAMAGE AND CORROSION

Corrosion of pipe steel exposed by mechanical damage.

Exposed steel will corrode if the applied cathodic protection is ineffective. Clean steel in gouges may be anodic to the surrounding pipe wall.

On above ground pipe areas exposed by mechanical damage will suffer atmospheric corrosion.

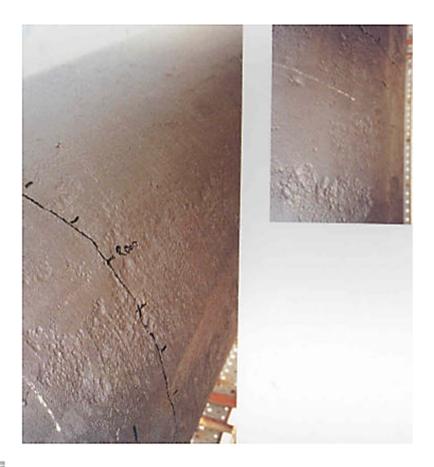
GENERAL CORROSION

Areas of irregular metal loss or pitting

Coating damage or disbanding combined with ineffective cathodic protection, for example due to shielding of the cathodic protection current under a disbanded coating.

General corrosion may also occur where soil contamination is entrained beneath a field applied coating.

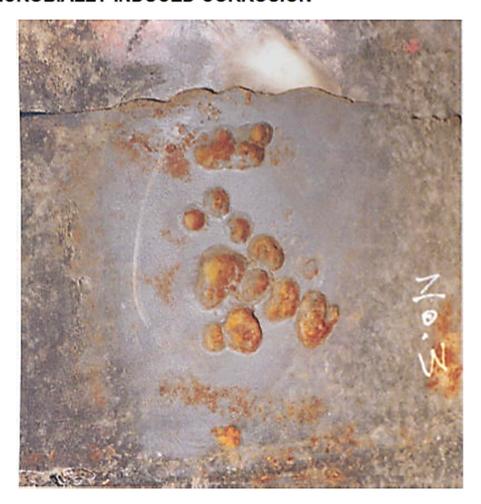
MIC - MICROBIALLY INDUCED CORROSION

Typically deep, sharp sided pits. Usually found under disbanded coating or hard accumulations on the pipe surface. When disturbed the area may smell of hydrogen sulphide.

The corrosion product within the pits is often soft, has no structure and is deep black in colour.

Bacterial activity in anaerobic conditions under the coating or surface deposit. The immediate area of microbial activity may be anodic to the surrounding pipe.

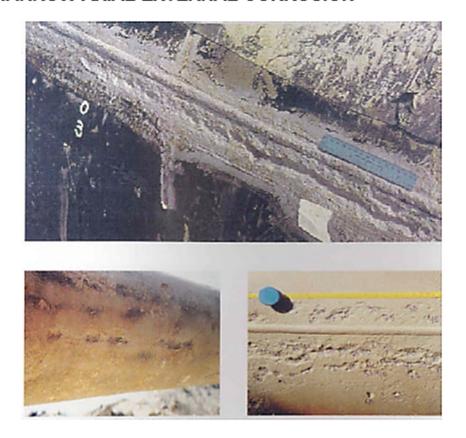
NAEC - NARROW AXIAL EXTERNAL CORROSION

Narrow lines of axial pitting, most commonly on either side of a seam weld or spiral weld. This pattern of corrosion may also occur at 3 o'clock and 9 o'clock beneath wrinkles in the coating caused by soil loading.

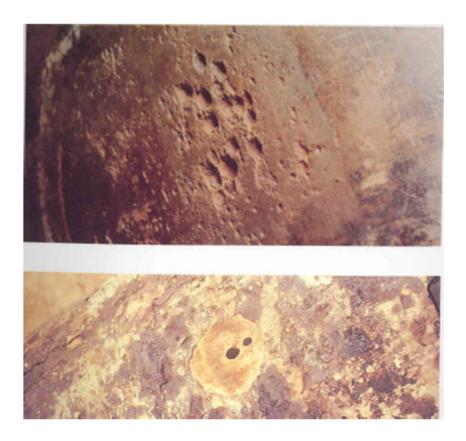
Localised corrosion, typically at areas where the coating has suffered impact or stone damage.

Damage to the coating and ineffective cathodic protection, for example where the pipe to soil potentials are less negative than -850 mV (with respect to a saturated copper -copper sulphate reference electrode).

Pitting may also be caused by microbial corrosion, stray current activity and galvanic effects.

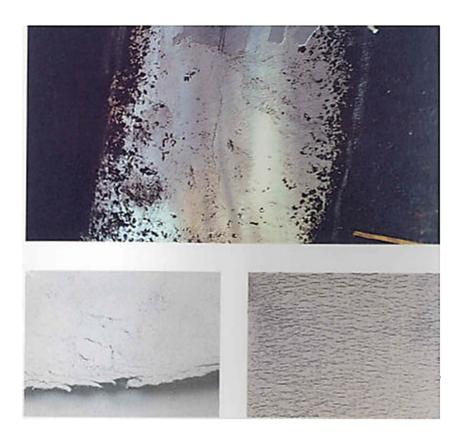
SCC - STRESS CORROSION CRACKING, HIGH

Irregular, intergranular cracks that are most commonly aligned axially on the pipe. Cracks are not usually associated with any pitting or general corrosion.

A complex array of factors contribute to the initiation and growth of high ph stress corrosion cracking including: high stress, pressure cycling, development of a carbonate – bicarbonate environment, partial shielding of the applied cathodic protection and permanent or seasonal wetness in the soil.

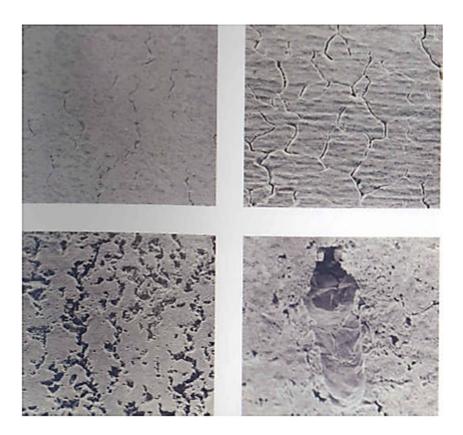
SCC – STRESS CORROSION CRACKING, INITIAL STAGES

These photo micrographs show preferential corrosion and crack initiation at grain boundaries aligned at right angles to the principal, cyclic stress acting on the pipeline.

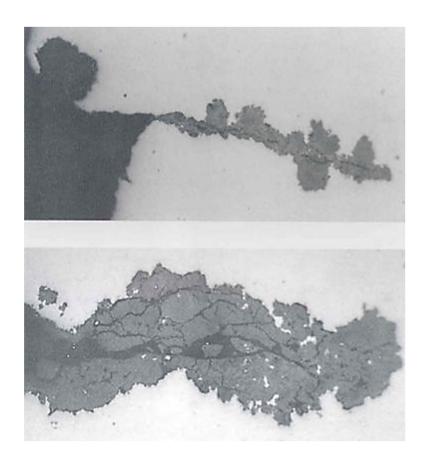
SCC - STRESS CORROSION CRACKING, NEAR NEUTRAL

Axial, transgranular cracks that are typically oxide or scale filled. Cracks may occur in association with pits and general corrosion.

This form of stress corrosion cracking occurs where the pipe surface is shielded from cathodic protection current, for example by a delaminated coating. It is thought to be most prevalent in high latitudes where there is a marked seasonal change in the carbon dioxide content of the soil. Some pressure cycling is required for initiation and growth.

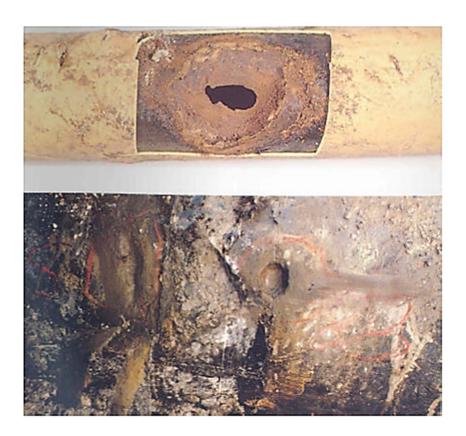
STRAY CURRENT

Concentration of deep corrosion at one, isolated location on the pipeline where there is one, or more, coating faults.

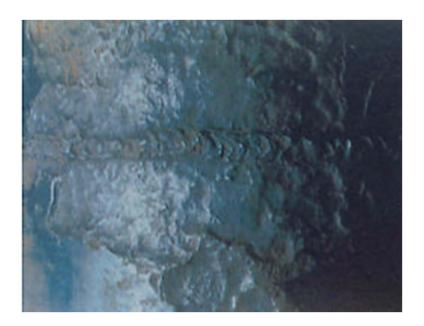
WELD AREA CORROSION

Corrosion limited to the immediate area of the field joint between the factory applied coating on the body of the pipe.

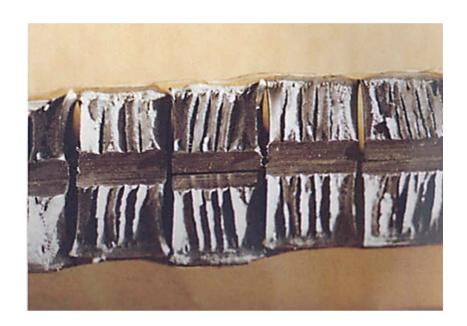
SEPARATIONS, CHARPY

Cracks, or crack like features that appear in the fracture face of mechanical test pieces.

Separations appear in Charpy, Crack Tip Opening Displacement and Drop Weight Tear Test pieces. Their occurrence may be influenced by steel chemistry and plate rolling conditions, particularly heavy deformation at low rolling temperatures. The crack like features are related to the steel structure, for example fine bands of martensite.

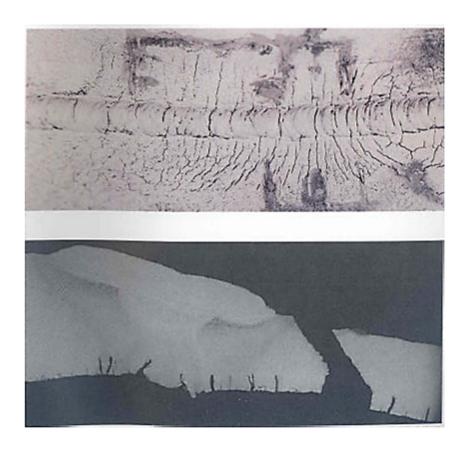
CO-CO2 SCC - STRESS CORROSION CRACKING

Internal cracking aligned at right angles to the principal stress.

A protective layer is formed on the pipe surface by a monolayer of adsorbed carbon monoxide. This film is dislocated at grain boundaries and exposes he steel to localized corrosion by water containing carbon dioxide.

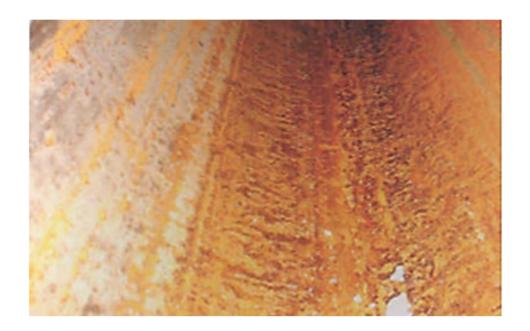
GROOVING

Narrow lines of pitting at the 6 o'clock position in a pipeline. The pits may join up to create an axial groove in the bottom of the pipeline.

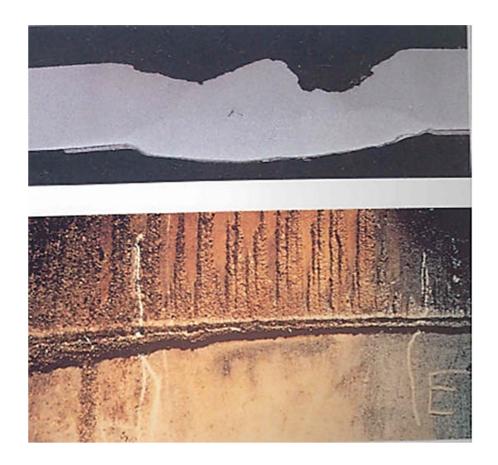
HAZ - HEAT AFFECTED ZONE CORROSION

Corrosion that is concentrated in a narrow band on either side of a weld, within the heat affected zone.

The heat affected zone is anodic to the pipe metal and weld metal. This forms a galvanic corrosion cell.

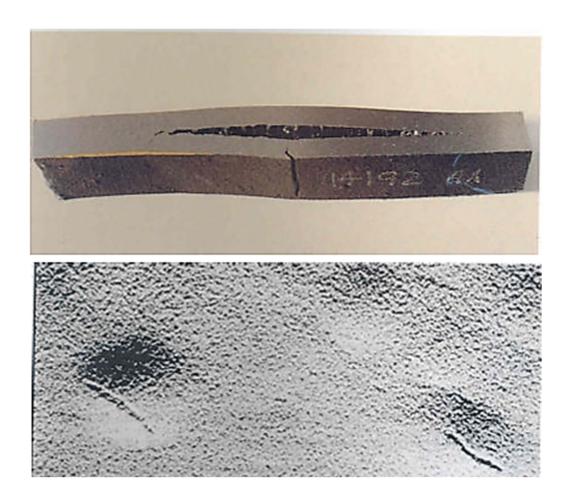
HIC - HYDROGEN INDUCED CRACKING

Mid-wall cracks that run parallel to the pipe wall. Cracks may join up, at different levels through wall cracks. Surface blisters may also contain cracks.

Hydrogen permeation from internal corrosion on sour service conditions. Atomic hydrogen diffuses into the pipe wall and hydrogen blisters form at inclusions. The gas pressure from these blisters generates crack growth.

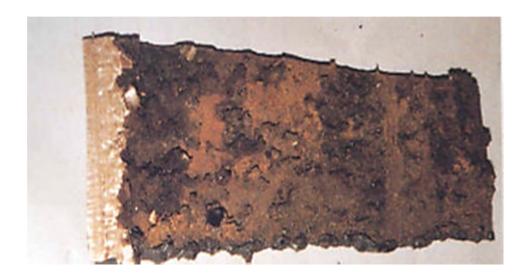
MESA

Extensive, steep sided corrosion between areas showing little or no corrosion.

In high temperature conditions, above \sim 60 C, protective scales are formed in sweet conditions. If these scales are damaged in conditions where they cannot re-form, for example in turbulent flow regimes, rapid sweet corrosion occurs.

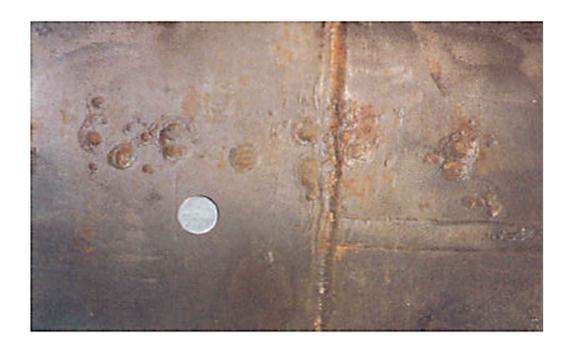
MIC - MICROBIALLY INDUCED CORROSION

Commonly occurs as distinct, deep and steep sided pits.

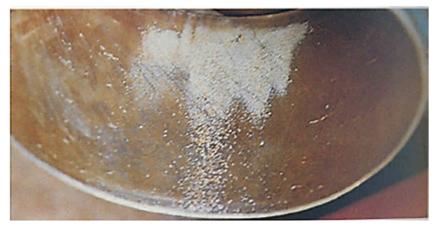
PITTING

Pitting occurs where water is present as a separatephase. In gas pipelines this may be caused by water condensation from the gas phase where the pipeline is cooled, for example by exposure to the sea water. In oil pipelines it may be caused by water drop out.

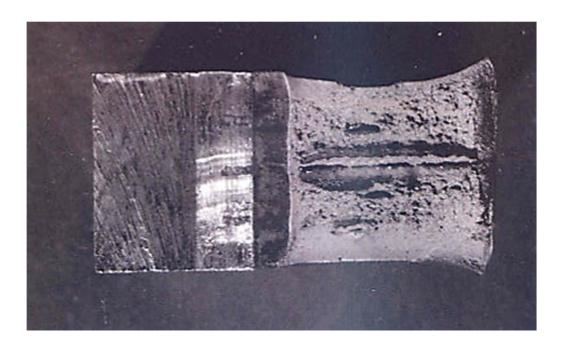
SEPARATIONS, CTOD

Cracks, or crack like features that appear in the fracture face of mechanical test pieces.

Separations appear in Charpy, Crack Tip Opening Displacement and Drop Weight Tear Test pieces. Their occurrence may be influenced by steel chemistry and plate rolling conditions, particularly heavy deformation at low rolling temperatures. The crack like features are related to the steel structure, for example fine bands of martensite.

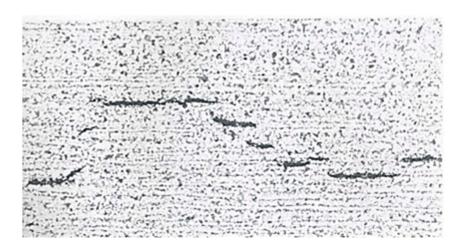
SOHIC - STRESS ORIENTED HYDROGEN INDUCED CRACKING

Cracks that run parallel to the pipe wall that join up, at different levels through wall cracks. Can occur in softened regions of the weld heat affected zone.

Hydrogen permeation from internal corrosion in sour service conditions. Atomic hydrogen diffuses into the pipe wall and hydrogen blisters generates crack growth. Cracks link together under the action of an applied stress, such as the operating pressure.

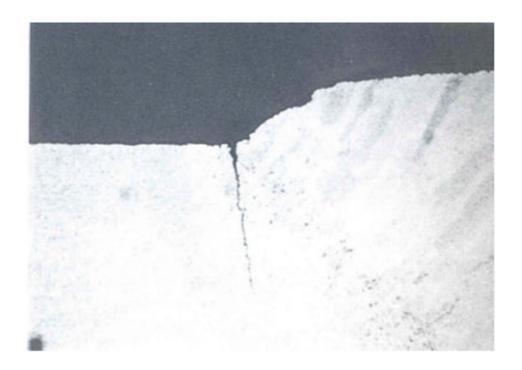
SSCC - SULPHIDE STRESS CORROSION CRACKING

Through wall cracking at hard spots, such as the heat affected zone of girth welds.

Hydrogen embrittlement of hard spots due to hydrogen diffusion from internal corrosion in sour conditions. Stress is required for crack growth, such as residual stresses within the weld.

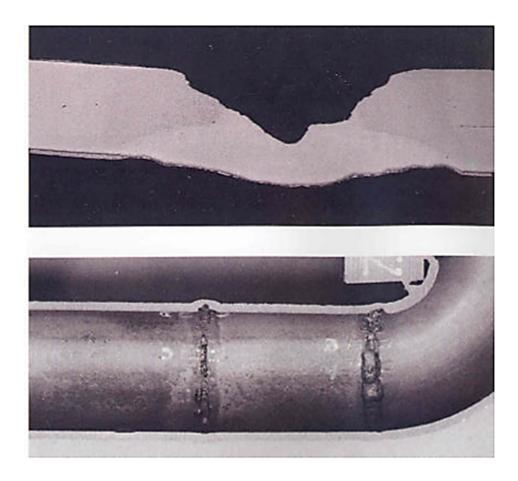
WELD CORROSION

Preferential corrosion of the weld metal.

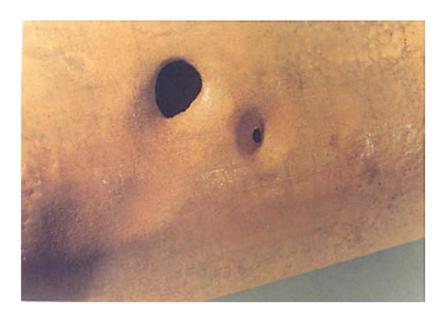
EROSION CORROSION

Localized, severe metal loss at location where the product flow is turbulent or where particles impact the pipe surface due to a change in direction of flow.

Turbulent flow (downstream of a valve or weld bead) or particle impingement removes surface films, scale or oxides to leave bright metal exposed. If this area is anodic to the adjacent pipe wall a galvanic corrosion cell will be formed.

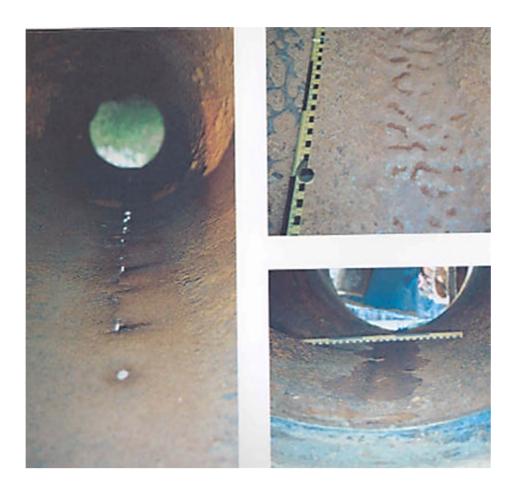
PARTICULATE EROSION

Metal loss, usually concentrated at the 6 o'clock position.

Particles of sand or scale are moved by the following product in a rolling or bouncing action. Impact by the particles may erode the pipe steel or destroy protective films and scales to allow erosion – corrosion.

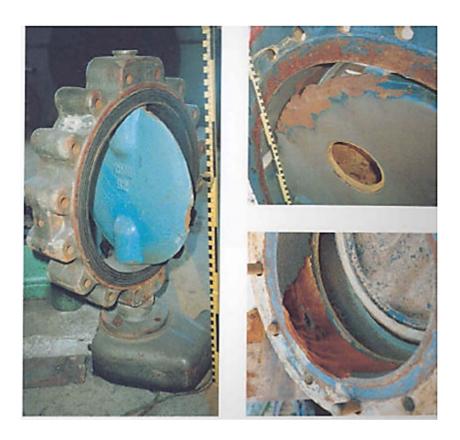
TURBULENT FLOW EROSION

Severe, often localized, metal loss at locations where the product flow is disturbed.

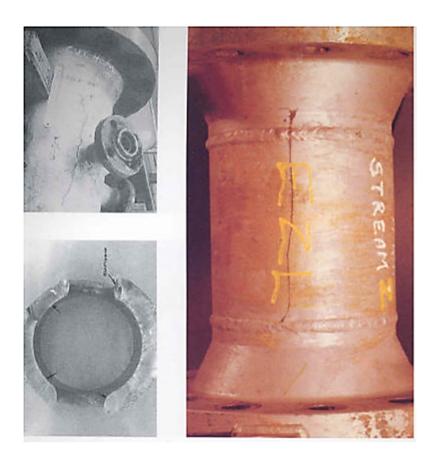
FATIGUE

Cracks aligned at right angles to the principal stress. Crack surfaces may show characteristic 'beach marks' that were formed at each stage of crack growth.

Cracks grow in response to stress, or pressure, cycling. Stress concentration occurs at the initiating defect or at the growing crack tip.

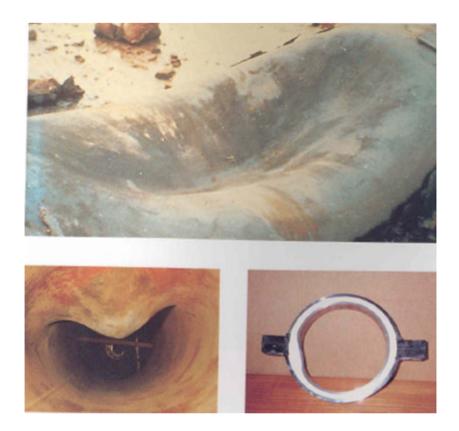
DENT

An indentation in the pipe wall.

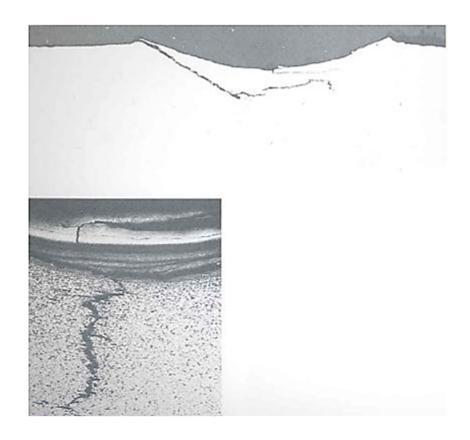
GOUGE AND CRACK

Irregular scores and gouging of the metal surface with cracking beneath the mechanical damage.

Mechanical damage by construction, excavation, drainage or agricultural equipment.

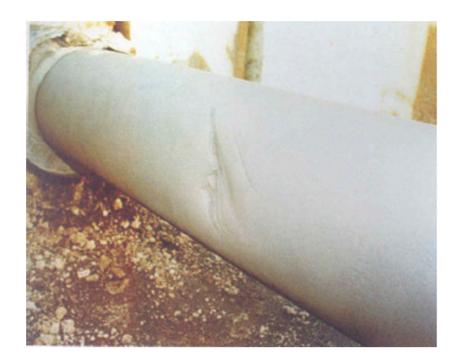
GOUGE AND DENT

Irregular scores and gouging of the metal surface contained within a dent.

Mechanical damage by construction, excavation, drainage or agricultural equipment.

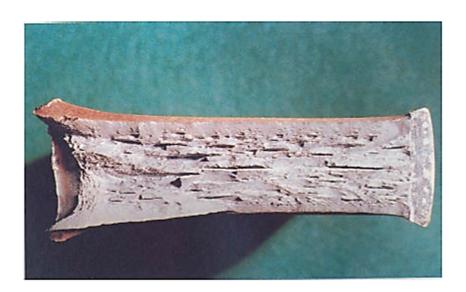
SEPARATIONS, DWTT

Cracks, or crack like features that appear in the fracture face of mechanical test pieces.

Separations appear in Charpy, Crack Tip Opening Displacement and Drop Weight Tear Test pieces. Their occurrence may be influenced by steel chemistry and plate rolling conditions, particularly heavy deformation at low rolling temperatures. The crack like features are related to the steel structure, for example fine bands of martensite.

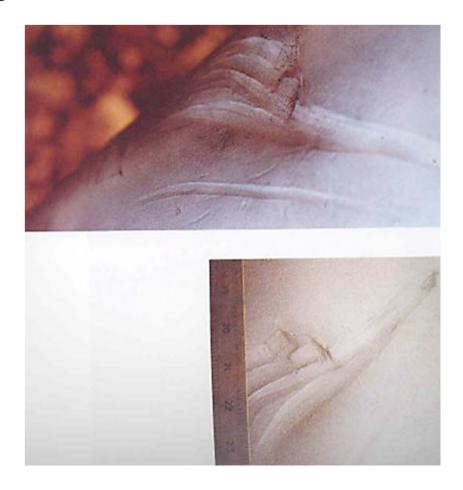
GOUGING

Irregular scores and gouging of the metal surface.

Mechanical damage by construction, excavation, drainage or agricultural equipment.

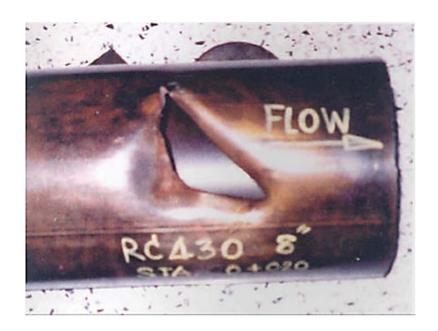
PENETRATION

Denting and penetration of the pipe wall.

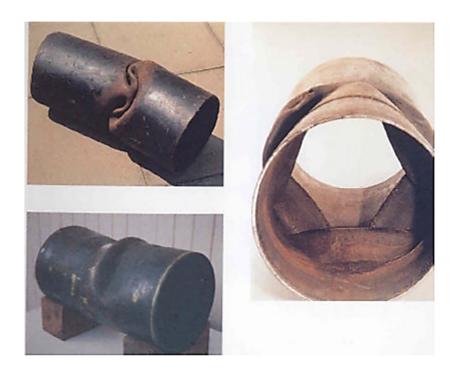
BUCKLE

Deformation of the pipe.

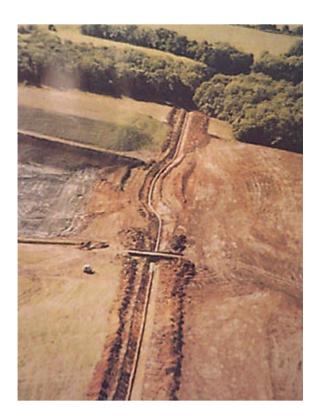
LANDSLIP

Sudden bulk movement of soil downslope.

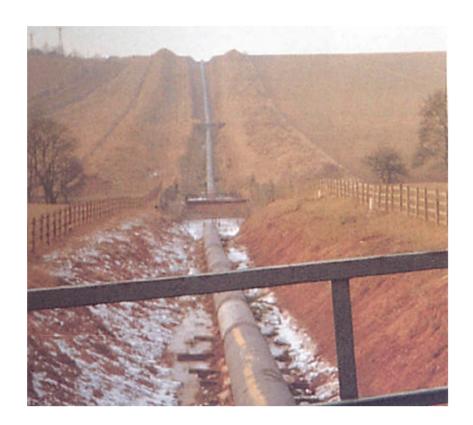
STRESS RELIEF

Soil creep, landslips, subsidence, swallow holes etc.

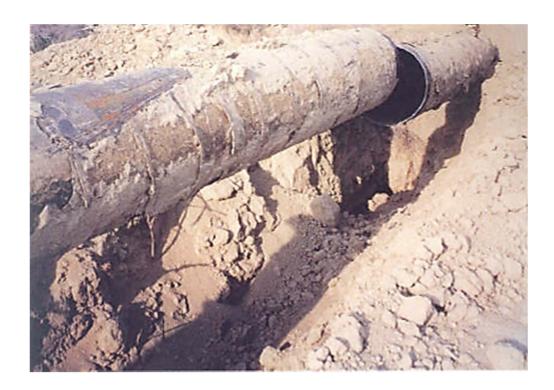
SUBSIDENCE

Sudden, localized collapse of the subsoil under a pipeline.

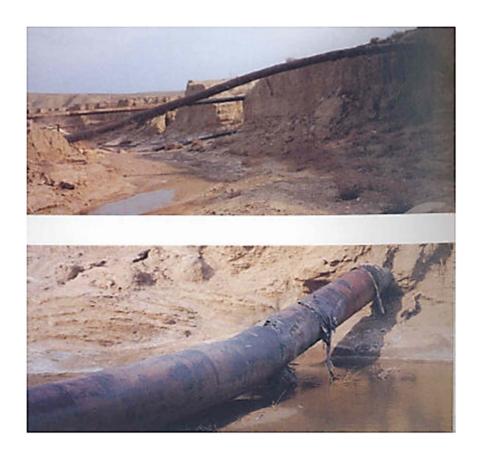
WASHOUT

Loss of backfill and the pipe bed

Severe erosion caused by flash floods.

Relieve any areas of stress concentration in the pipeline. Reinstate the pipe bed and provide protection against repeat washout or replace the section of pipeline

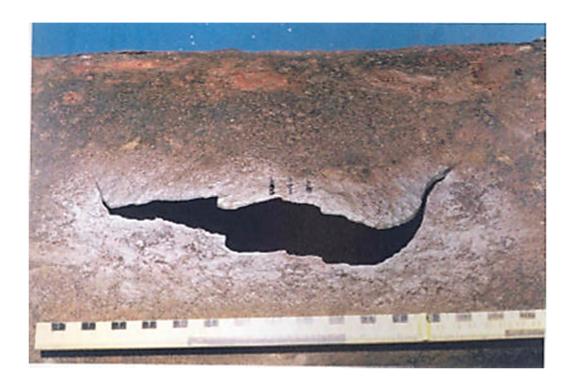
DUCTILE TEARING

Localized tear or rupture through the pipe wall.

Ductile tearing of the remaining ligament of the pipe, wall in an area of severe corrosion, due to the internal pressure of the product.

The risk of failure initiation is greatest from long, axial defects. Conventional magnetic flux leakage pigs may not provide accurate sizing of long, narrow axial defects.

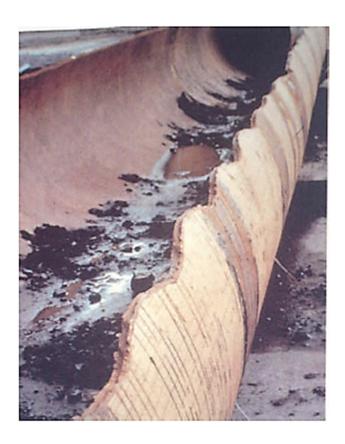
RUPTURE

Sinusoidal fracture

Crack growth in a brittle pipe steel proceeds faster than the depressurisation front following the initial rupture

Assess the steel properties, such as toughness, to assess the risk of a propagating fracture.

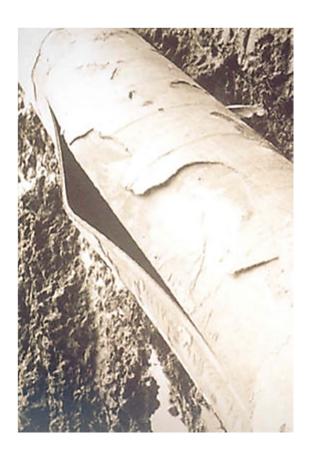
SEAM WELD FAILURE

Localized rupture

Failure caused by over-pressurisation or stress concentration at a defect.

Crack propagation will be made limited in a pipe steel with good toughness.

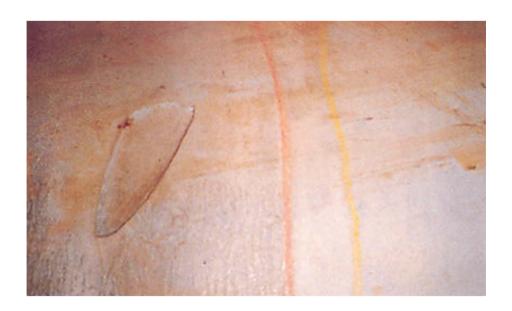
SLIVER

A thin. Elongated flap of metal rolled into the pipe surface, often with oxide or scale trapped beneath it.

Small slivers are not structurally significant. Soluble salts contained within scale or oxides beneath the sliver may initiate pitting corrosion. Slivers also create holidays in thin film coatings. Superficial slivers may be removed by grinding before application of the coating.

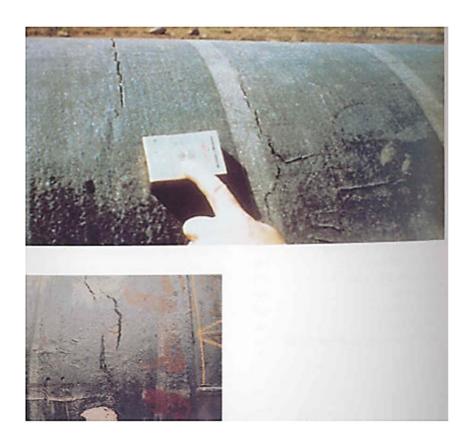
COLD BEND CRACKS

Irregular, circumferential cracks extending through the thickness of the coating.

Coating flexibility may be reduced at low temperature. If cold bending in the field is carried out at low temperature the coating may not have sufficient flexibility to tolerate the bending strain. If the coating adhesion is good cracking may result.

Remove all loose coating and any contaminants on the pipe surface. Mechanically wire brush the substrate and coating and use a trowelling grade, two pack liquid urethane coating to fill the void and overlap onto sound coating.

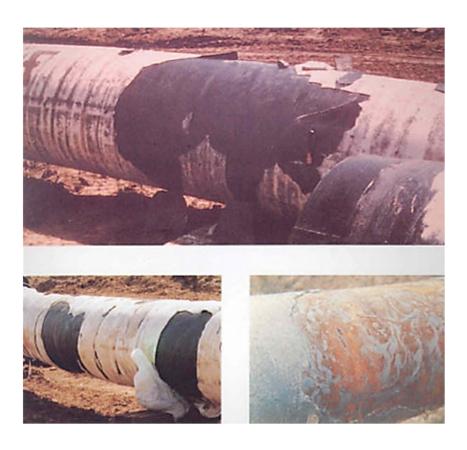
COLD BEND DELAMINATION

Complete loss of adhesion over large areas of the pipe surface.

Ensure the coating has the required flexibility for cold bending and set a minimum temperature limit for bending operations.

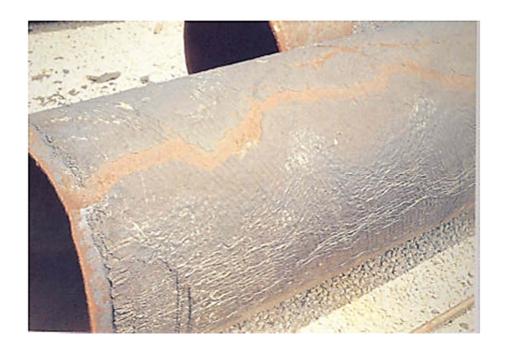
HIGH TEMPERATURE

Brittle, degraded coating which may show cracking, wrinkling and porosity.

Creep related degradation processes, such as wrinkling, proceed faster at higher temperatures.

Control product temperatures to a level below the softening point of the coating, especially at compressor or pumping station outlets.

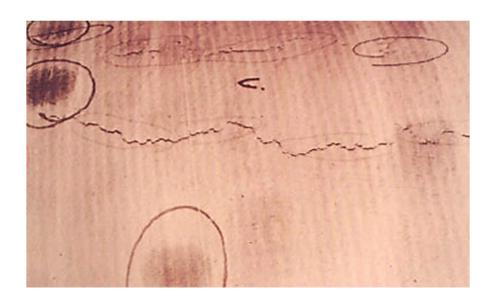
HYDROSTATIC TEST CRACKS

Irregular axial cracks through the coating.

Localized high strain during hydrostatic pressure tests at greater than 100% of the specified minimum yield strength.

Cracking may be concentrated along crimp lines out into the plate during manufacture, for example along either side of the submerged arc weld in 'U-and-O' formed pipe, and on either side of the spiral weld in spiral welded pipe.

Ensure coating flexibility is adequate at the environment temperature and water temperature at the time of the hydrostatic pressure test.

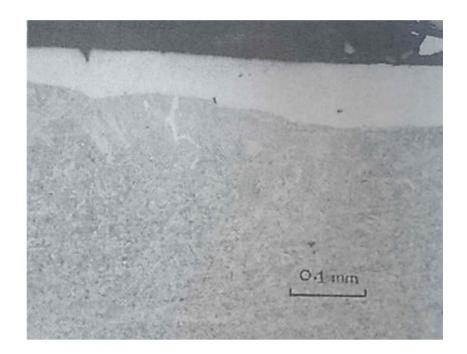
COPPER PENETRATION

Cracks like features normally at right angles to the pipe or plate surface.

Copper contamination occurs during the Pilger Mill process, for example following external contamination from defective equipment. Copper on the pipe surface penetrates into grain boundaries and forms a line of weakness that may open up, into crack like features, under stress.

In extreme cases the cracks can extend through the pipe wall.

Copper cracking should be detected by the Quality Control and pipe inspection procedures in the pipe mill.

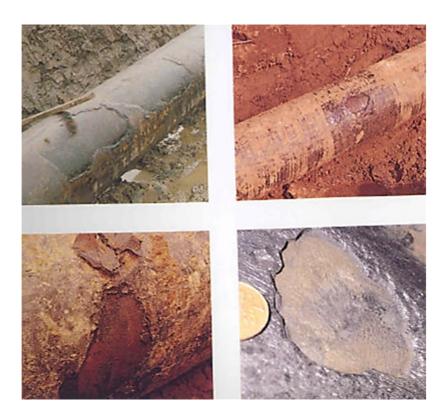
IMPACT DAMAGE

Complete loss of adhesion around the point of impact.

High energy impact from rocks or equipment exceed the performance specification for the coating. Under such impact conditions hot enamels may show brittle behaviour.

Remove loose coating and any contamination. Repair using a two pack liquid urethane or a full encirclement heat shrink, wrap around sleeve after appropriate surface preparation.

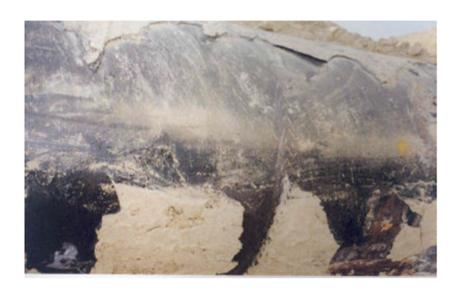
MECHANICAL DAMAGE

Scores or damage to the coating with possible loss of adhesion around the area of mechanical damage.

Damage from heavy plant during handling and ditching of pipe at the time of construction.

For areas where the coating is not damaged through to the substrate repair by the use of a hot trowel or spatula. Where the metal substrate is exposed remove all loose coating and any contaminants on the pipe surface. Mechanically wire brush the substrate and coating and use a trowelling grade, two pack liquid urethane coating to fill the void and overlap onto sound coating.

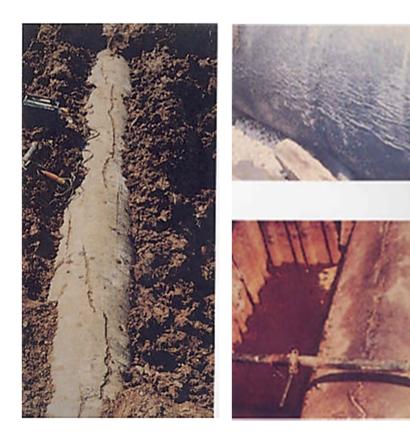
SOIL LOADING

Irregular cracking of the coating on the crown of large diameter pipe that extends through to the metal. Linear wrinkles, parallel to the pipe axis, as the 3 o'clock and 9 o'clock position. The wrinkles may be filled with water.

Settlement of the backfill, after construction, generates a tensile load in coating on the top half of large diameter pipe. Coatings that are susceptible to creep may develop cracks, wrinkles or both in response to this applied tensile load.

Use coatings that are not susceptible to creep. Overwrap the primary corrosion protection coatings with an adherent, low friction coating. Overwrap with a loose, deformable protective layer, but this layer MUST NOT interfere with CP current to the pipe.

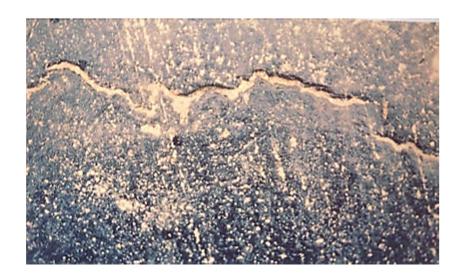
SOIL STRESSING

Irregular cracking and wrinkling of the coating with possible loss of adhesion.

Use coatings that are not susceptible to creep. Overwrap the primary corrosion protection coatings with an adherent, low friction coating. Overwrap with a loose, deformable protective layer, but this layer MUST NOT interfere with CP current access to the pipe. Strip all areas of coating that show loss of adhesion or voids and all areas with moisture beneath the coating. Re-coat with a compatible, two pack liquid repair system after appropriate surface preparation.

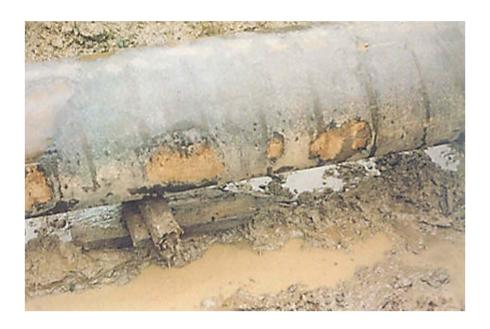
STONE DAMAGE

Irregular shaped holes in the coating, possibly in association with delamination or disbonding.

High point loads from stones standing proud of the pipe bed. If the profile of the pipe bed is irregular stone damage will be concentrated at high points.

Grade the pipe bed before ditching the pipe and use some form of padding or protection in stony ground. If the damage does not expose the metal substrate then use a hot trowel to spread the enamel into the damaged area. If the metal substrate is exposed then remove all loose coating. Where possible abrasively blast clean the exposed substrate and feather the blast cleaning onto the surrounding coating. If abrasive blast cleaning is not possible then use mechanical wire brushing. Apply a trowelling or brushing grade of a compatible, two pack liquid repair system and overlap onto the surrounding coating.

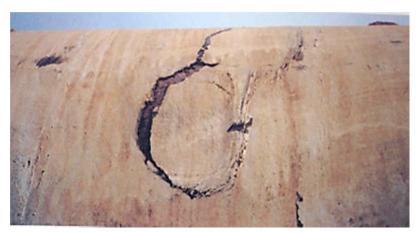
SUSTAINED LOADS

Remove all loose coating. Where possible abrasively blast clean the exposed substrate and feather the blast cleaning onto the surrounding coating. If abrasive blast cleaning is not possible then use mechanical wire brushing. Apply a trowelling or brushing grade of a two pack, liquid urethane and overlap onto the surrounding coating.

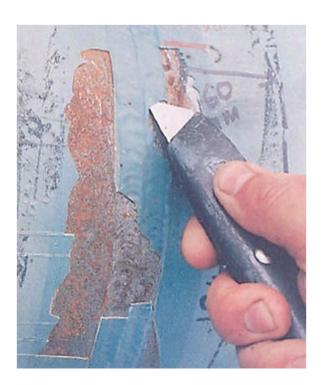
BLISTERING AT FIELD JOINTS

Very poor adhesion of the coating to the pipe.

Remove all loose coating. Prepare the exposed substrate by abrasive blast cleaning, roughen the surrounding coating and feather the edges. Remove all contamination. Apply a two pack, liquid urethane or epoxy repair material.

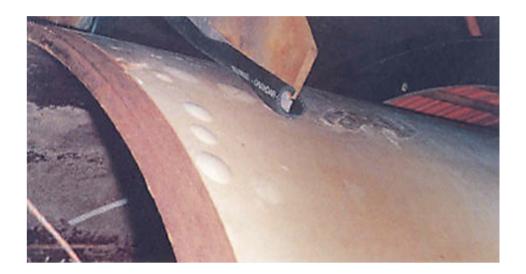
BLISTERS

Raised areas of coating.

Blistering may occur over areas of contamination on the pipe surface or where there is a relatively high level of moisture within the coating or at the coating – steel interface. Blisters can appear in the coating plant but are most common during induction heating for field joint coating. Blisters may develop when coated pipe is reheated for any reason.

For isolated blisters remove all areas of coating with poor adhesion. Roughen the adjacent area of sound coating, remove all contamination and ensure the surface is dry. Apply a two pack, liquid repair material.

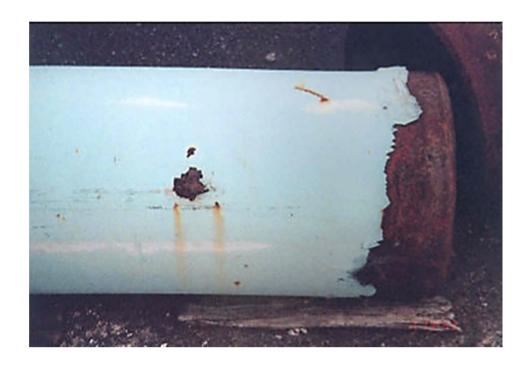
CORROSION AT CUT BACK

Lifting of the coating at the ends of the pipe with corrosion underneath.

Moisture creep under the coating from the cut back or moisture ingress through defective coating. Incorrect temperature profile along the pipe in the coating mill resulting in 'cold' pipe ends and poor adhesion.

Ensure that the plant application parameters are correct. Resistance to adhesion loss will be improved by the use of chemical treatments such as phosphoric acid and chromate. Apply a temporary protective to the cut back on pipes that are expected to remain in storage for long periods. Remove all loose coating procedures or blast clean and feather onto sound coating, remove contamination and apply a two pack liquid urethane or epoxy repair material.

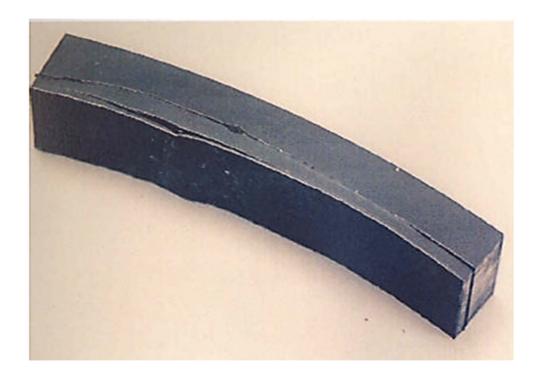
DOUBLE SHELL

A discontinuity in the pipe wall that, in extreme cases, splits the pipe wall into two segments.

Separations that run at an angle to the pipe wall may be structurally significant and should be detected by the inspection procedures in the pipe mill. Separations that rum parallel to the pipe surface may not be detected, but may not be significant.

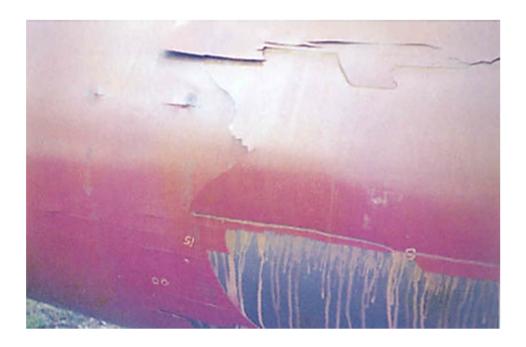
CRACKS

Thin lines that appear as a different colour to the main body of coating. After weathering rust staining may accentuate the line of the cracks.

Cracking may occur during cold bending or hydrostatic testing and the risk of cracking is increased if these operations are carried out at low temperature and at high strain. The risk of cracking is increased by over-cure of the coating.

Establish a minimum temperature limit for cold bending and hydrostatic testing and limit the degree of strain to lie within the coating's demonstrated flexibility.

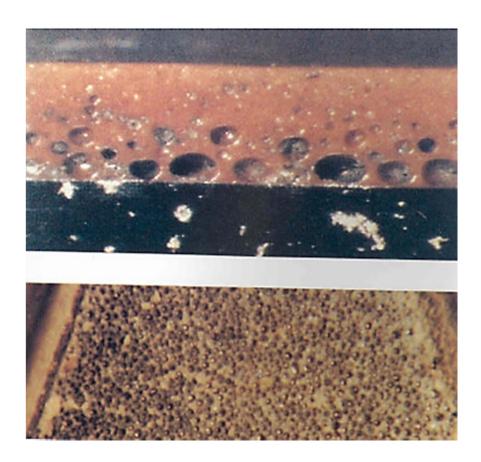
FOAMING

Round, gas filled voids within the coating. The void content is usually highest close to the metal surface.

Application temperature too high or moisture content of the powder is too high.

Ensure that the moisture content of the powder complies with the manufacturers recommendations.

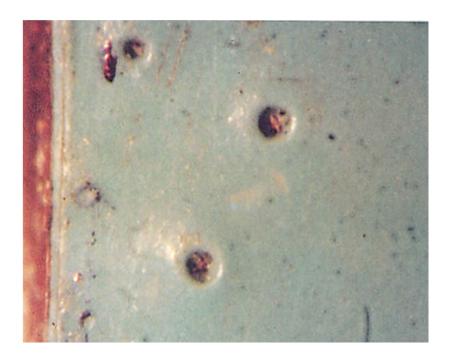
INCLUSION

Bumps and protrusions on the surface of the coating.

Remove all affected coating and abrade the area of damage with an overlap onto sound coating. Remove all contamination. Apply a two pack, liquid urethane or epoxy repair material

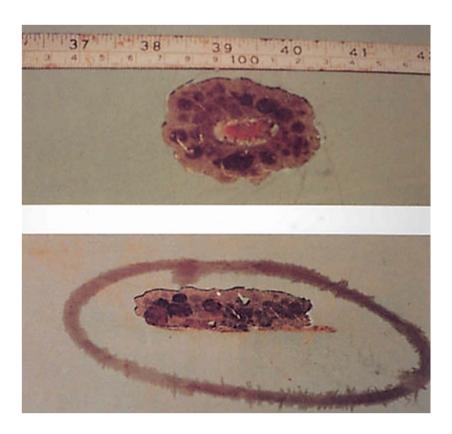
LEOPARD SPOTTING

Rust spotting beneath delaminated or disbonded coating around pinholes in the coating.

Incomplete removal of salt contamination during surface preparation which creates small corrosion cells as moisture penetrates to the steel surface.

Remove all loose coating and abrade the area of damage with an overlap onto sound coating. Remove all contamination. Apply a two pack, liquid urethane or epoxy repair material.

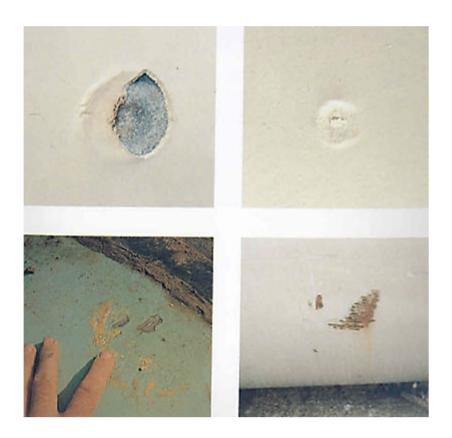
MECHANICAL DAMAGE

Irregular shaped areas where the coating has been lost.

Impacts from excavation or construction equipment or from pipe bevels during handling. Stone damage due to vandalism or impacts from rocks in the backfill may also occur.

Remove all loose coating and abrade the area of damage with an overlap onto sound coating. Remove all contamination. Apply a two pack, liquid urethane or epoxy repair material.

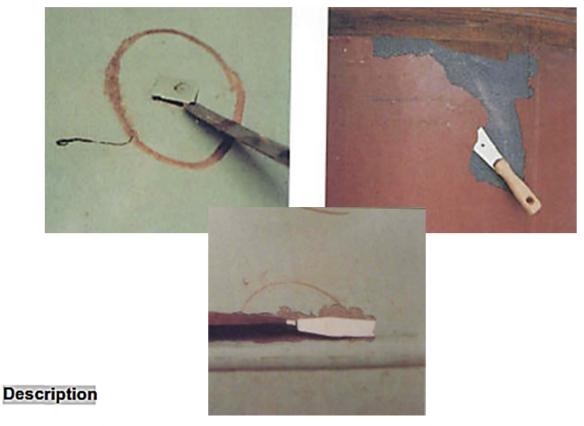
POOR ADHESION

Coating has lost all adhesion, or can be easily peeled from the substrate.

A number of factors may contribute to this problem, including: incorrect surface profile; shielding of the pipe surface from blast abrasive cleaning by the linear seam weld bead; contamination of the surface; incorrect application temperature; inadequate flow of the fused coating into the blast profile.

Remove loose coating and apply the procedures approved for the coating of field joints.

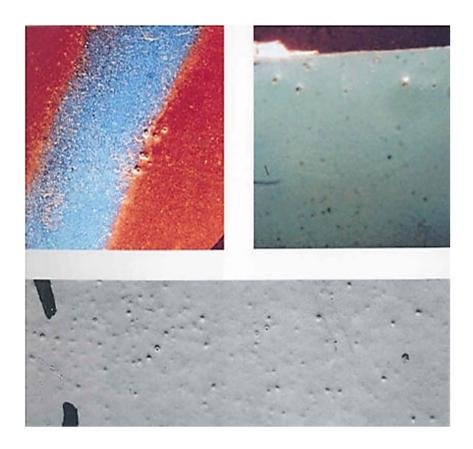
ROUGHNESS/PINHOLES

Broken blisters showing at the coating surface. On badly affected pipe this may appear as general roughness on the surface of the coating.

Inadequate surface preparation. Blistering may be caused by soluble salts or corrosion products remaining on the pipe surface after surface preparation for coating application. Moisture contained in the contamination is driven off during the heating and coating process. This moisture generates bubbles in the coating which appear on the surface as raised 'eruptions' and pinholes.

Upgrade the surface preparation procedures to remove contamination, for example by the use of phosphoric acid treatment. Remove the affected coating, prepare the surface and apply a two pack liquid urethane or epoxy.

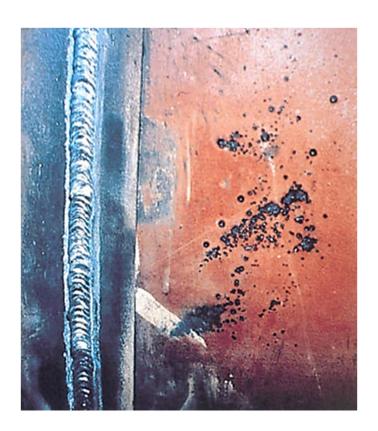
WELD SPATTER

Irregular holidays in the coating adjacent to girth welds.

Damage caused during girth welding. Weld spatter causes localized defects by burning through the fusion bonded epoxy powder coating.

Protect the pipeline coating from weld spatter adjacent to the cut back area at the end of the pipe.

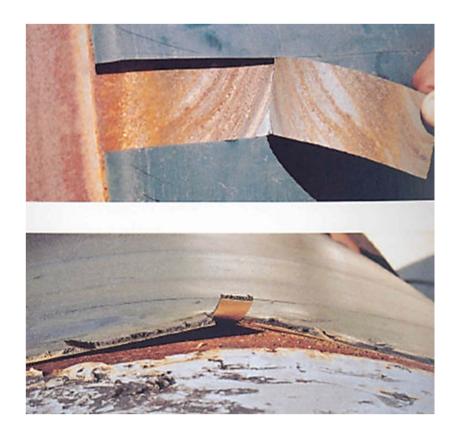
ADHESION LOSS AT CUT BACK

Complete loss of adhesion, during storage, of the coating next to the cutback at the bevel ends of pipe or fittings. Corrosion may be present beneath the affected coating .

Moisture creep under the coating during storage. This process will be accelerated by contamination under the coating and poor original adhesion due to incorrect application.

Cut back the affected areas to sound coating. This creates a larger cut back than normal at pipe joints. Prepare and coat the enlarged cut back using the normal field joint coating procedures.

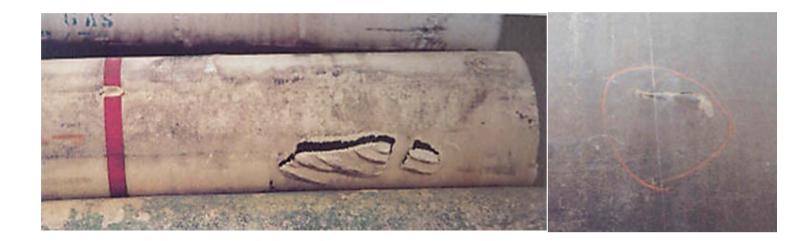
MECHANICAL DAMAGE

Irregular shaped tears or damage to the coating that exposes the pipe surface or allows water to penetrate to the pipe surface.

Damage from excavation or construction equipment, or from impacts from pipe bevels during handling.

Damage may also result from point loads during storage, for example placing pipe directly onto wooden battens, and from stone or rock impact in the pipe bed or backfill.

Remove all of the loose coating. Chamfer the edges of the sound coating and clean and prepare the damaged area including an overlap onto sound coating.

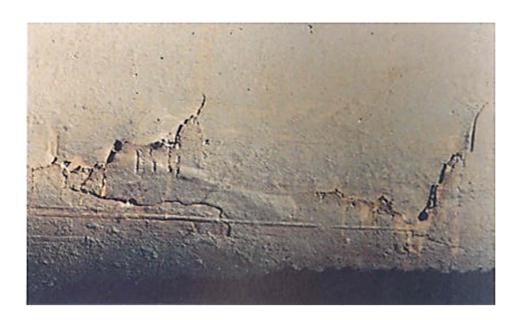
INGOT DEFECTS

Irregular shaped crack-like defects running into the pipe wall at a high angle to the pipe surface.

Defects in the surface of the original ingot that have not been removed during scarfing in the pipe forming process.

Small surface defects are not structurally significant but may create defects in thin film coatings.

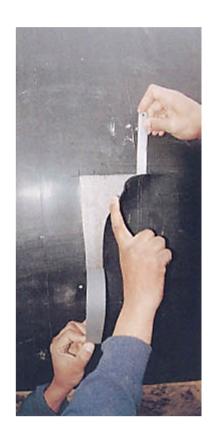
POOR ADHESION

Loss of bond to the substrate such that all layers of the coating may be removed cleanly from the metal substrate.

After construction: Strip the coating and repair with a two pack liquid urethane or a wrap around heat shrink material.

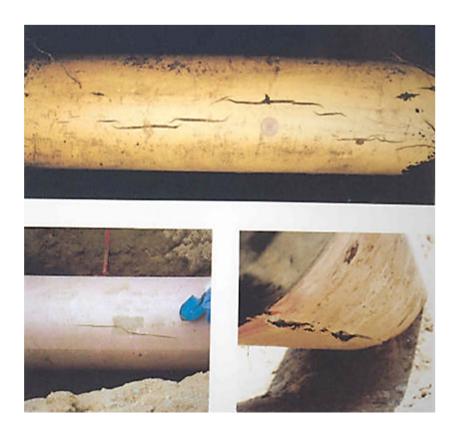
STRESS CRACKING

Irregular cracks penetrating through the polyolefin layer. Cracks are predominantly longitudinal on pipes with a diameter larger than 150 mm, and may be circumferential on small diameter pipe.

A combination of poor stress crack resistance in the polyethylene polymer and residual stress within the coating from the cooling phase of the coating application process.

Use only polyolefin polymers with good stress crack resistance.

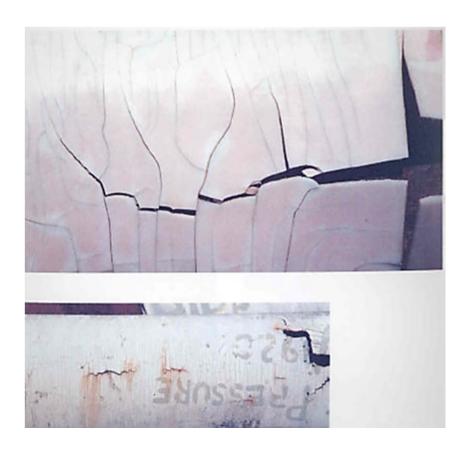
UV DEGRADATION

Crazing and cracking of the polyethylene.

UV degradation and embrittlement of a susceptible polyolefin polymer during prolonged storage or in service above ground.

Use polyolefin polymers with good stress crack resistance. Use carbon black filler to minimize Ultra Violet penetration. Protect the coating from Ultra Violet exposure.

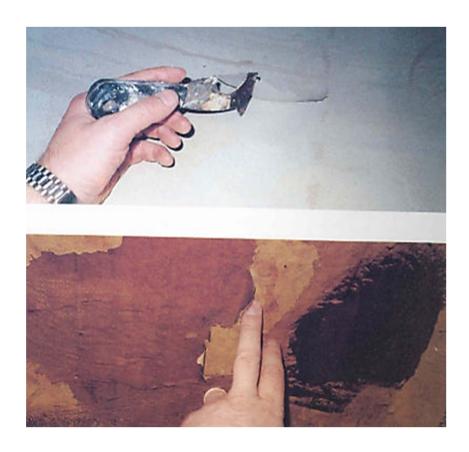
DELAMINATION

Loss of adhesion between one layer of coating and the next.

Ensure that the manufacturers recommendations are followed for the timing of over-coating.

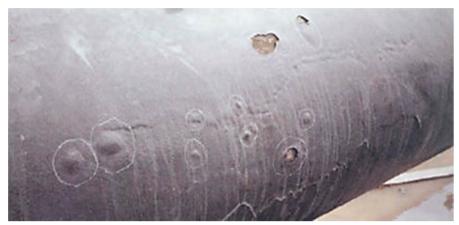
MIS METERING

Cut out affected areas back to sound coating. Chamfer the edge of the coating and prepare the surface. Apply a compatible two pack, liquid repair material.

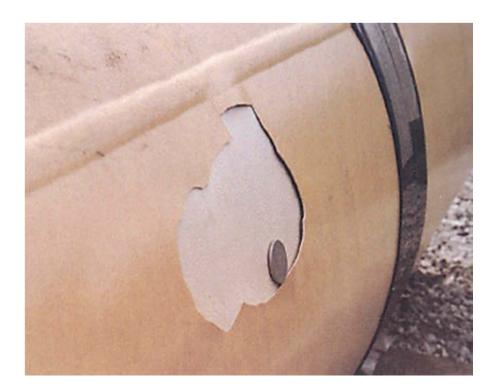
POOR ADHESION

Coating may be removed from the substrate.

Completely remove the affected coating. Re-prepare the substrate and re-coat.

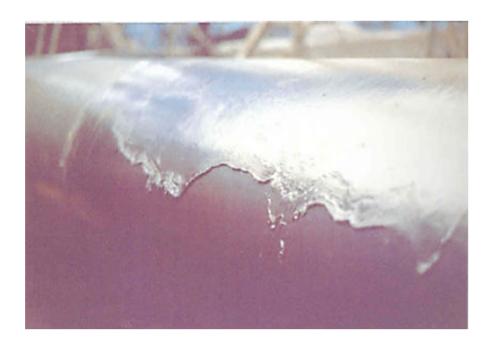
SAGGING

Runs and sags visible on the coating surface.

Runs and sags are unsightly but if the coating shows correct adhesion and cure the protection performance may be unimpaired.

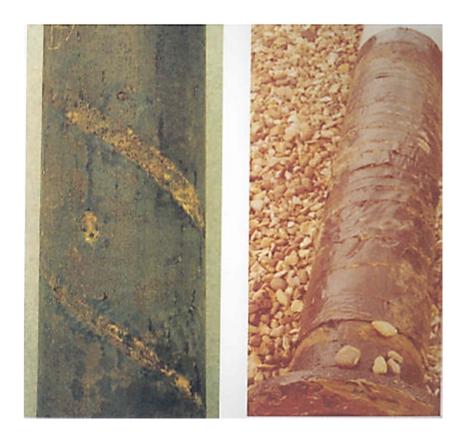
ADHESION LOSS AT OVERLAP

Spiral pattern of corrosion following the line of overlap between successive turns of tape.

Specify the minimum acceptable overlap between successive turns of tape, for example 55 %. Carry out coating procedure qualification tests and operate an effective quality control policy an site. Remove all of the cold applied laminate tape and prepare the substrate and coating on either side. Apply a compatible two pack, liquid urethane coating or re-wrap with cold applied laminate tape ensuring a minimum overlap of at least 55 % between turns.

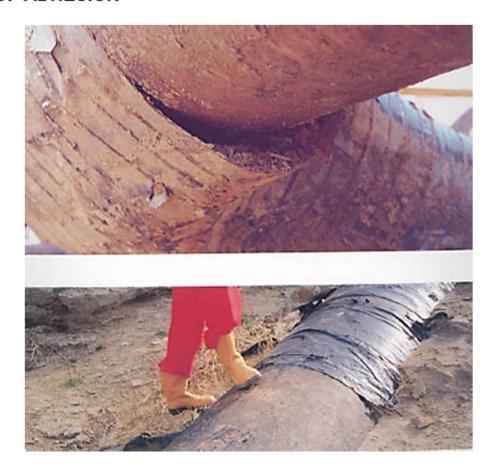
LOSS OF ADHESION

Tape becomes detached from pipe surface and water enters behind the coating. Where soil is washed in the coating may sag under the weight.

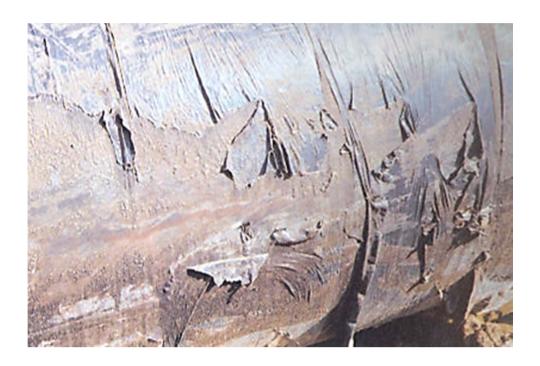
MECHANICAL DAMAGE

Tearing of lifting of the coating in areas where it has been subject to an impact load.

Remove all loose coating.

For small areas of damage use an overwrap of cold applied laminate tape, ensuring a minimum of three complete turns around the pipe and an overlap of 55% between turns.

For large areas of damage prepare the exposed metal substrate and the adjacent coating and apply a compatible two pack, liquid coating or rewrap with cold applied laminate tape ensuring a 55% overlap between successive turns of tape.

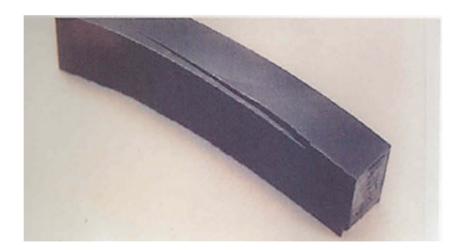
LAMINATONS

A discontinuity lying parallel to the pipe surface, usually marked by a concentration of nonmetallics.

Rolling-out of inclusions, blow holes, pipes or ingot cracks in the parent material.

Large laminations may be structurally significant. Some older pipelines contain pipes with large laminations that have not created a safety hazard in many years service. However, such defects could pose a problem if through-thickness stresses are generated in the pipe wall, for example during top tap or repair welding operations.

Surface breaking laminations may contribute to coating faults and may serve as an initiation point for pitting corrosion.

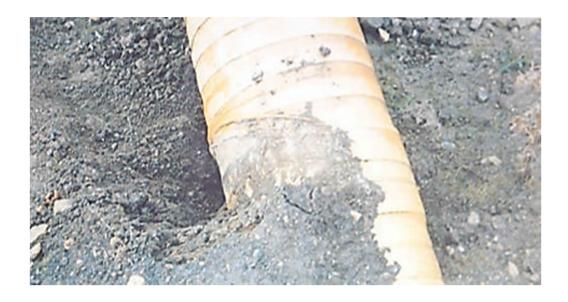
SOIL CREEP

Coating is wrinkled and may be displaced longitudinally along the pipe axis.

Soil creep occurs on slopes and this movement will be at a maximum after backfilling as the fill settles and compacts. The nett movement is downslope, under the action of gravity. Coating damage will be greatest where the pipeline route follows the line of maximum slope. Only coatings that are susceptible to creep will be affected.

Overwrap the primary corrosion protection coatings with an adherent, low friction coating.

Overwrap with a loose, deformable protective layer, but this layer MUST NOT interfere with cathodic protection current access to the pipe.

Strip all areas of coating that show loss of adhesion or voids and all areas with moisture beneath the coating. Re-coat with a compatible repair material, such as a two pack, liquid urethane.
