Pipe defects

Sarajevo 2022

Prepared by: DSc Dževad Hadžihafizović

Manufacturing: ERW Pipe Defects

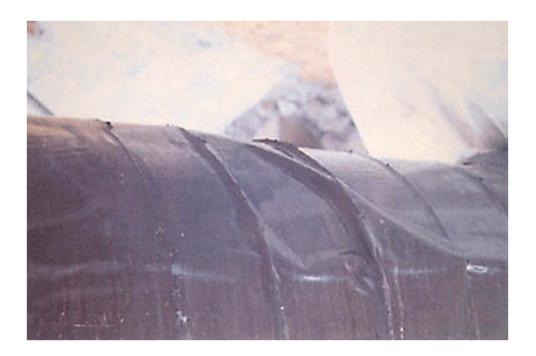
SOIL STRESSING

Loosening and lifting of the tape, with associated loss of adhesion, particularly at the edges of the tape and at the end of the 'wrap'.

Heavy clay soils can expand on wetting and contract on drying. This expansion and contraction can be transferred from the clay to the coating resulting in loosening, lifting and loss of adhesion.

All the damaged coating must be removed and the metal substrate and surrounding sound coating must be cleaned. Re-coat using a compatible two-pack, liquid coating, heat shrink materials or cold applied laminate tape.

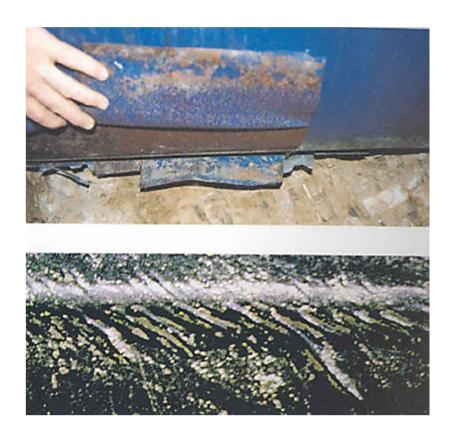
TENTING OR BRIDGING AT SEAM WELD

Air or water filled voids beneath cold applied laminate tape on either side of the seam or spiral weld bead.

- 1. Profile either side of the weld bead with mastic before applying the tape.
- 2. Place a longitudinal strip of tape over the weld bead and the adjacent pipe before applying the main tape coating.
- 3. All the damaged coating must be removed and the metal substrate and surrounding sound coating must be cleaned. Re-coat using a compatible two-pack, liquid coating, heat shrink materials or cold applied laminate tape.

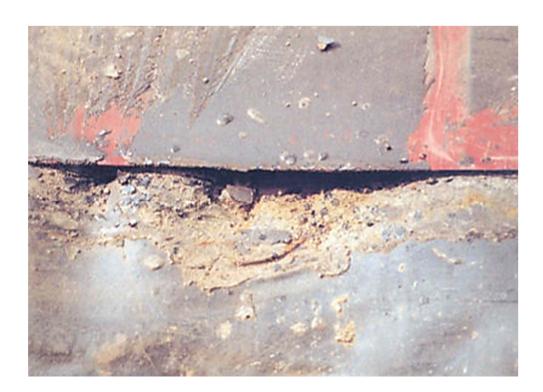
POOR APPLICATION

Poor adhesion, or complete loss of adhesion, usually at the 6 o'clock position.

Strip the coating and re-coat with cold applied laminate tape, where the backfill conditions are good, or apply a new heat shrink wrap-around. Alternatively a two pack liquid coating may be applied provided it is compatible with the coating on the pipe body.

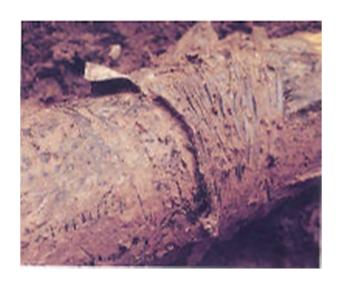
SOIL LOADING

Over-wrap with a loose, deformable protective layer which MUST NOT interfere with cathodic protection current access to the pipe.

Completely remove the coating. Prepare the joint area and apply a compatible two pack. Liquid material with an overlap onto the coating on the body of the pipe.

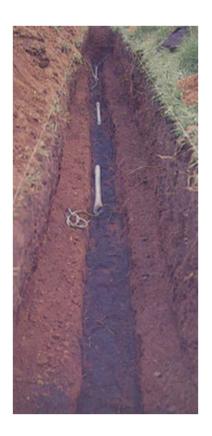
GROUND BED

The ground bed should be located 100-200m from the pipeline to minimise problems of over protection at the drain point and to ensure uniform current distribution over a long length of pipeline. Ground beds must not be located close to other pipelines or framed structures to avoid electrical interference and stray current corrosion. Where space is limited, for example on a compressor station, a vertical ground bed may be used. The anodes are installed in a borehole at depth to give good current distribution on the complex site pipework.

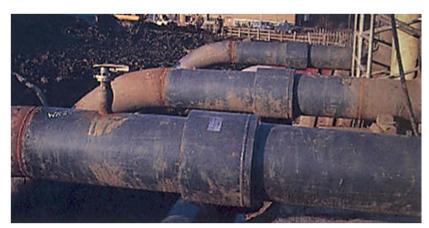
INSULATION JOINT

Pipework at a plant site may be shorted to reinforcing bars in concrete or other structural steelwork through pipe supports, control lines etc. Contacts of this kind create problems with the successful application of cathodic protection.

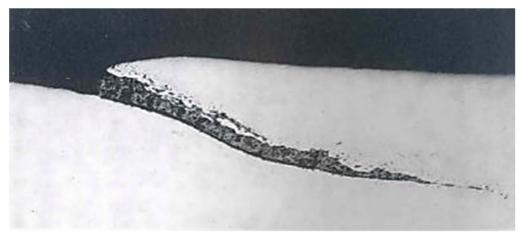
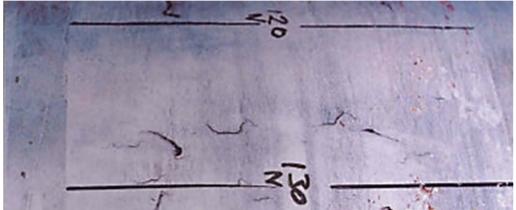
LONGITUDINAL SURFACE LAPS

A flap of metal lying flat on the pipe surface, usually with a trapped residue of oxide or scale beneath it.

Generally small laps have little or no structural significance. Laps to create holidays, or defects, in thin film coatings. Soluble salts trapped in the scale or oxides beneath the lap may act as a corrosion 'hot spot' and initiate pitting.

Superficial surface laps may be removed by grinding before application of the coating.

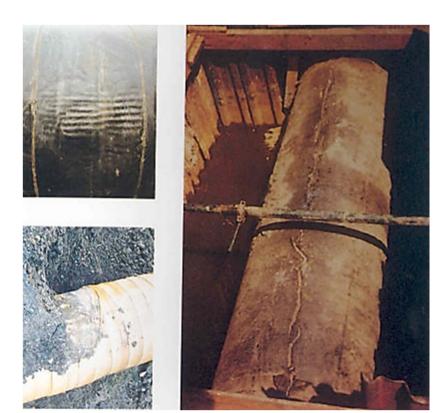
COATING AND SOIL

Thermoplastic coatings are susceptible to creep under sustained loads, for example from the soil. Defects generated by sustained soil loads can be found in hot enamel coatings, cold applied tapes and heat shrink materials.

The commonest symptoms include cracking, wrinkling, coating displacement and penetration.

Defects are typically located as follows:

- Cracking on the crown of the pipe
- Wrinkling on the 'sides' of the pipe
- Stone penetration on the bottom of the pipe, particularly where the pipe bed is uneven
- Coating displacement in the downslope direction

Random disruption is expected in expansive clays.

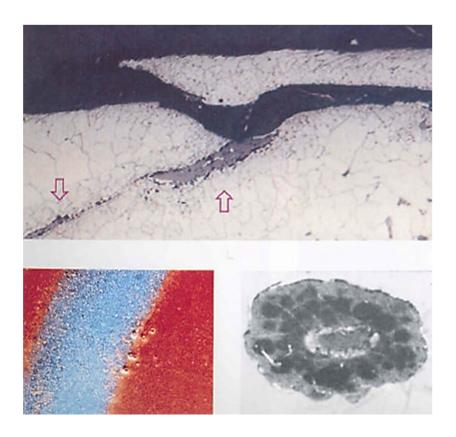
PIPE SURFACE PREPARATION

Trapped slag exposed at the pipe surface act as a reservoir for moisture and for salts accumulated during transport of pipe by sea and storage on a dockside.

During the application of thin film, fusion bonded epoxy powder coatings, steam and gas may escape from the slag to create small defects or bubbles in the coating.

Residual salt acts as a catalyst for corrosion and loss of adhesion with characteristic rust spotting, 'leopard spots', where salt remains on the pipe surface.

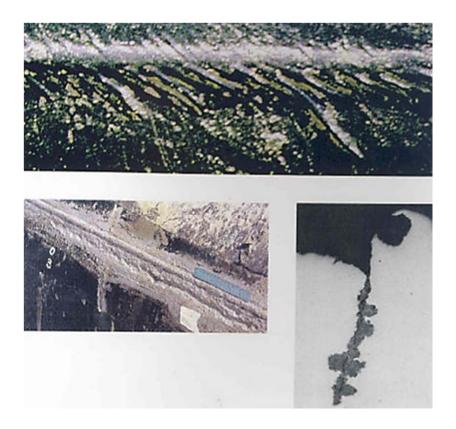
TAPE - NAEC - SCC

Bridging of cold applied tape over the cap of the seam weld leaves a void on either side of the weld line. When water gets into this void a corrosion risk is created. The applied cathodic protection current cannot control this corrosion risk because the pipe is shielded from the CP current by the insulating coating.

On spiral welded pipe this results in a pattern of corrosion that follows the spiral weld.

Near neutral pH stress corrosion crack growth may also occur but the total axial length of interconnected cracks will be restricted.

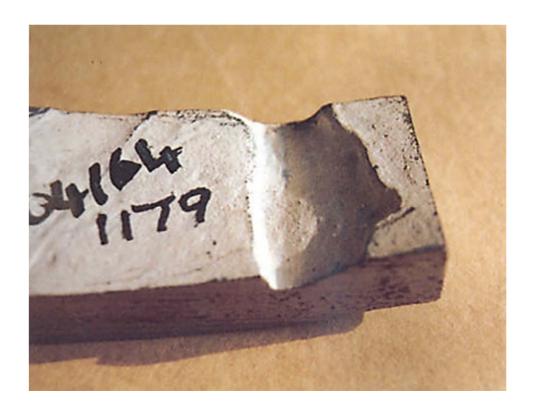
MANUFACTURING DEFECTS

Irregular shaped defects in the pipe wall.

Solidification defects in the ingot that are carried through into the pipe or pieces of lapped material that have fallen out.

Significant manufacturing defects should be identified b pressure testing in the pipe mill or during the pre-commissioning pressure test.

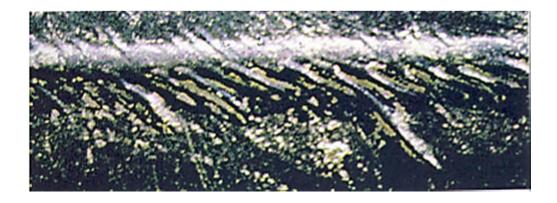
TAPE AND SPIRAL WELD

Bridging of cold applied tape over the cap of the seam weld leaves a void on either side of the weld line. When water gets into this void a corrosion risk is created. The applied cathodic protection current cannot control this corrosion risk because the pipe is shielded from the CP current by the insulating coating.

Lines of 'narrow axial' corrosion result. These areas of corrosion may also be susceptible to the initiation and growth of near neutral pH stress corrosion cracks.

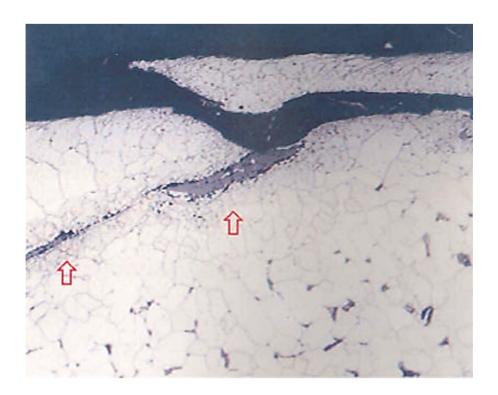
SLAG INCLUSION

Non-metallic inclusion in the pipe wall.

Caused when an ingot is contaminated with slag. In well controlled pipe production most slag inclusions are removed during the piercing process and when the ends of the ingot are trimmed during the pipe forming process. The shape of the slag inclusion will be governed by the forging process.

Slag inclusions are usually too small to be structurally significant. However, surface breaking slag may initiate a corrosion 'hot spot' or a defect in a thin film pipe coating. Superficial slag inclusions may be removed by grinding before application of the coating.

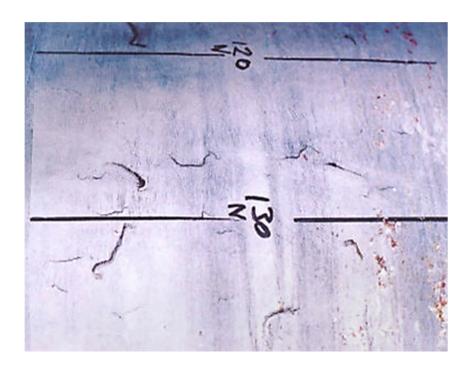
SURFACE DEFECTS

Shallow defects that appear at the pipe surface.

Various causes including ingot defects, longitudinal surface laps, slag inclusions, slivers, transverse tears and surface roughness.

Most defects are not structurally significant but may create defects in thin film coatings and act as an initiation point for pitting corrosion.

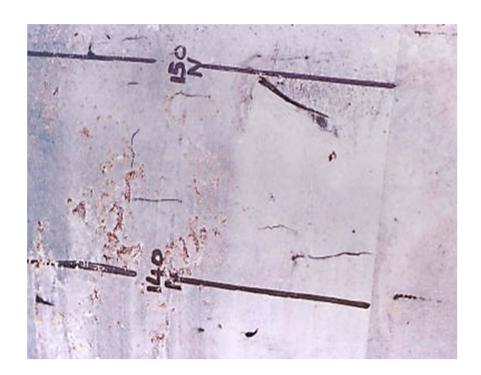
TRANSVERSE TEARS

Crack like features at the pipe surface running in the hoop direction.

Cracks in the ingot, for example transverse shrinkage cracks, may be carried through to the pipe if insufficient material is removed from the ingot surface during the scarfing process.

Transverse tears may create defects in thin film coatings. Superficial transverse tears may be removed by grinding before application of the coating.

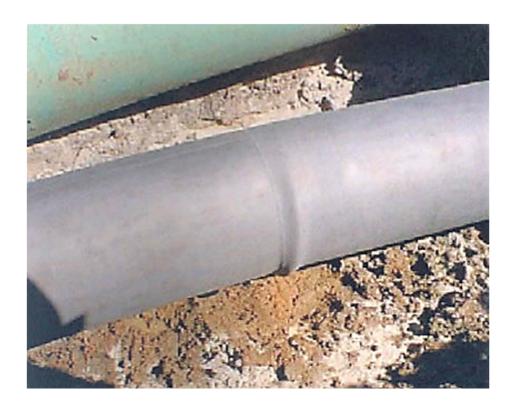
COLD BEND KINK

Circumferential kink or ripple in the pipe that has been subject to cold bending in the field

Caused by poor control of the field bending process

Discard the pipe or cut out affected.

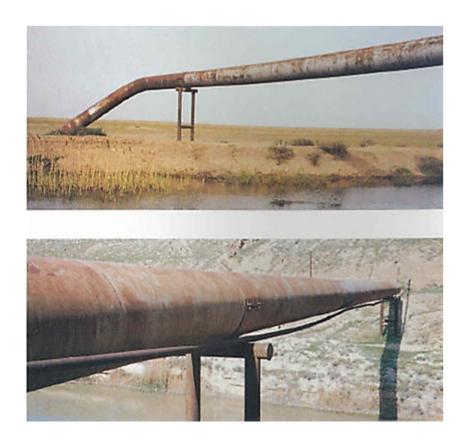
CONTACTS

The pipeline is in electrical contact with 'foreign' structures such as pipe supports or reinforcing bars in concrete

Electrical contacts create a drain on the applied cathodic protection current and may prevent effective protection. Galvanic or interference current corrosion may result and lead to rapid pitting and through wall penetration in the affected area.

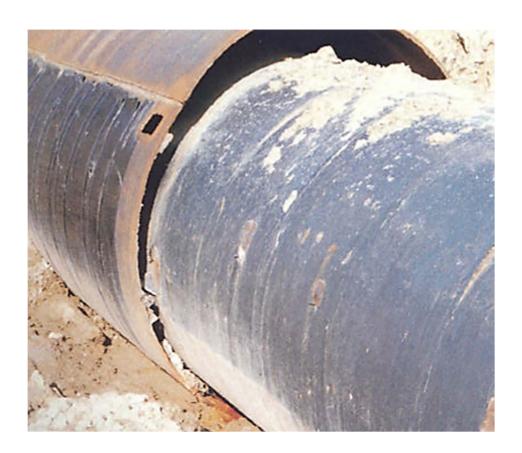
ECCENTRIC TOUCHING CASING

The casing is not aligned parallel with the carrier pipe and, in extreme cases is in contact with the carrier pipe

Electrical contact between the casing and the carrier pipe may create a local drain on the applied cathodic protection and create a localized corrosion cell.

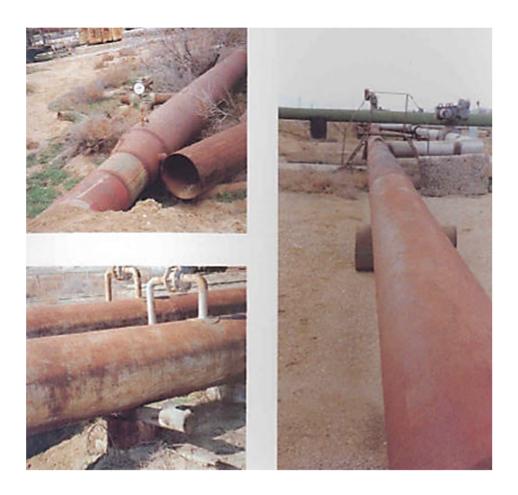
INCORRECT PIPE SUPPORT

Above ground pipe is supported on objects other than manufactured or shaped pipe supports.

Incorrect pipe supports may create problems that include stress concentration, damage to the protective coating or electrical contacts that interfere with the efficient operation of the applied cathodic protection.

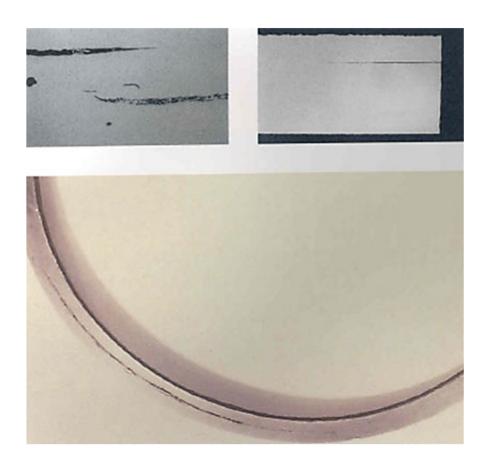
LAMINATIONS

A discontinuity lying parallel to the pipe surface, usually marked by a concentration of non-metallics.

Large laminations may be structurally significant. Some older pipelines contain pipes with large laminations that have not created a safety hazard in many years service.

Surface breaking laminations may contribute to coating faults and may serve as an initiation point for pitting corrosion.

Superficial laminations may be removed by grinding before application of the coating.

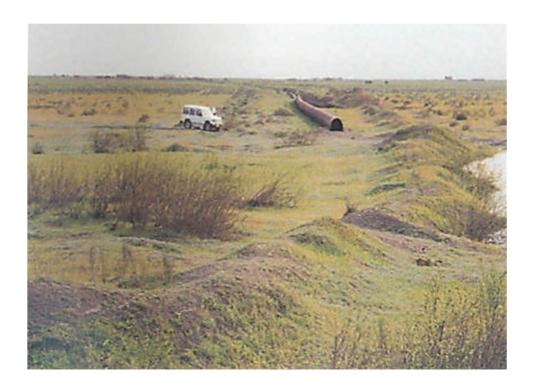
LACK OF COVER

Shallow depth of burial

The pipe is particularly vulnerable to third party mechanical damage and vandalism.

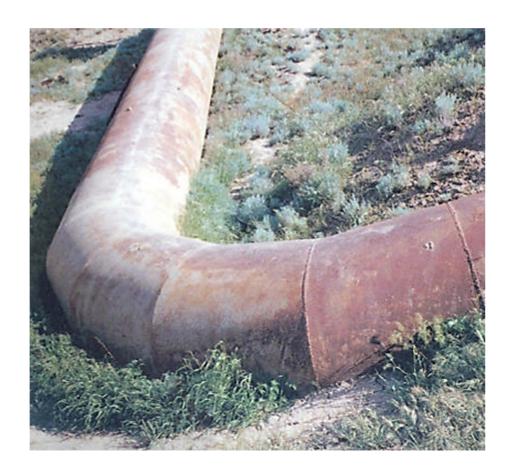
MITRE BEND

Mitre bends, also known as 'lobster back bends' are made by welding together short pieces of pipe with mitred ends.

Mitre bends should be replaced with forged bends in high pressure pipelines.

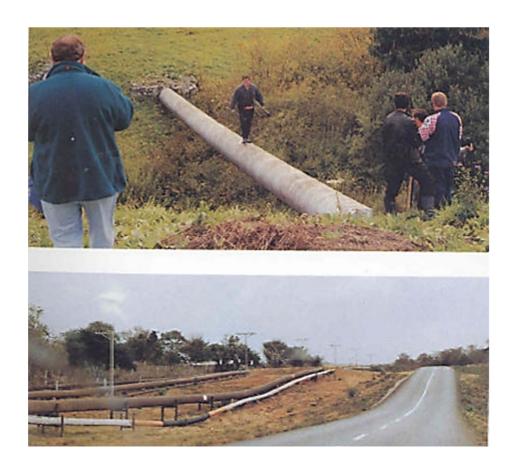
UNPROTECTED PIPE

The pipeline is exposed above ground without security fencing or other protective measures.

Exposed pipe may be susceptible to vandalism, sabotage or accidental damage.

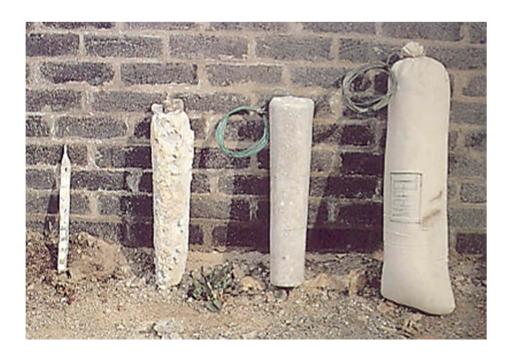
SACRIFICIAL ANODE

Zinc or Magnesium alloy sacrificial anode packaged in a low resistance Bentonite fill.

Zinc anodes may be ineffectual in soils contaminated with industrial waste, such as coke. Magnesium anodes are required for effective cathodic protection in these conditions.

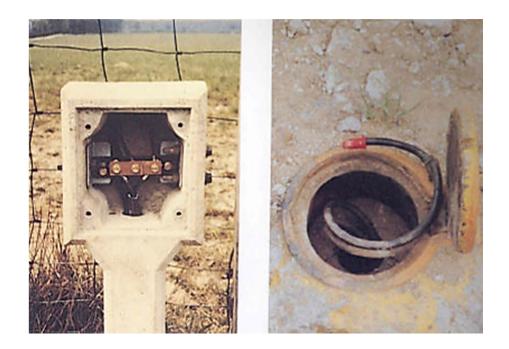
TEST POINT

A cable connection to a buried pipe, that terminates at a test post or box on the surface. The surface connection measurements to be made.

Accurate pipe to rail potential measurements are needed to maintain the effectiveness of the cathodic protection applied to a pipeline. Routine monitoring may be carried out at test posts only by recording accurate instant of potential of a test coupon buried at a test post. A periodic close interval potential survey, between test posts may also be required to fully audit the effectiveness of a cathodic protection scheme.

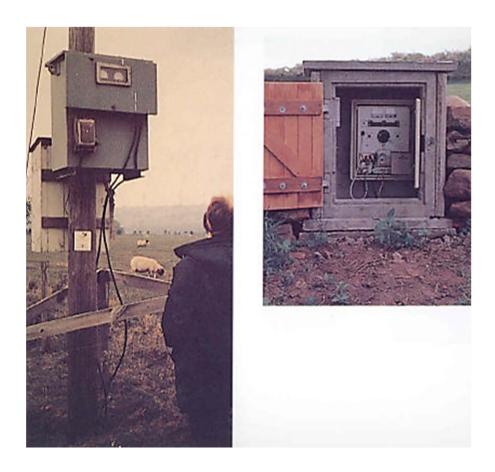
TRANSFORMER RECTIFIER

Mains or solar powered power supplies for large cathodic protection schemes on cross-country pipelines and plant sites.
