# Dam Safety Inspection Report Guidelines (BLM)

# HANDBOOK H-9177-1

## DAM SAFETY INSPECTION REPORT GUIDELINES

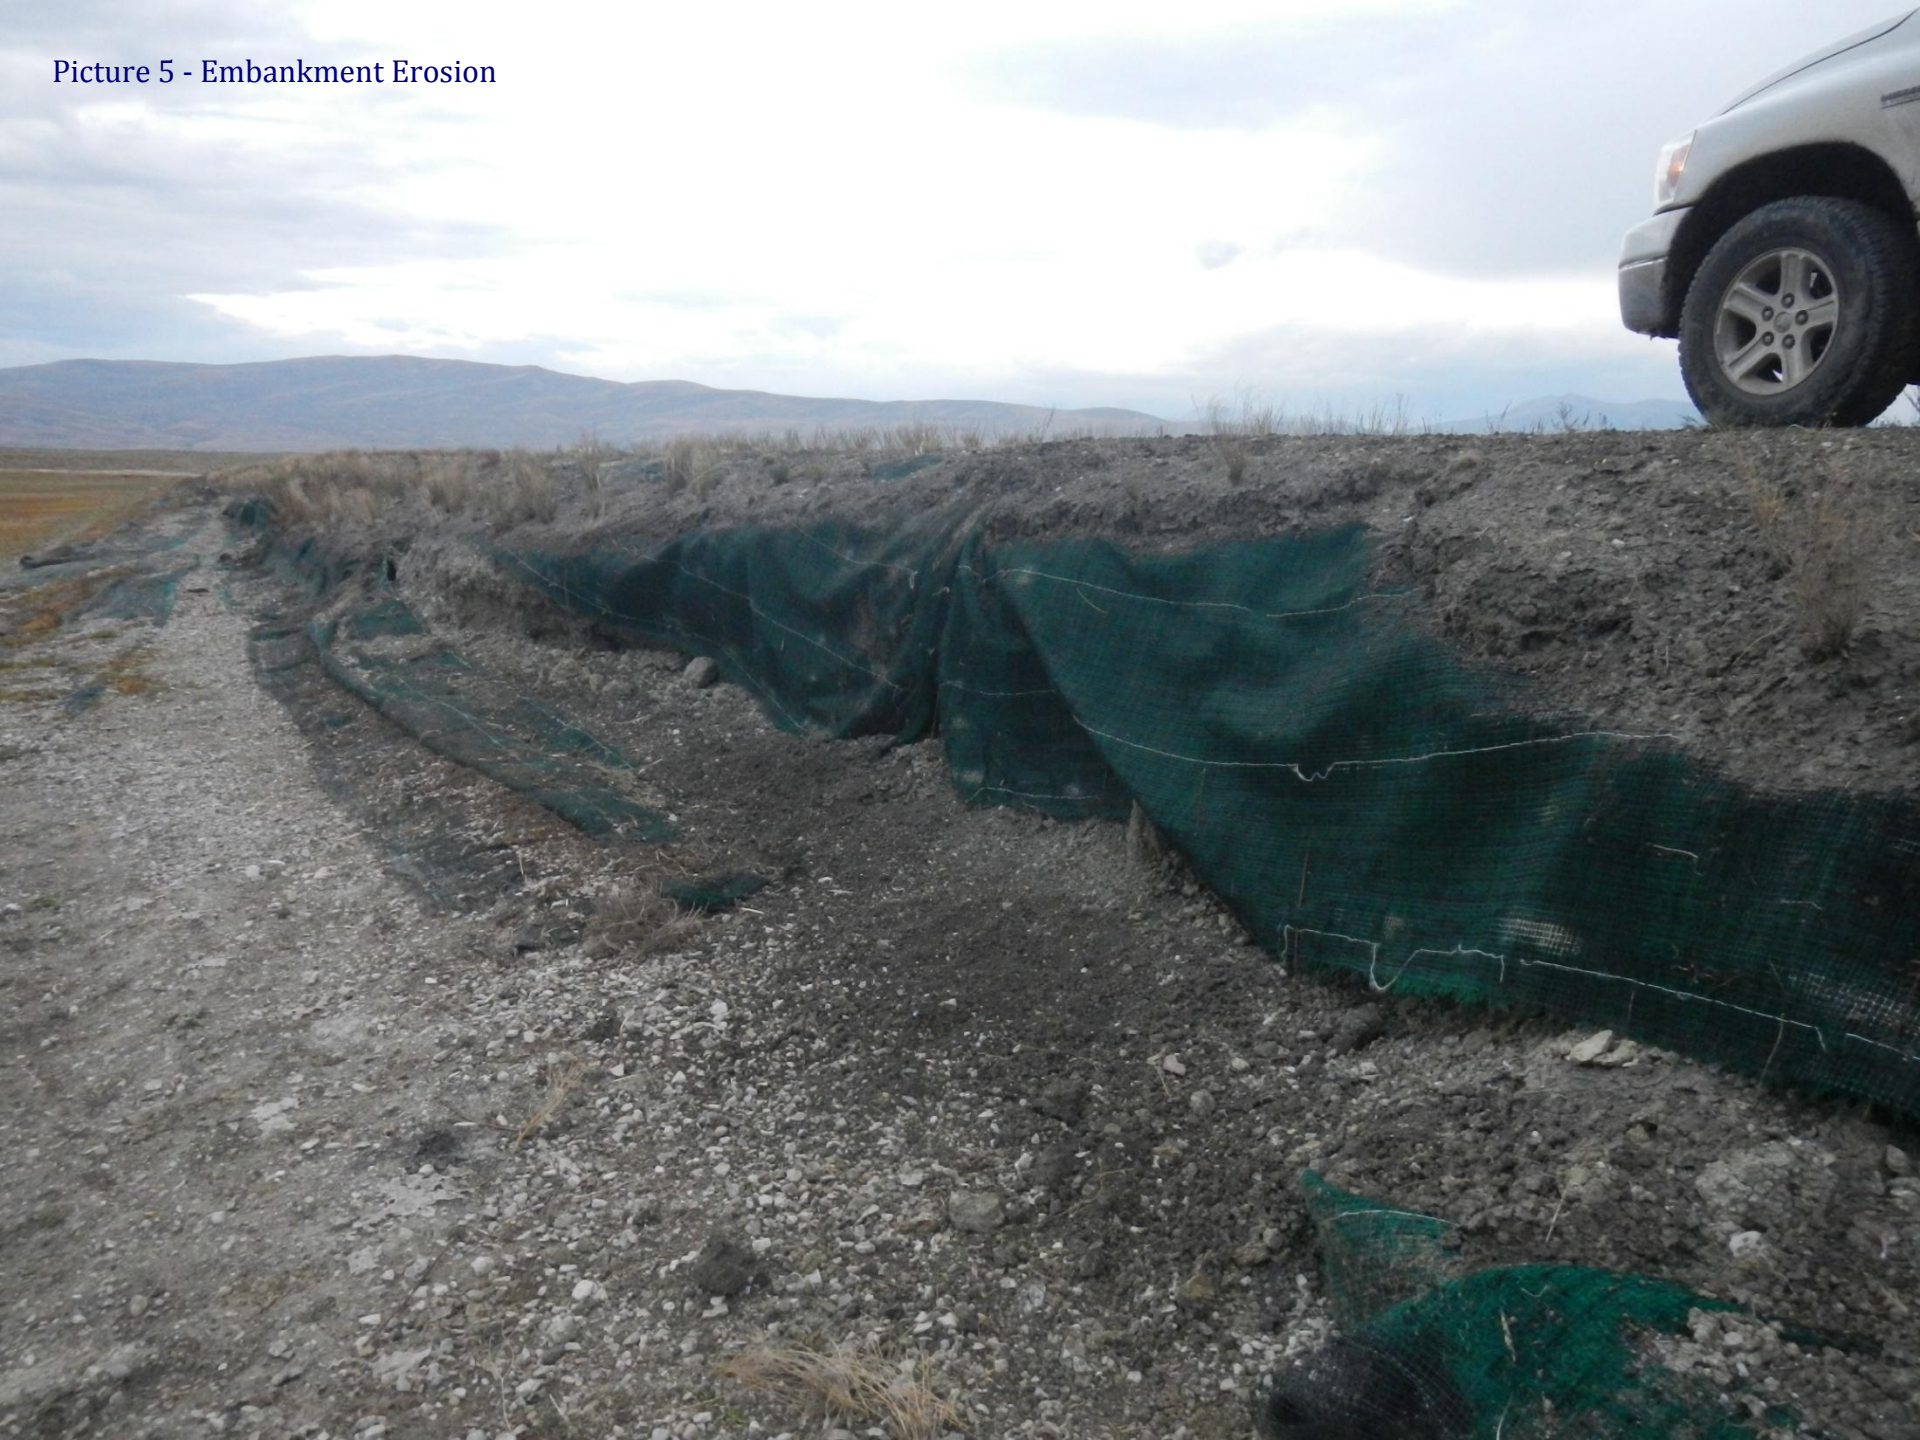
Picture 5 - Embankment Erosion

- Proper erosion control measures are necessary for preventing loss, displacement, or deterioration of upstream embankment facing; crest damage and breaching; and erosion of the downstream face.

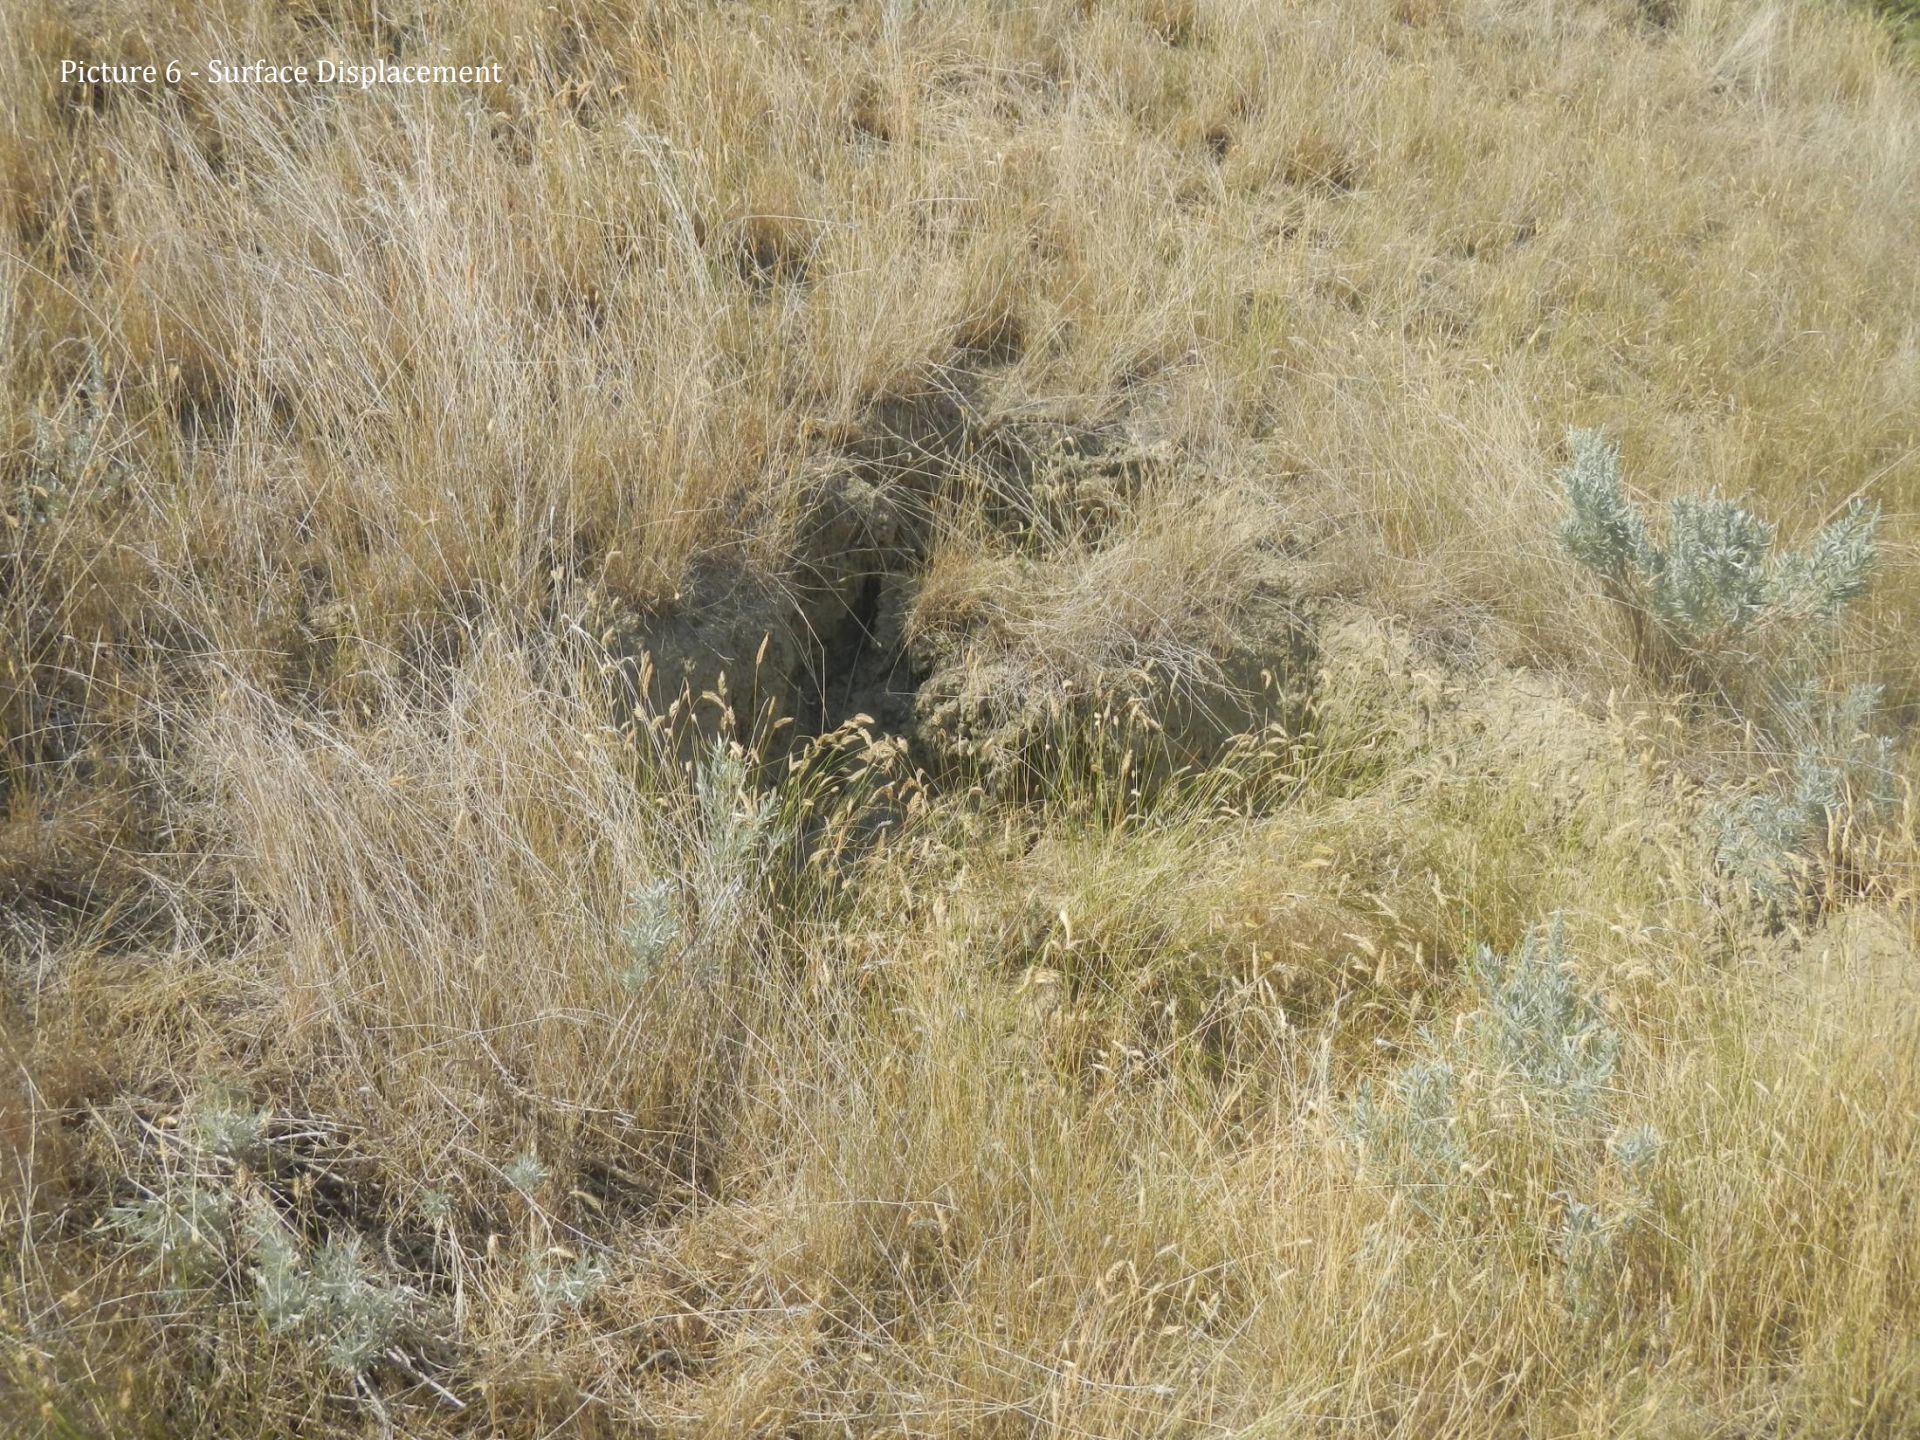
Picture 6 - Surface Displacement

Reaction of structures often reflects foundation changes. Visual surface displacements in the crest, backslope, or foreslope of the dam should be noted. Depressions or sags in the crest or slopes of an embankment dam might reflect embankment or foundation consolidation, solutioning, or piping.

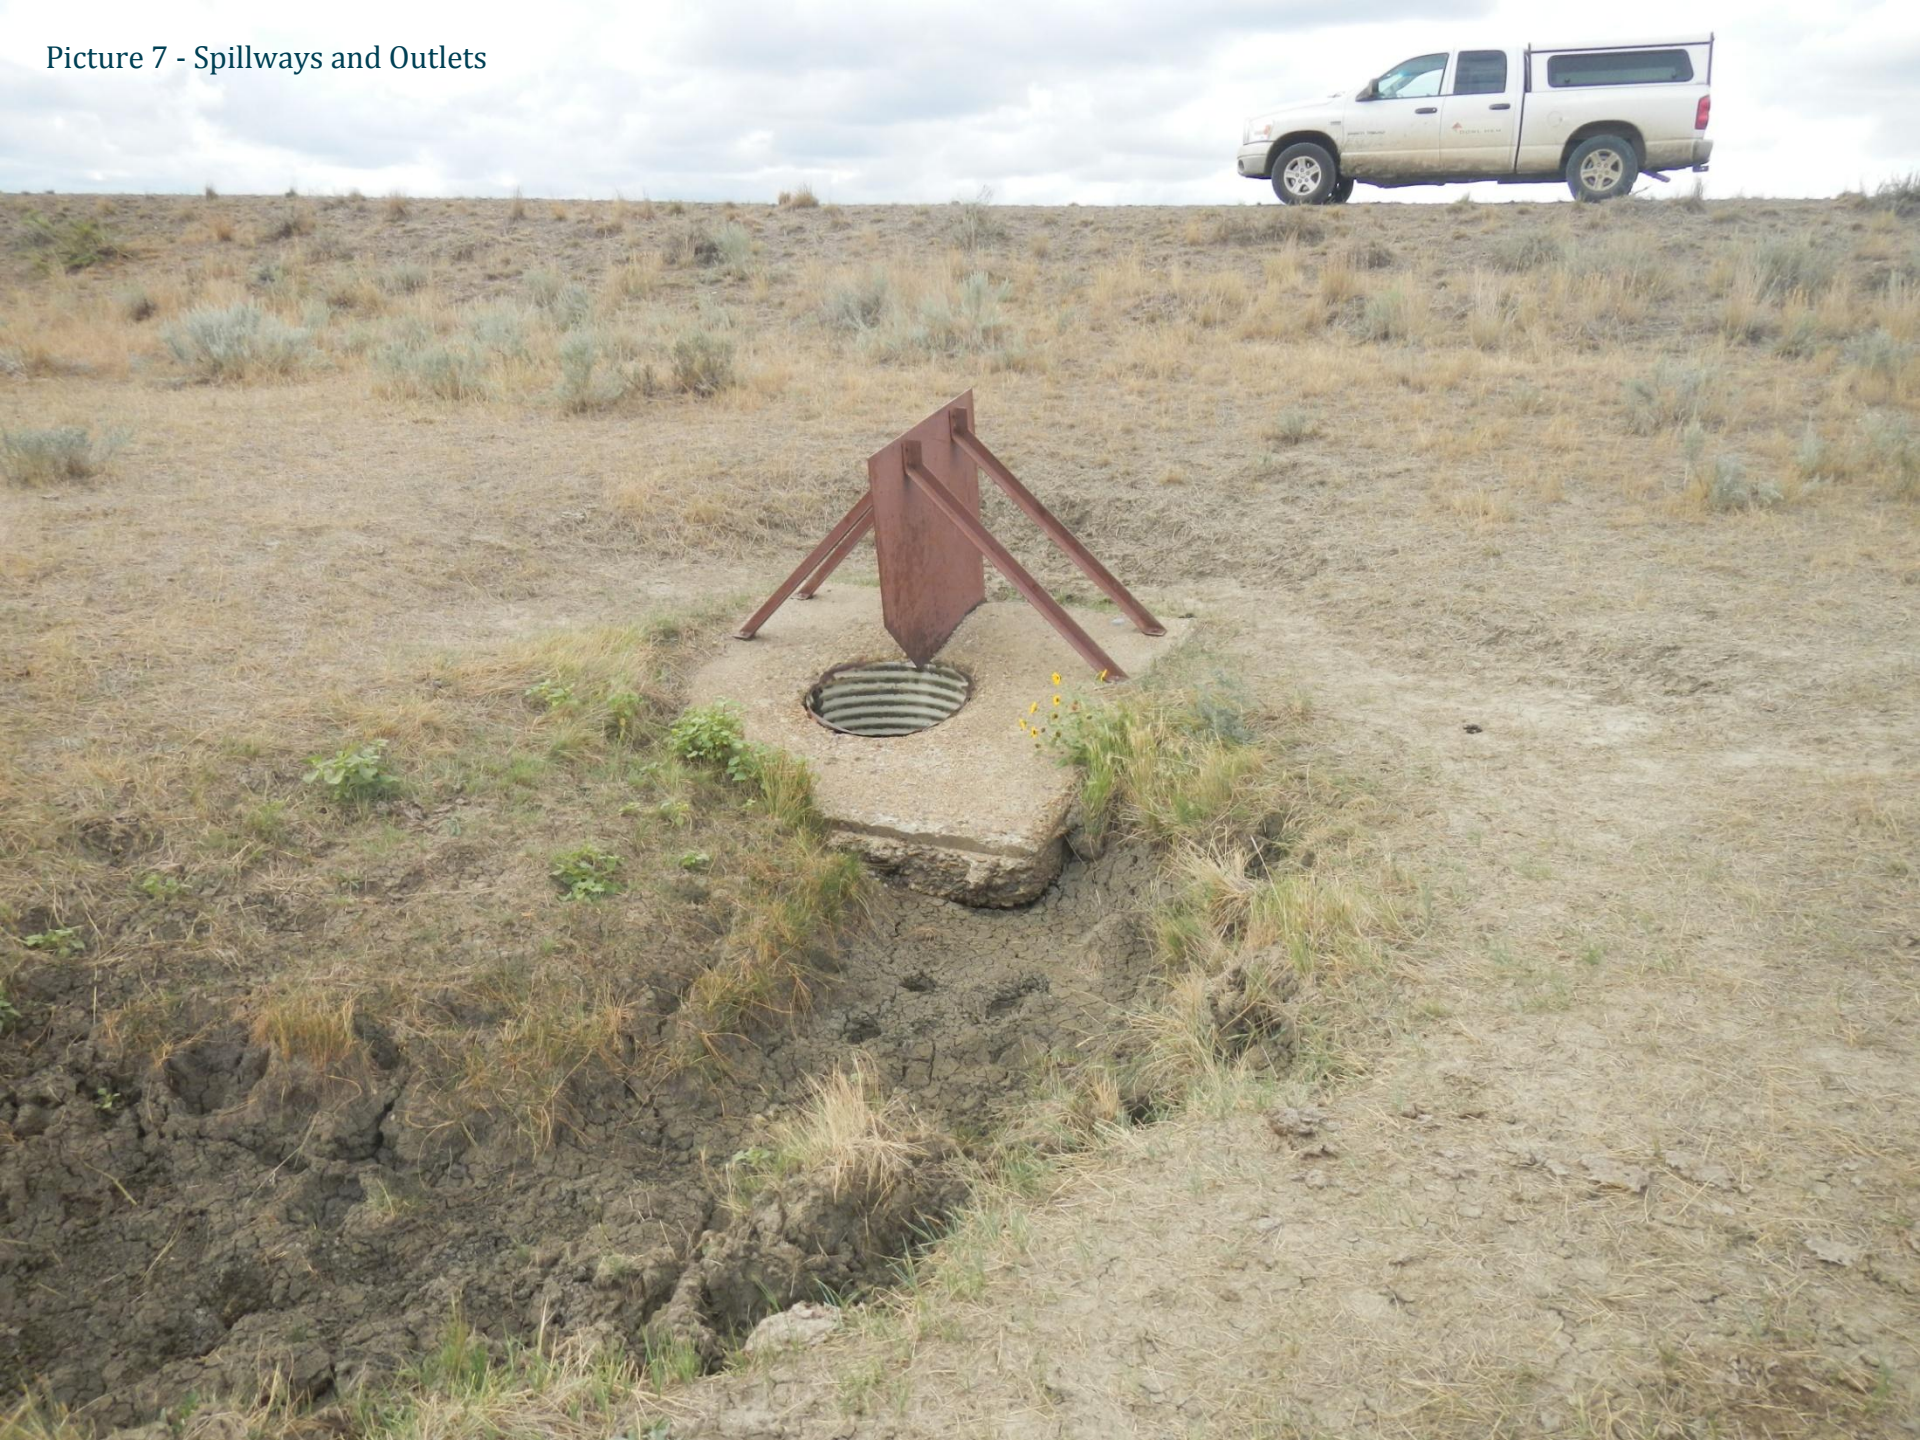
Picture 7 - Spillways and Outlets

- Spillways or outlet works can be defective because of hydraulic inadequacy, structural inadequacy, or operational malfunctions. Spillways and outlets should be checked to ensure that they are in good condition, free of obstructions, and capable of carrying the volume of flow for which they were designed. Verify the type, number, location, and dimensions of all spillways and outlets at the time of inspection.
