# Root Cause Failure Analysis

**Pinpointing  
the true cause  
of electric motor  
failures**

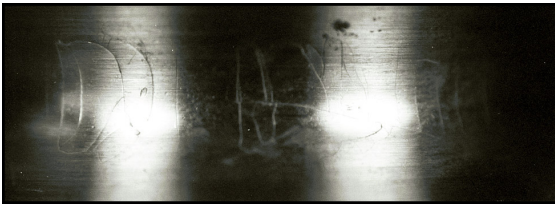
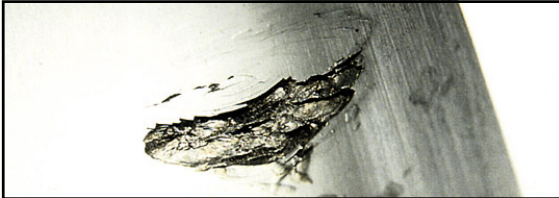
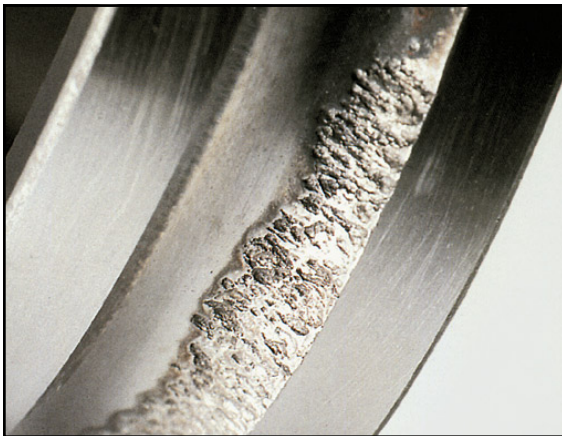
**FIGURE 1: THE FATIGUE PROCESS**

These photographs show the progression of a fatigue failure, from microscopic fractures, through spalling, to catastrophic failure. How quickly this happens depends on speed, time, temperature, load, vibration and lubricant.

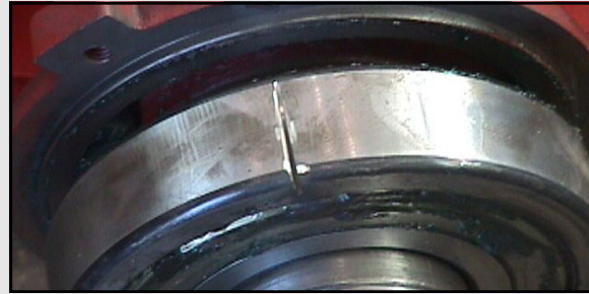
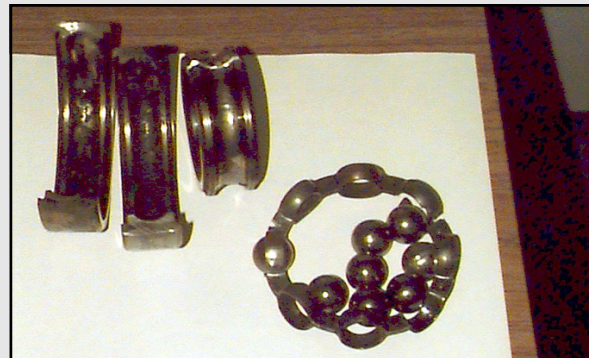
Above, the side of the bearing toward the rotor has been marked prior to dissection. Below, a dissected ball bearing.

In order to correctly interpret a bearing failure, it is helpful to mark the position of each bearing as it is removed. When axial thrust is a factor, the direction of thrust may point to a coupling problem or an internal preload condition. A practical method is to use a die grinder or engraver to identify which side of each bearing is toward the rotor before the bearings are removed. Dissect the bearing using a die grinder rather than a torch, which heats and destroys evidence.

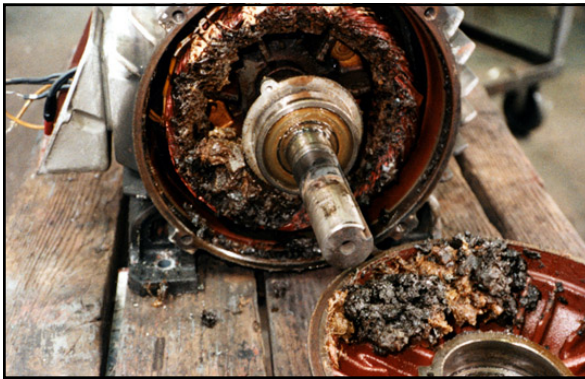
Grease quiets a noisy bearing. This bearing was noisy for quite some time.

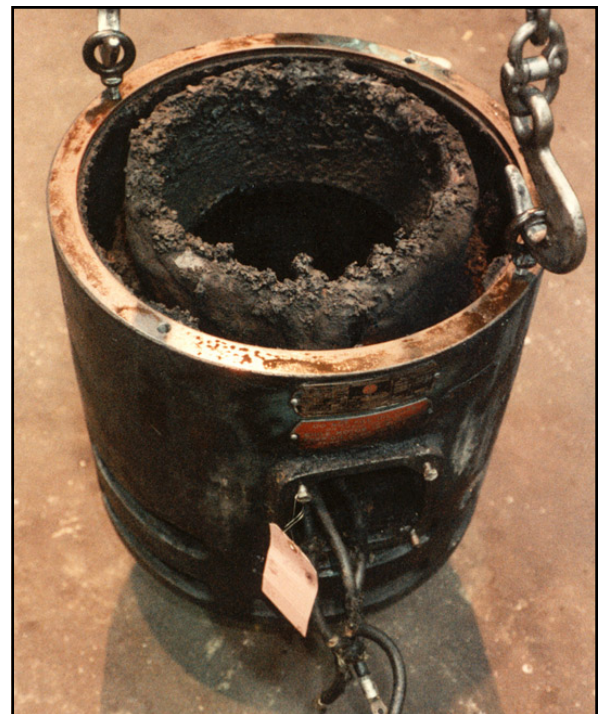
The upper bearing carrier, bolted inside the end bracket, has too much clearance to the shaft. Gravity, grease and dirt are not a good combination.

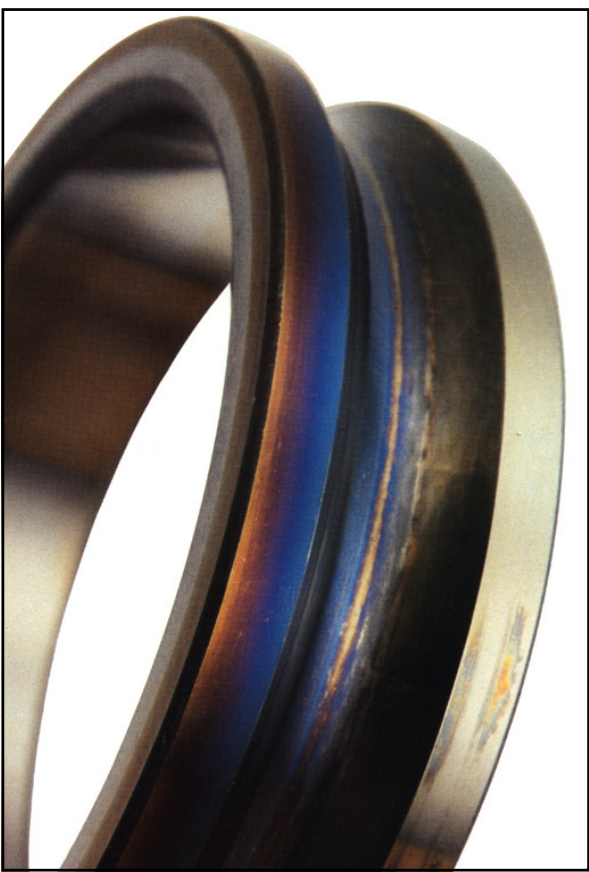
Symptoms of overheating are discoloration of the races, balls and cages from straw to blue. Temperatures in excess of 400° F (205° C) can anneal the race and ball materials. The resulting loss in hardness reduces the bearing capacity, causing early failure. Courtesy of The Barden Corporation

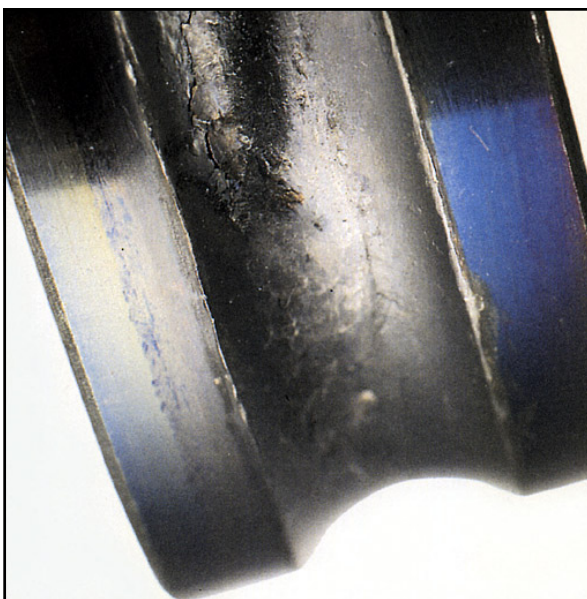
Lubricant failure will lead to excessive wear, overheating and subsequent bearing failure.

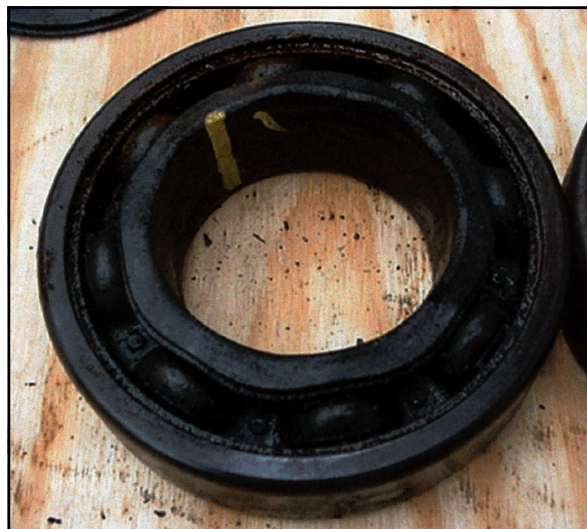
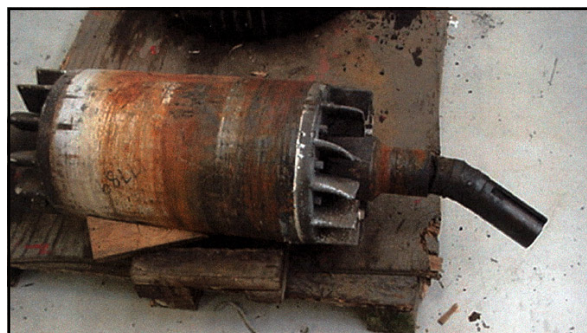
The temperature of this bearing exceeded the “dropping point” of the grease. This is the temperature at which oil separates—or drops out—from the grease base. This bearing failure led to the bent shaft.

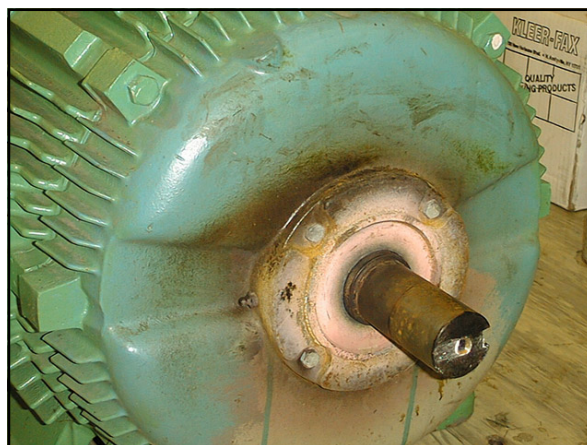
This motor failure started as a failed bearing. The burnt paint shows the extreme heat created by this failure. The bearing failure resulted in damage to the rotor as well as the stator.

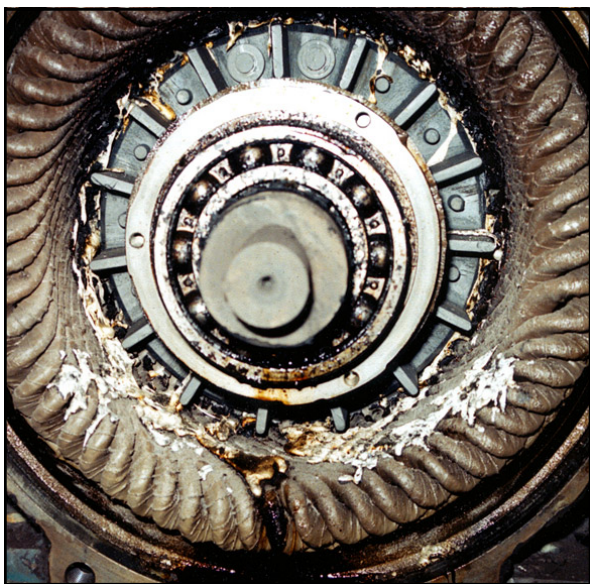
In this case, the heat source was a stalled rotor. Heat migrated from the rotor through the shaft to the bearing. Different greases have different dropping points (the temperature at which oil separates from the grease base).

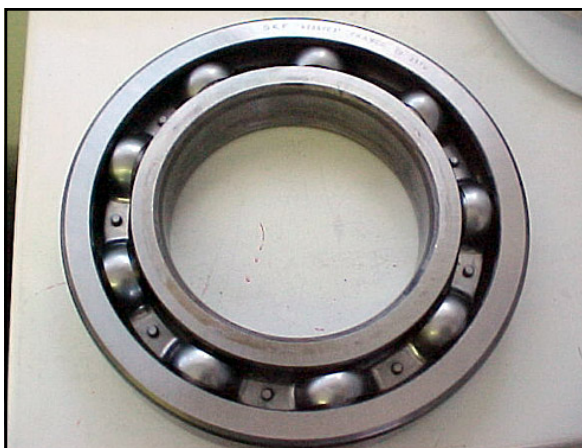
This bearing shows signs of heat discoloration. It was overheated prior to installation.

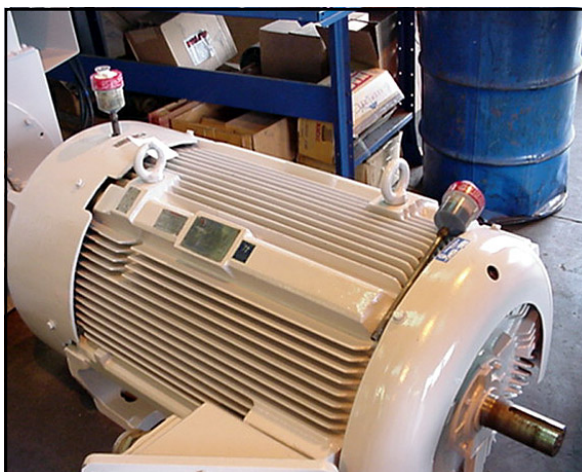
The additional air shroud on the drive end deflects air across the drive end bearing housing. If removed by an end user or previous repairer, the drive end bearing temperature will increase.

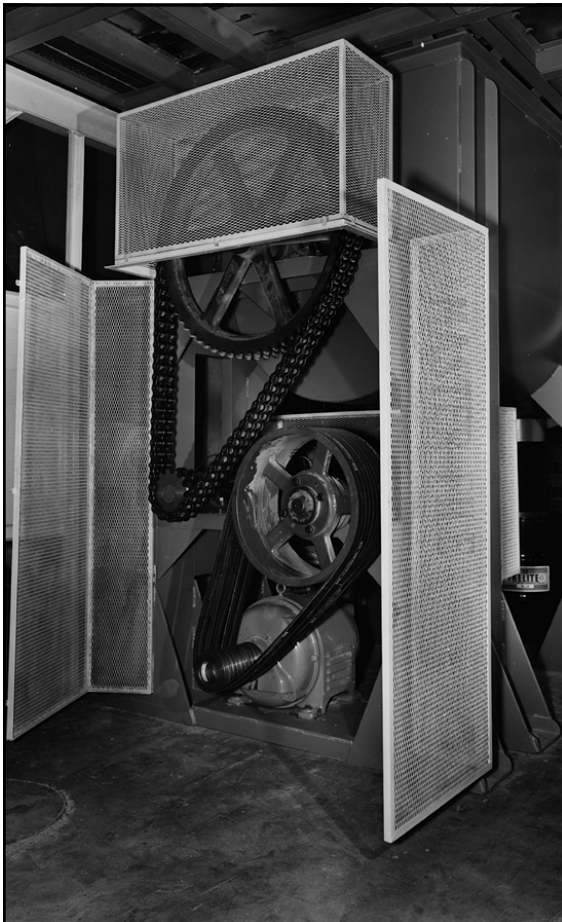
**FIGURE 10: BELTED APPLICATION**

Pulley diameter and number of belts can affect radial loads. See alignment material in Section 6.

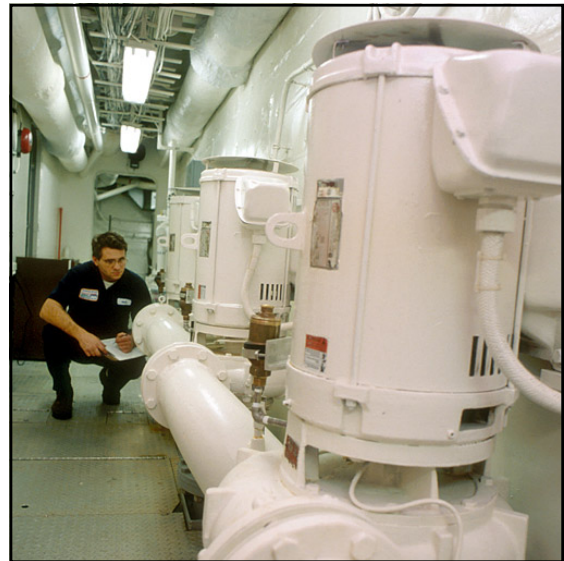
**FIGURE 11: HORIZONTAL MOTOR MOUNTED VERTICALLY**

An end user may save money by purchasing a horizontal C-face motor instead of a vertical. However, this may reduce the effectiveness of lubrication paths.

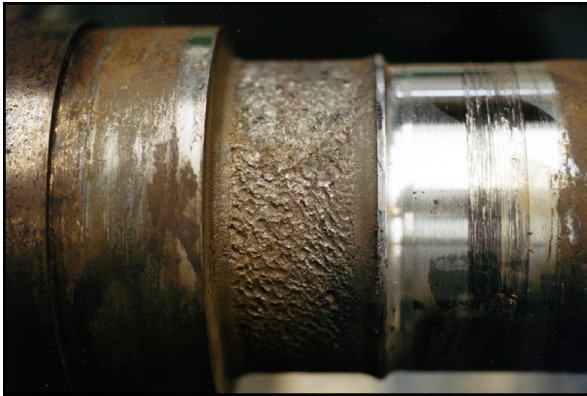
These shafts show signs of a classic case of excess radial load on a ball bearing.

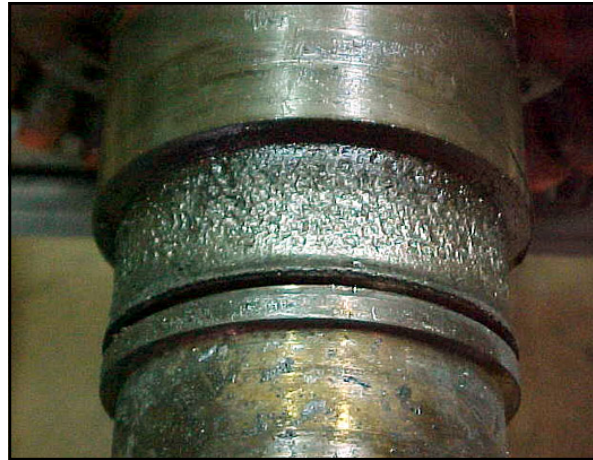
This application requires a roller bearing for the drive end. The pulley should be installed as close to the bracket as possible. Worn belt grooves increase belt slip and may cause the operator to overtighten the belts and overload the bearing.

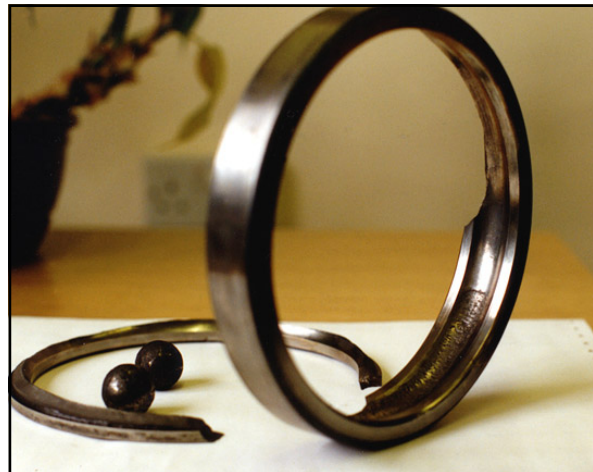
Heavy shock loads can cause unusual fractures of the outer race and/or balls.

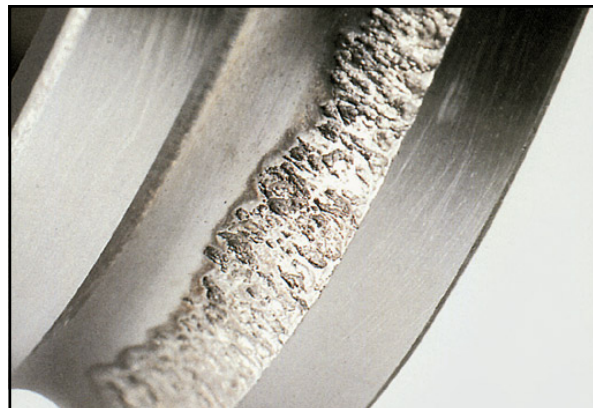
Severe spalling caused by excessive load. This spalling is part of the natural failure process as a bearing reaches the end of its life.

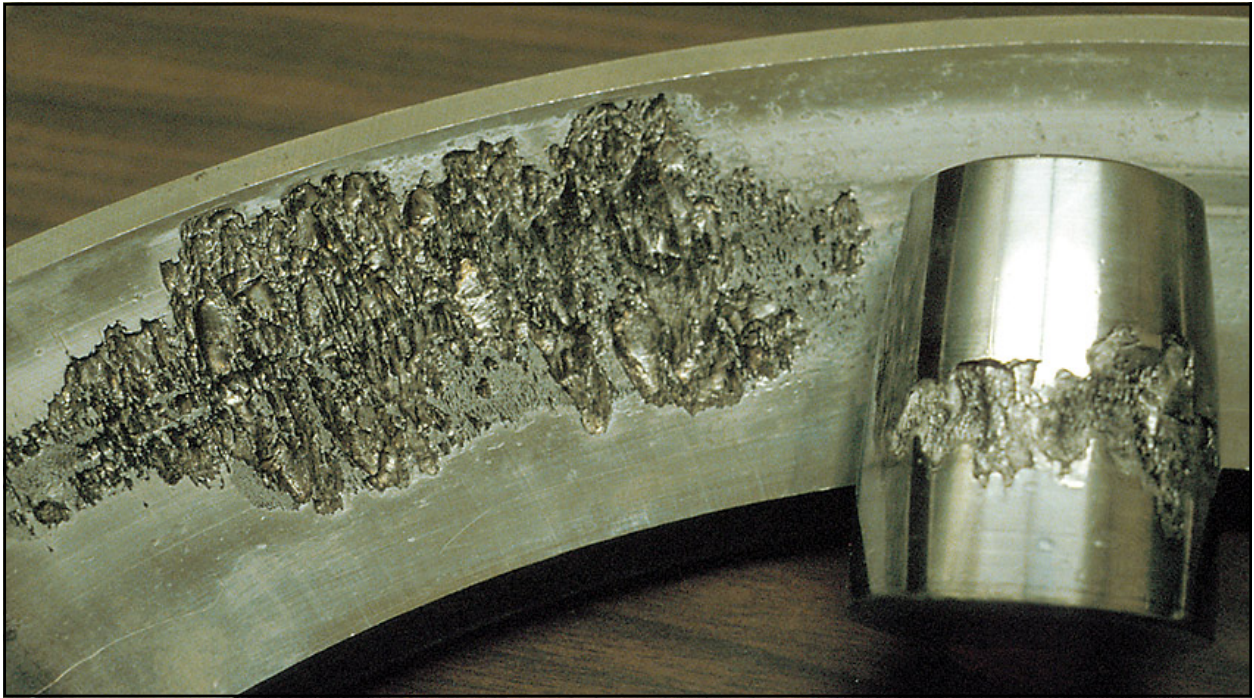
When a spherical roller bearing is used, momentary upthrust conditions can cause impact damage when the thrust load is suddenly restored. Some spherical roller bearings are spring loaded to prevent this sort of damage.

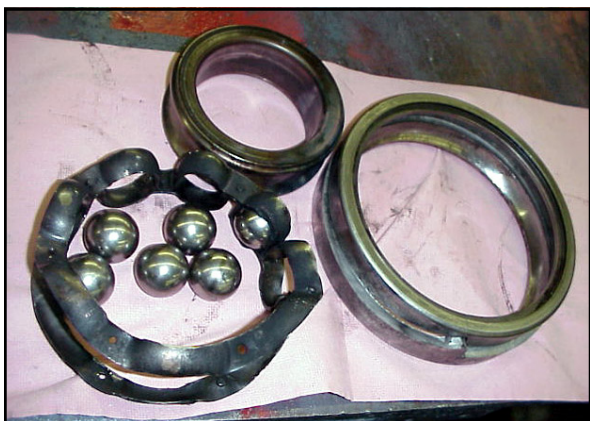
A split outer race (circumferentially) is caused by high shock impact. This unusual failure is more common in applications such as a crusher or hammer mill.

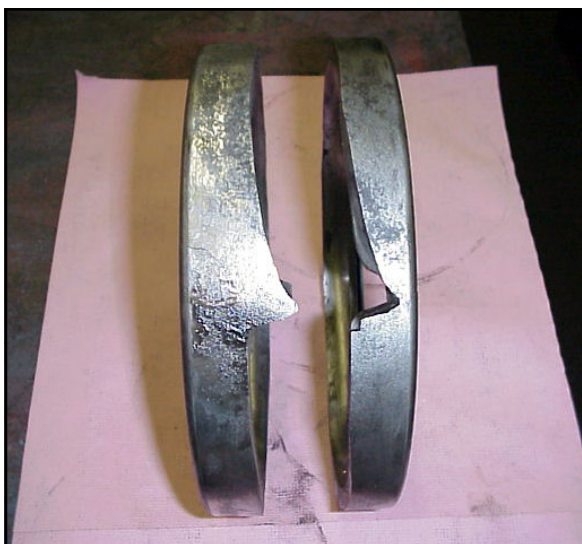
Heavy axial loading or axial impact can chip the outer race shoulder of a roller bearing.

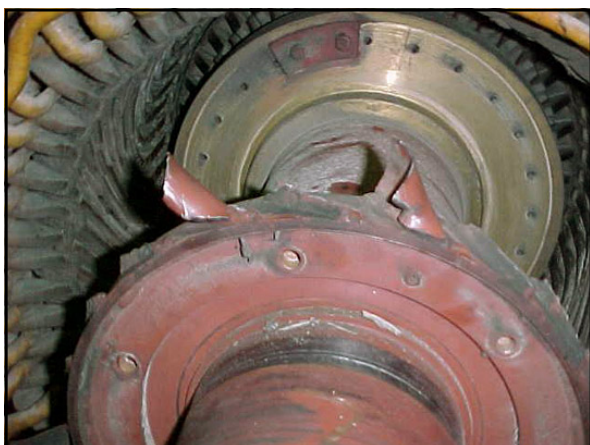
The bearing of this motor was damaged by vibration caused by a damaged cooling fan.

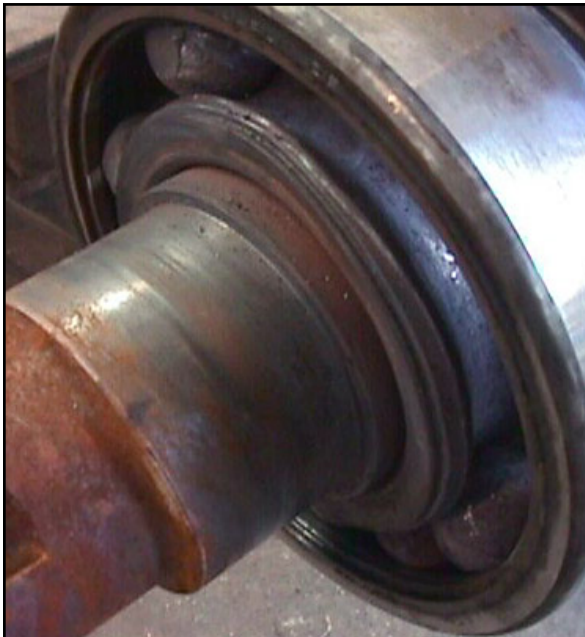
Grease was flushed from this bearing. Water, steam or solvents are often the cause of this type of damage.

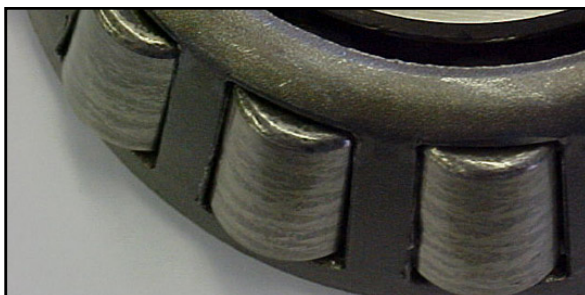
The irregular striped discoloration was caused when contamination was pressed in the roller path.

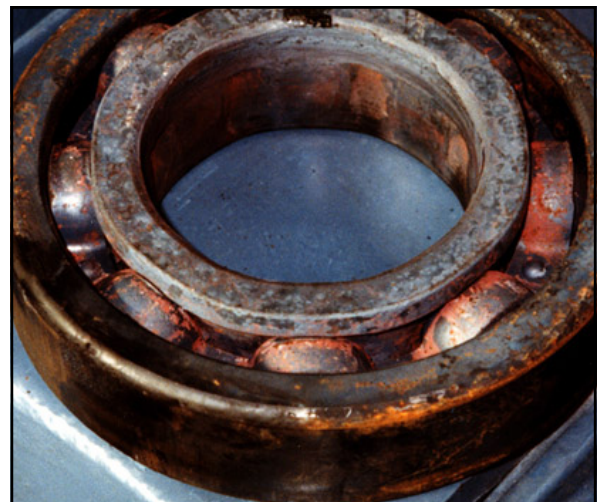
The lubricant was washed out of the bearing. Rust is evident.

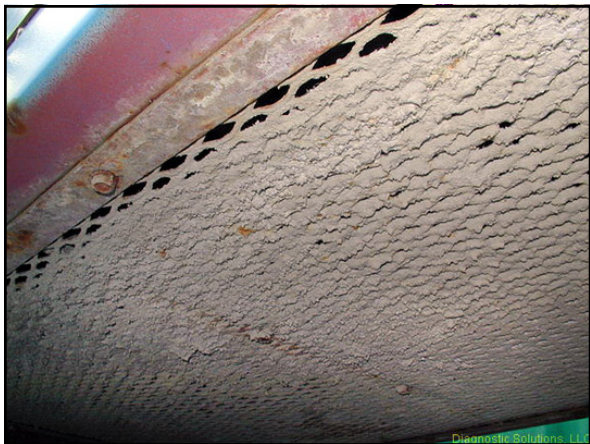
Restricted ventilation may increase winding and/or rotor temperatures. Heat transfers to the bearing housing and elevates the bearing temperature.

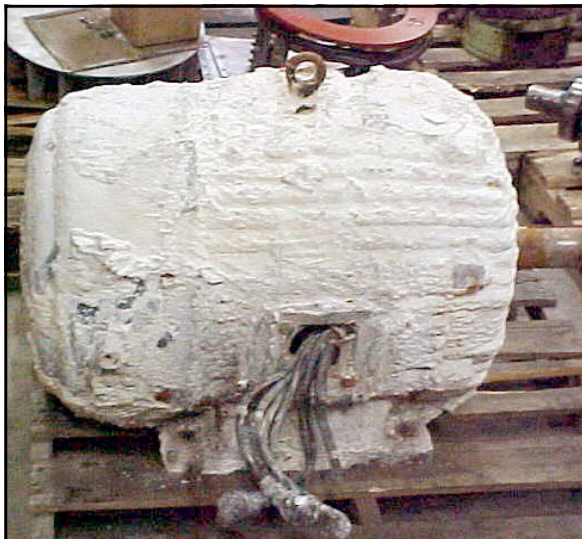
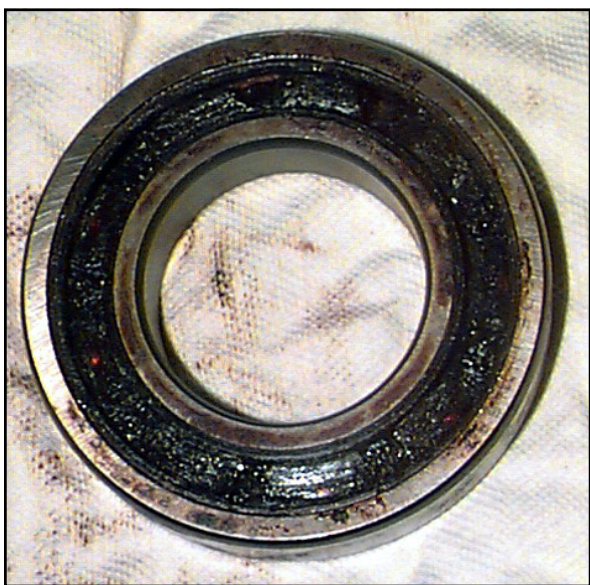
Dust and other fine dry contaminants absorb oil and thicken the grease base.

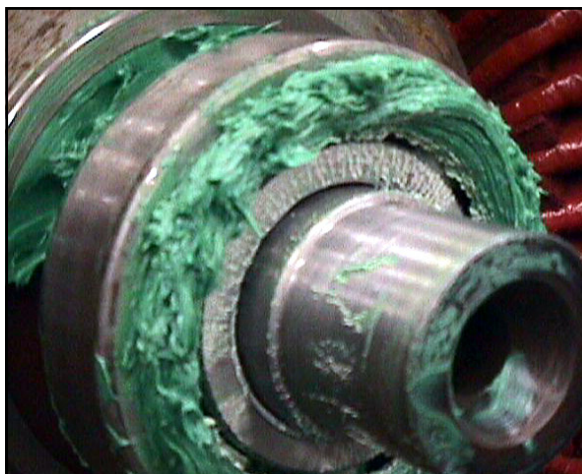
Grease compatibility problems may result from mixing incompatible greases, or from ingress of other contaminants. Dry powders may absorb the oil causing the grease to thicken.

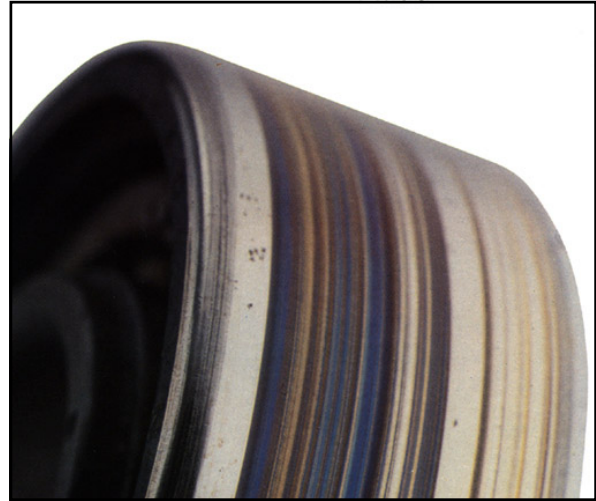
Discoloration and scoring is the result of the outer race slipping in the bearing housing.

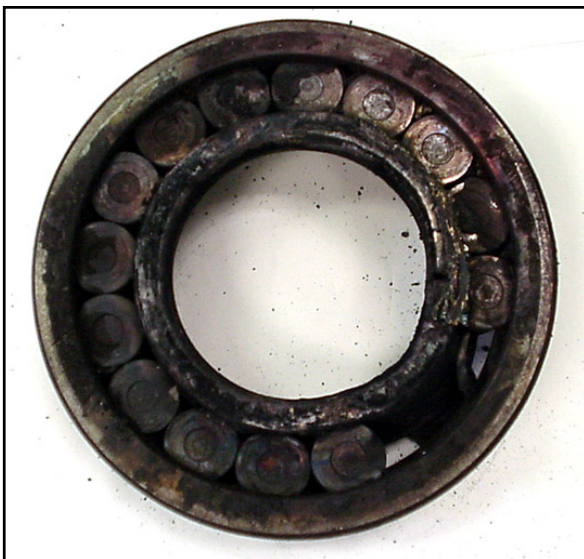
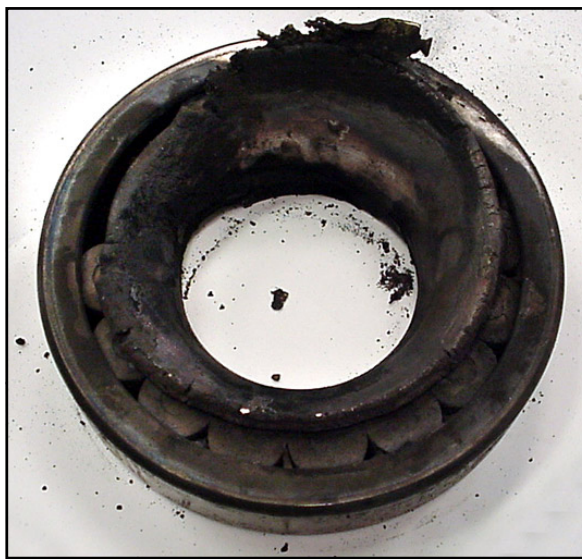
Severe vibration literally forged the inner race of this bearing once the race temperature reached 1200° F (650° C).

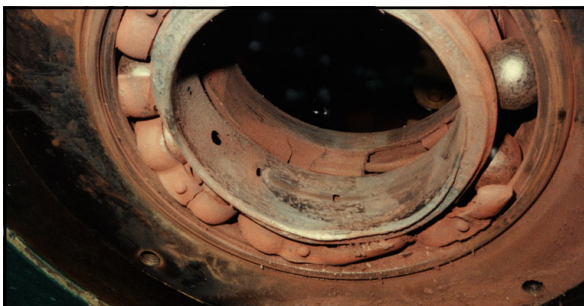
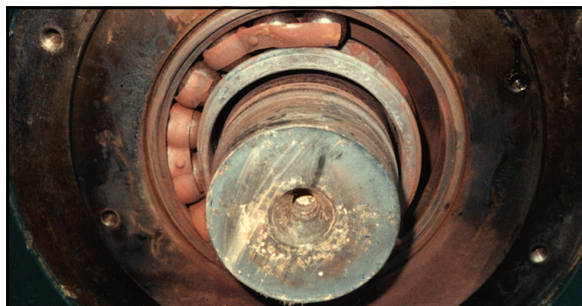
Loss of fit damaged this bearing. The inner race spun on the shaft, generating heat. Thermal breakdown of the lubricant followed causing the rolling elements to seize and forge to the inner race, which expanded it further.

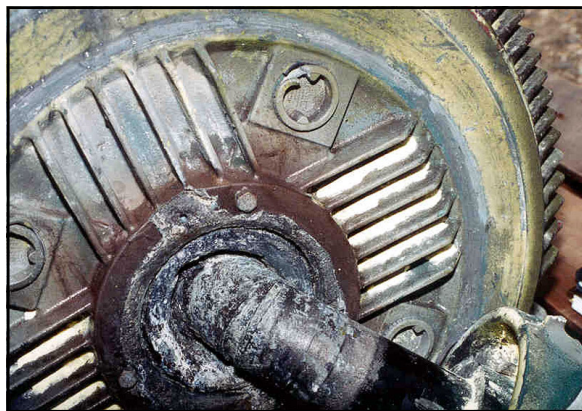
Loss of fit (left) may follow a bearing failure or it may result from corrosion, product contaminants or insufficient clearance. A motor in a corrosive atmosphere, operating infrequently, is susceptible to this mode of failure. The combination of an aluminum bracket and steel shaft can be vulnerable. Resulting friction could cause the shaft to seize, or friction-generated heat could weaken the shaft (right).

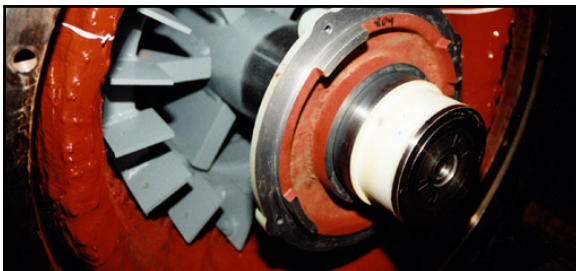
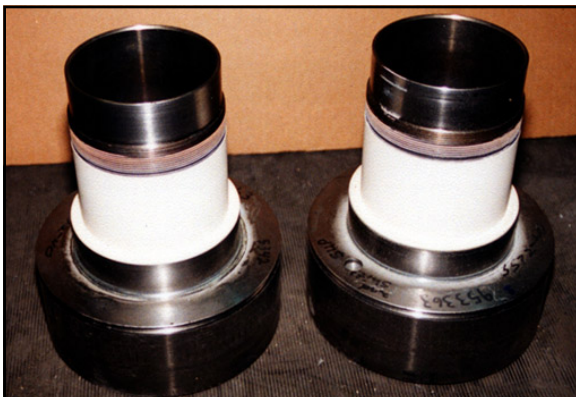
**FIGURE 14: INSULATING WITH CERAMIC SPRAY**

Ceramic or aluminum oxide spray is one method of insulating. Above, an opposite drive end bearing journal, and below, vertical motor bearing carriers, all of which have been insulated with ceramic spray.

Ceramic spray can be applied to the shaft journal, and must be precision-ground to size (Figure 14). Ceramic chips easily, so handling requires care. Because the layer of ceramic is relatively thin, care should be taken when balancing a shaft with ceramic-coated journals. The rotor weight should not be placed on the journals, for balancing or inspection, because the point-loading is likely to break the ceramic loose from the shaft. The damage often does not show up until the motor is in service, at which time the ceramic fractures, leaving the bearing with a loose shaft fit.

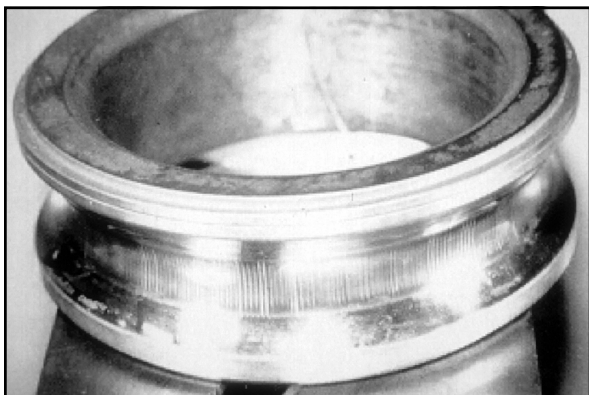
The spacing of the fluting marks depends on rpm, diameter, radial load and magnitude of the shaft voltage.

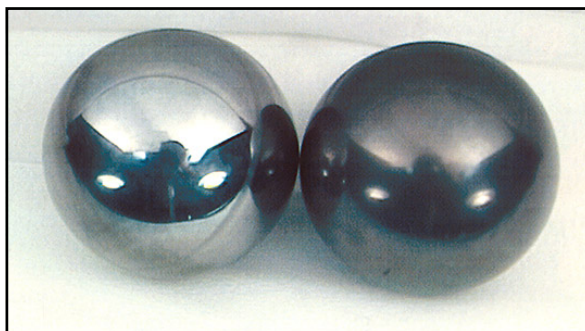
When rotational speed varies, the shaft currents may cause a dull, frosted appearance instead of fluting.

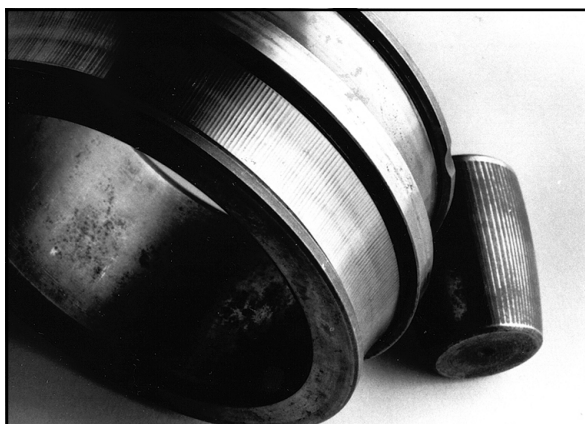
Fluting only occurred on the non-loaded roller path because the arcing occurred only at the gap between the rollers and the race. A good analogy is the points in an older automobile ignition system.

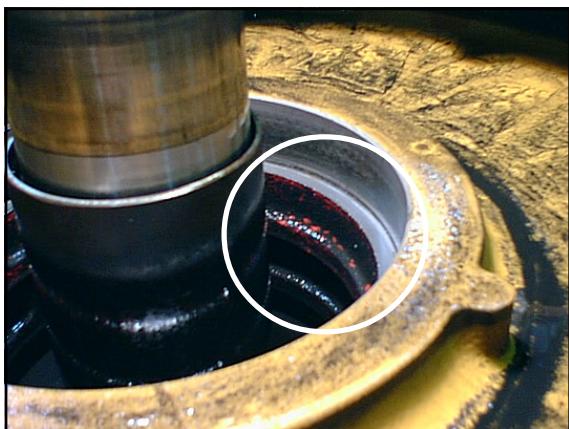
**FIGURE 17: BEARING SPACER**

The spacer supports the thrust bearing, ensuring that the bearing is positioned correctly for the oil level.

- Mismatch of thrust needs.
  - High-thrust bearings coupled to a low-thrust pump.
  - Low-thrust bearings coupled to a high-thrust pump.
  - Lack of upthrust capability on a pump with occasional upthrust.
- Bearing arrangement has been changed for occasional upthrust, but no clamping ring/thrust shoulder is provided. The bearing orientations are correct, but the upthrust bearing cannot function because there is nothing to thrust against. (See the top illustration in Figure 16.)
- Bearing thrust capacity has been changed by adding or removing a bearing without changing lubrication provisions. If a thrust bearing is removed from a 2-thrust-bearing arrangement, the lower bearing should be removed, with a spacer (Figure 17) used beneath the remaining bearing. A clue is to compare the oil level

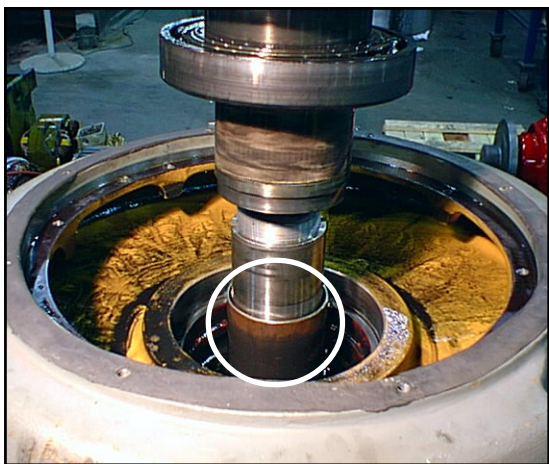
**FIGURE 21: STAND TUBE**

The stand tube serves as an oil drain. If bumped during the assembly process, the tube can be tilted or made to leak.

Oil leaks can result from overfilling, excessive clearances, blocked vent passages, foaming oil, machining problems, missing parts, design flaws and other causes. The location of the oil leak can sometimes be traced back from the oil trail. Oil traces from the vent openings may indicate pressurization of the oil chamber, often caused by blocked vent passages elsewhere in the assembly. Oil coating the rotor and windings may indicate a loosened stand tube (Figure 21) or improper machining of the interior of the bearing carrier (Figure 22).

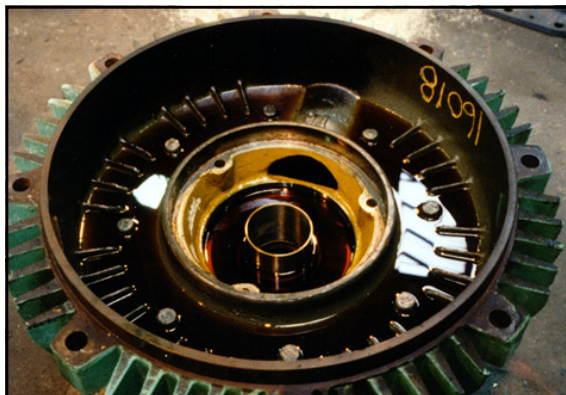
**FIGURE 23: OIL POOLED IN THE BOTTOM BRACKET**

The quantity of oil in this bottom end bracket indicates an oil leak of significant duration.

Oil pooled on the rotor, but not coating the windings, usually results from shipping and handling after the motor was removed from service. In either case, the stand tube should be inspected for possible leaks. Oil pooled in the bottom bracket may offer clues as to the magnitude of the leak (Figure 23).

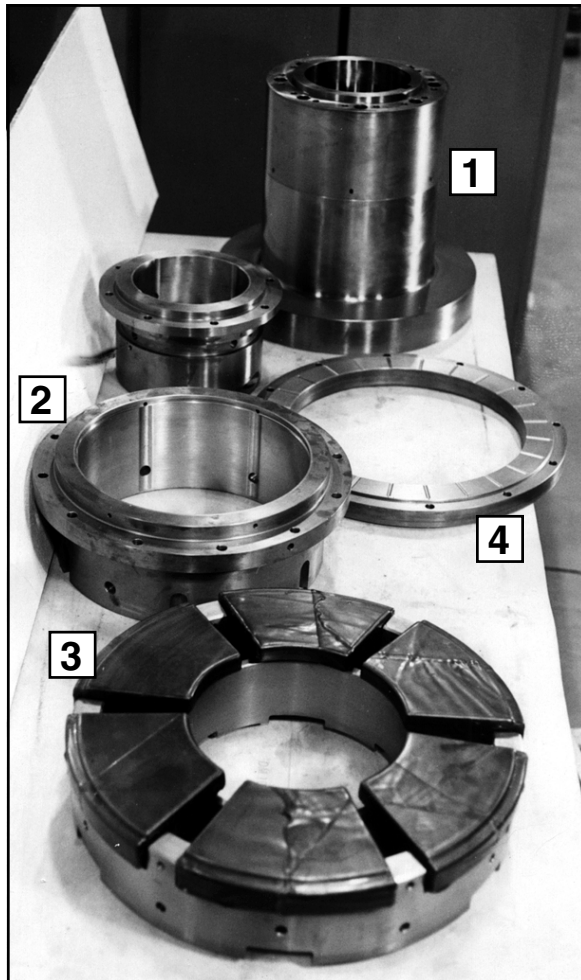
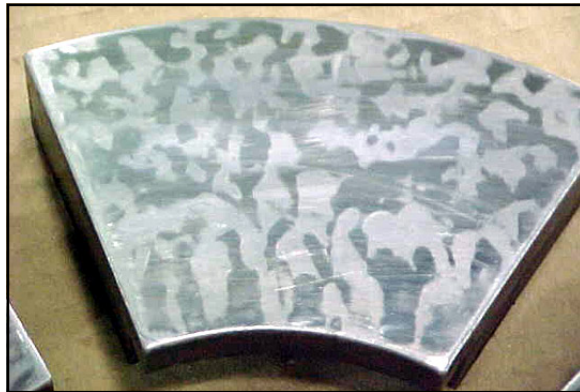
FIGURE 25: TILT PAD BEARINGS

The tilt pads have a thin layer of babbitt, precision-machined and etched (bottom right) to aid oil retention. Parts of a tilt pad bearing include:

- 1) Thrust runner.
- 2) Babbitt guide bearing.

- 3) Tilt pad and leveling assembly.
- 4) Upthrust limiting plate.
- 5) Tilt pad
- 6) Leveler/rocker.

The babbitt tilt pad bearing (Kingsbury™ bearing, plate bearing, hydrodynamic bearing) has an enviable record for longevity. The typical application for the tilt pad bearing has been hydroelectric generators, where low speed and continuous operation are the norm. One or two starts per year, and operating speeds around 100 to 400 rpm are favorable conditions for any bearing. Tilt pad bearing do not perform well when started frequently or at higher rpms. (See Figure 25.)

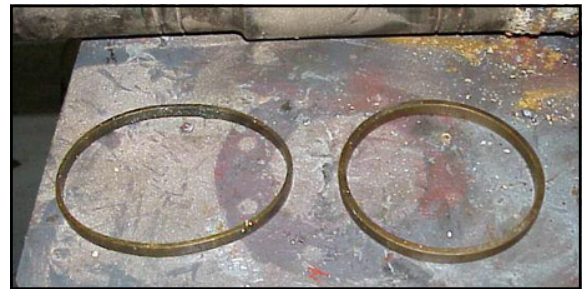
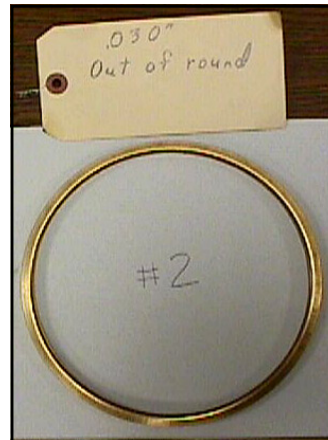
FIGURE 29: OIL RING SHAPE

Oil rings must be round (within about 0.002") and flat to rotate at a consistent speed. Above, the oil ring on the left has an obvious elliptical shape. At left, the oil ring appears round with a simple visual inspection, but it is actually .030" out of round.

Oil rings must be round [within about 0.002" (0.5mm)] and flat to rotate at a consistent speed. An eccentric ring will "lope," or change speed as it rotates. A bent ring will track erratically, causing the oil to foam. (See Figure 29.)

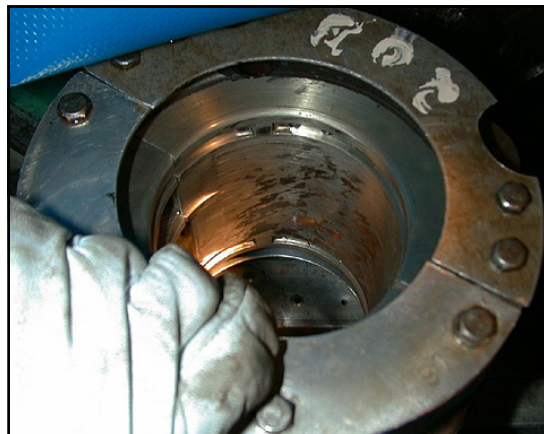
**FIGURE 32: OIL DISTRIBUTION GROOVE TOO SMALL**

The patchy contact pattern is one indication that the bearing is "oil starved." A deeper, wider distribution groove is required.

When bearings are replaced in a 2-pole machine, too small a distribution groove is evidenced by heat, a 'patchy' appearance to the babbitt surface, and difficulty in obtaining a good wear pattern. (See Figure 32.)

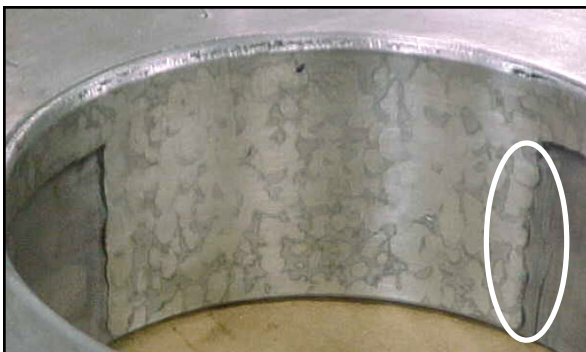
This bearing has been puddled and machined. The mottled surface was caused by using a babbitt grade different from the parent material. Note the irregular edge of the distribution groove.

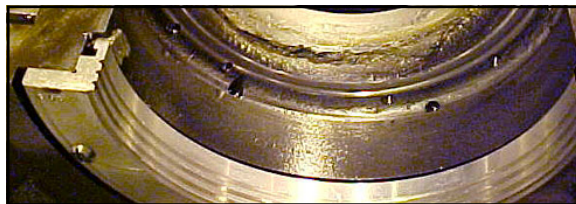
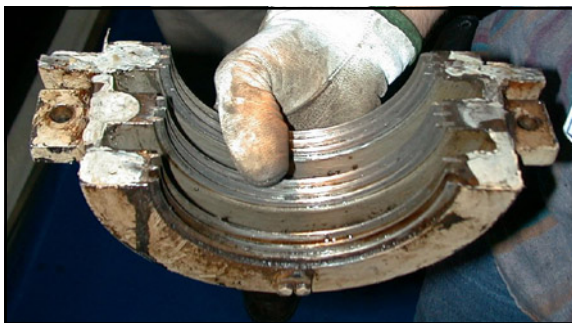
**FIGURE 37: LABYRINTH SEALS**

Labyrinth seals may be integral to the bracket (top), or removable by design (middle and bottom).

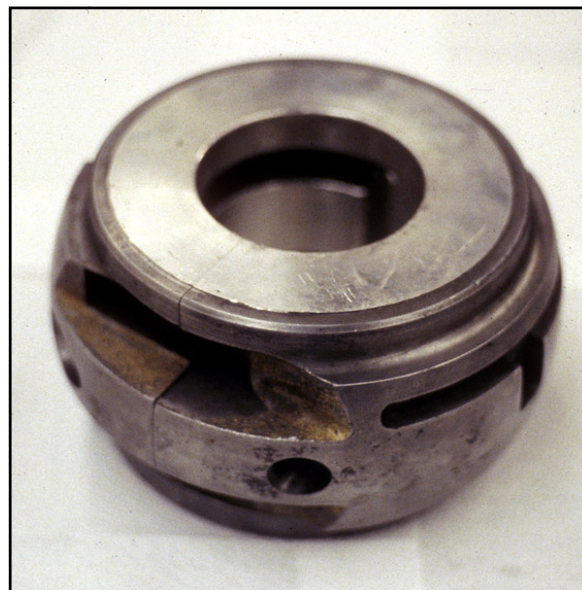
**FIGURE 40: SPHERICAL SLEEVE BEARINGS**

The spherical sleeve bearing, if properly installed, will align itself to the shaft.

Spherical bearings (Figure 40), also called self-aligning

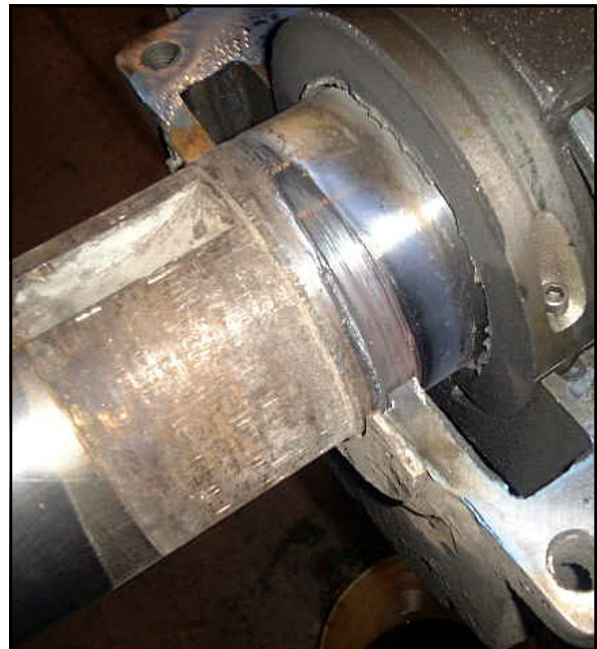
A bearing loose in the housing could permit the shaft to come into contact with the seal.

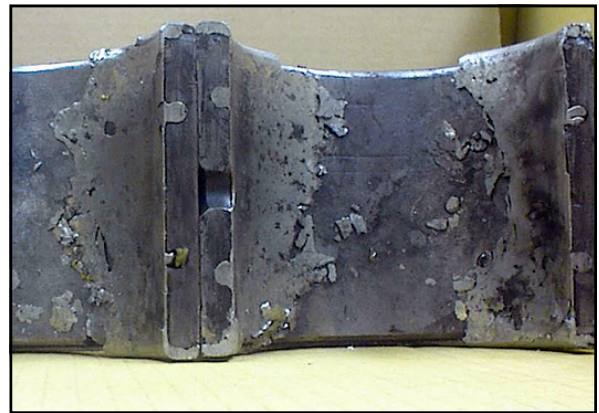
Examples (above and below) of babbit fractured by high vibration and/or impact damage.

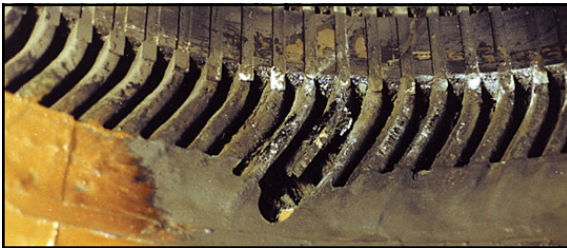
**FIGURE 5: GROUND FAULTS**

Random wound

Form wound

Often the only condition that will take a motor off line is a phase-to-phase fault. Because the fault current is so high, extreme damage is usually done to all turns and coils on both sides of the phase as illustrated in Figure 5.

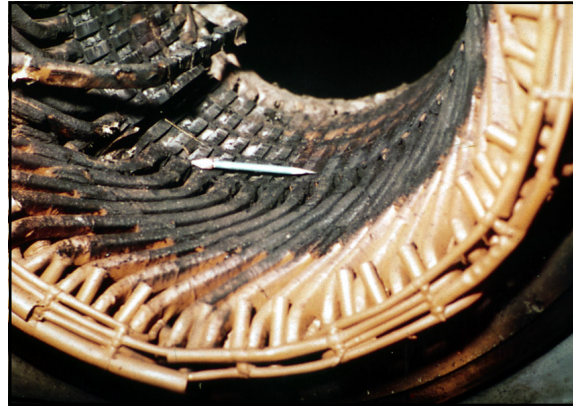
**FIGURE 6: TRADITIONAL THERMAL OVERLOAD PATTERNS**

Symmetrical overheating caused by an excessive amount of equal current in each coil. The burned appearance indicates there was more heat in the core than in the winding's endturns.

Uniform overheating caused by restricted ventilation or excessive ambient temperatures.

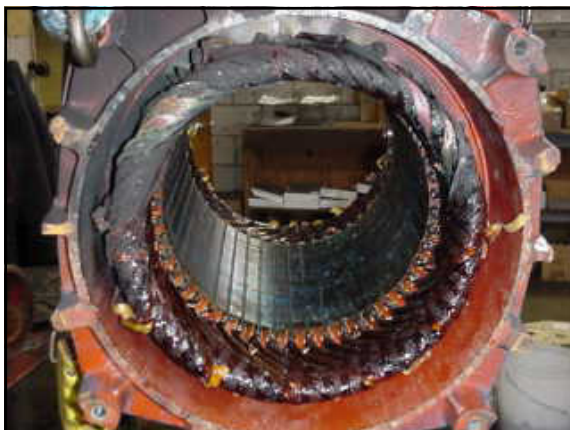
**FIGURE 9: NONSYMMETRICAL THERMAL OVERHEATING**

This type of pattern is normally caused by a defective internal connection.

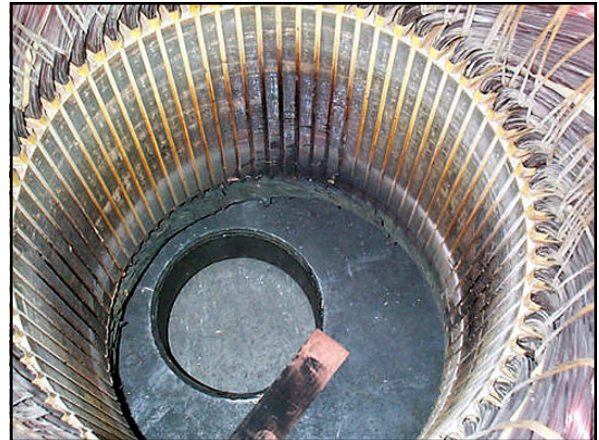
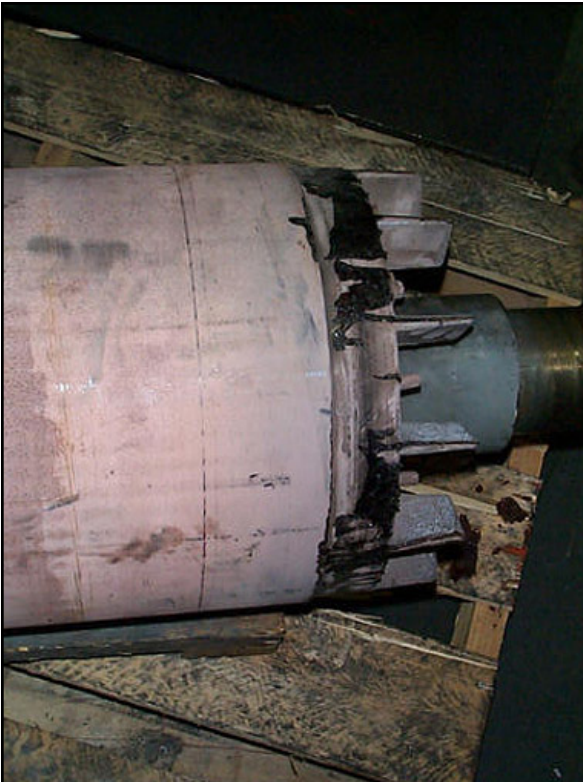
**UNBALANCED VOLTAGE**

Unbalanced voltage can cause symmetrical overheating of the rotor and uneven heating in the stator. Depending on the source of the unbalanced voltage, the stator will have either one or two phases that show signs of overheating. The end turns may not show signs of overheating since they are cooler than the winding in the slot, if there is adequate airflow. In this example, the voltage unbalance was severe enough that it eventually led to a ground failure in the slot due to overheating of the rotor. The winding itself shows no damage except in the 4 poles around the stator, in the center. The center of the rotor was the hottest spot due to the unbalance.

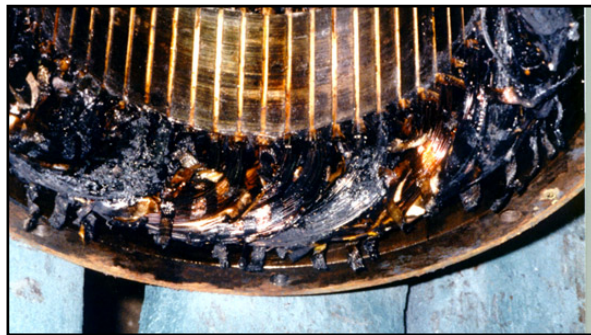
The windings above are wye connected and failed during starting. One-third of the groups are burned indicating the windings were subject to single phasing. The heating was so severe that the aluminum rotor melted. The evidence of “flung” aluminum indicates that the motor was running for a period of time before it failed.

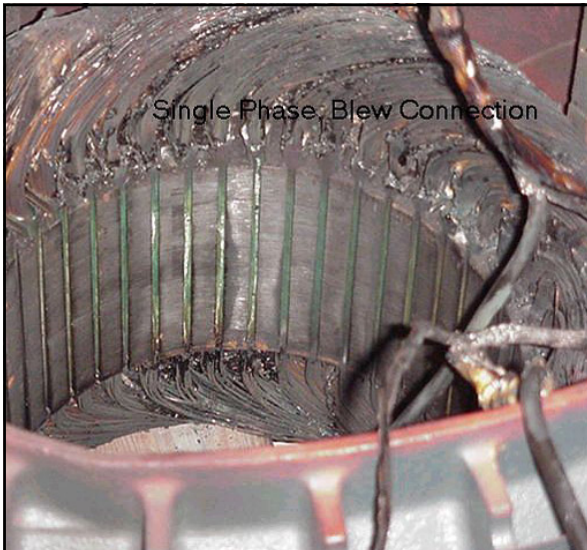
This single-phased condition resulted from an internal open. A broken jumper, a wire broken at the star point or a corner of a delta connection could each result in a single-phased condition. Not all single-phased failures result from fuse or contactor problems. If a customer insists that the fuses are intact and finds no other evidence of a single-phased condition, check the connection for evidence of open circuits.

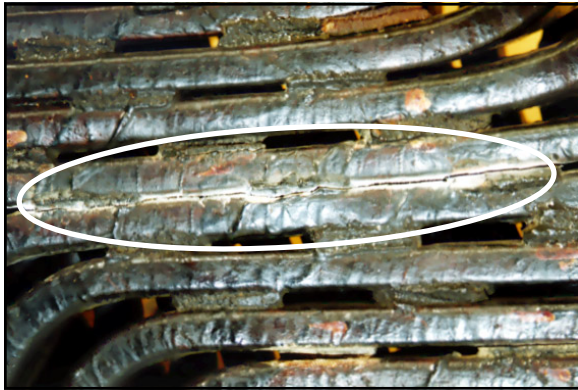
**FIGURE 14: EXAMPLE OF PARTIAL DISCHARGE (CORONA)**

Adjacent coils of different phases are in close contact. Properly-spaced coils have additional insulation: the air gap between them.

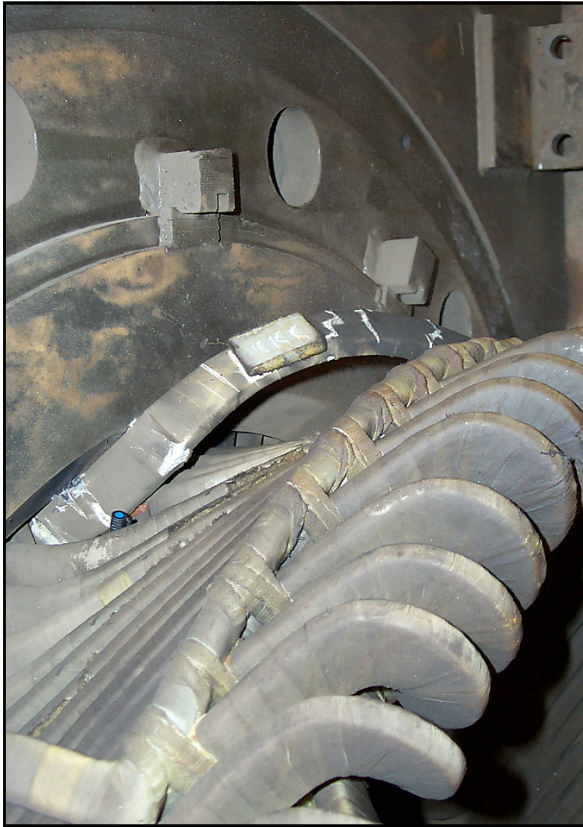
**RECLOSURE/TRANSIENT VOLTAGES**

Whether caused by a rapid bus transfer, lightning, over-correction of power factor or “other,” the result of a high-voltage transient often looks like sabotage. A 200% overvoltage may result in 30 to 40 times line current, with  $(30 \text{ to } 40)^2$  increase in mechanical force acting to displace the coils. In many cases the damage is most noticeable at the lead coils. The extremely high stresses involved cause the winding to fail at the weakest point. The more sturdy the coil blocking, and the shorter the coil extensions, the more resistant a winding is to this type of failure.

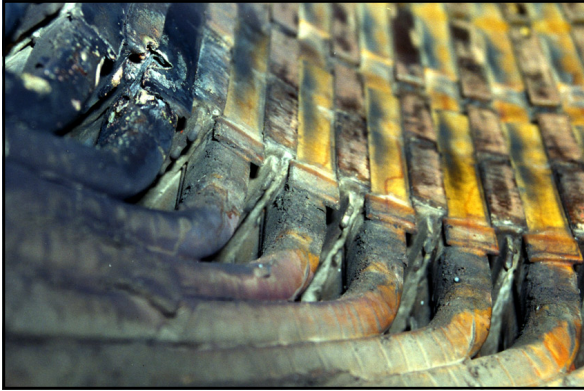
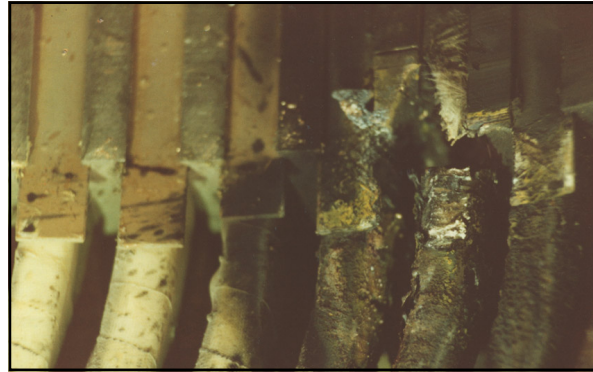
## GROUNDS AND SHORTS

The end of each slot acts as a fulcrum where force from the flexing coil is concentrated. Not only is this a point of mechanical stress, but it is also subject to electrical stress as ground potential. The combination of electrical and mechanical stress make this the most likely place for ground failures. Eddy-current losses are one result of ground failures in the laminated core, as laminations are fused together, sometimes with copper from the failed windings. Failure to clear these shorted regions results in hot spots in the core, which shorten the insulation life of a replacement winding.
