# Root Cause Failure Analysis

**Pinpointing  
the true cause  
of electric motor  
failures**

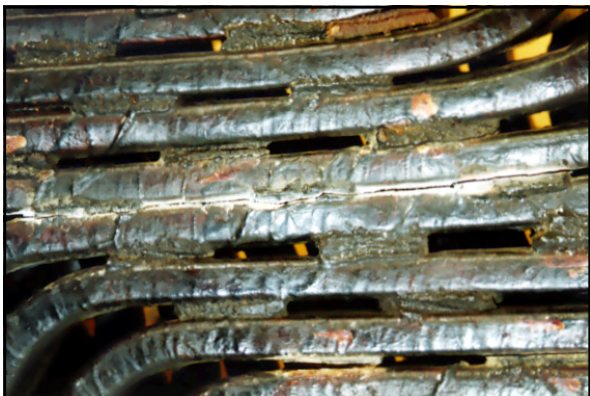
Adjacent coils of different phases are in close contact. It is common for coil manufacturers to use less insulation on the coil ends than on the slot sections where ground potential is a concern. Properly-spaced coils have additional insulation: the air gap between them. Partial discharge tracking is usually evident as a white residue from the continual electrical discharge that occurs.

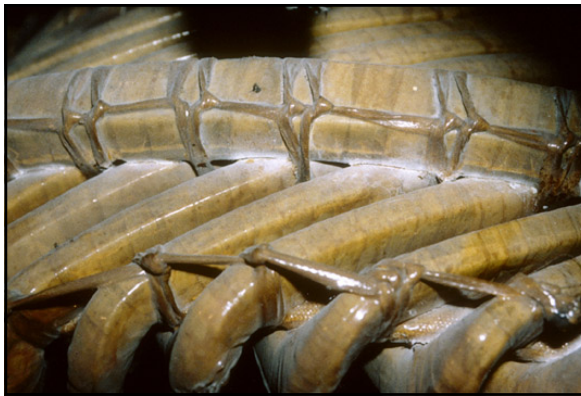
At first glance, this looks like partial discharge. Closer inspection revealed poor bracing support of the coils. Felt padding or use of surge rope would eliminate this problem.

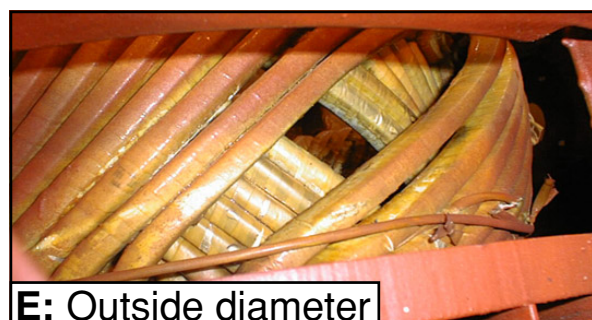
**WINDING MOVEMENT AND COIL BRACING**

Compare the straight line of blocking in Examples A and B to the staggered line of blocks in Example C. The straight line of surge rope and felt blocks in Examples A and B will provide strength to minimize coil movement. The long end turns in Examples C, D and E should have been braced by two rows of blocks, however, only one row was used. In Example D, the felt block is also not tall enough to form the desired “dog bone” shape which further locks the block to the coil. Whether individual or a continuous strip tucked between coils, the felt block can only bond when in contact with the coils. In Example E, one felt block was used on the inside diameter, but it was placed too close to the knuckle and provided very little bracing. On the outside diameter, no felt blocks were used.

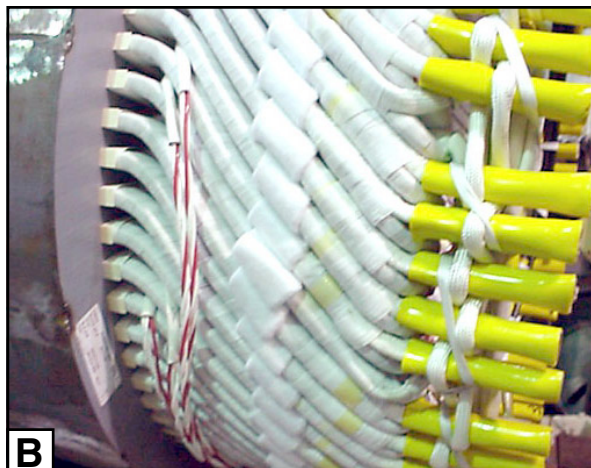
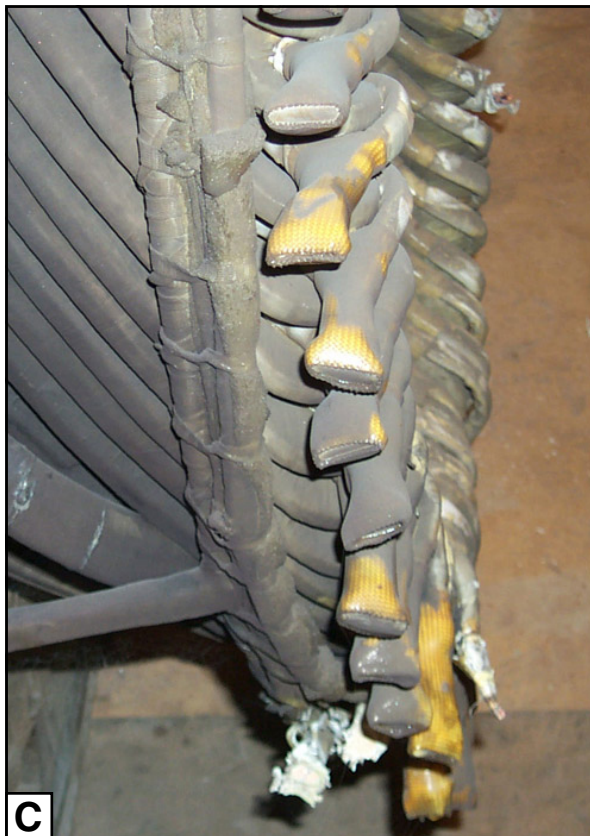
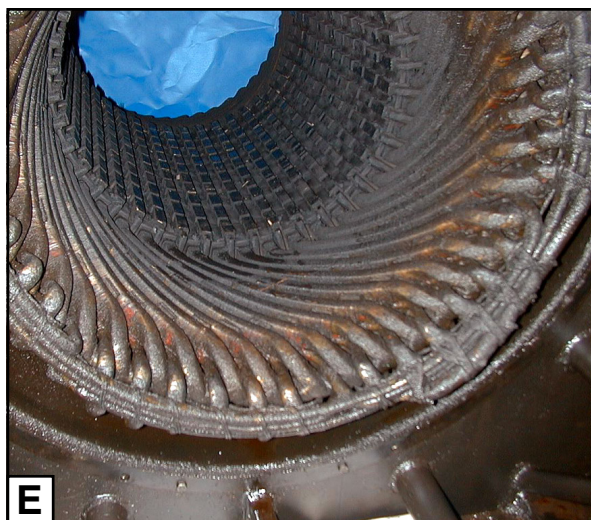
**WINDING MOVEMENT AND COIL BRACING**

Bracing of the connection is also critical to prevent work-hardening of the copper, or chafing of the sleeving that ultimately results in phase-to-phase failure. Compare the series stubs in Examples A and B to those unbraced in Example C. If the series connections can be easily moved, failure is more likely than if they are solid. Jumpers that fail may indicate movement or inadequate spacing. Compare the “butterfly tie” lacing used in Example D to the uncontrolled contact in Example E.

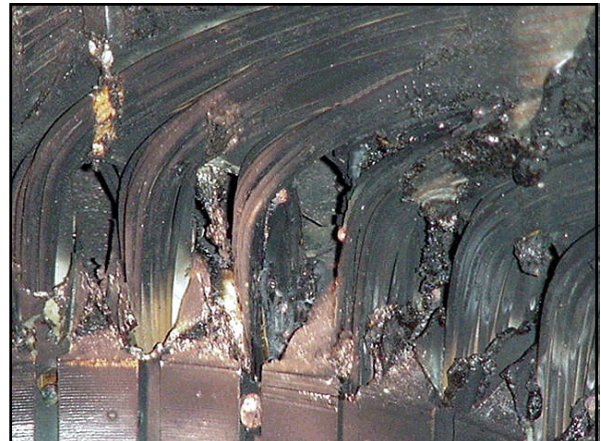
High slot fill also helps brace windings. Low slot fill (above) can lead to failures like the example at right.

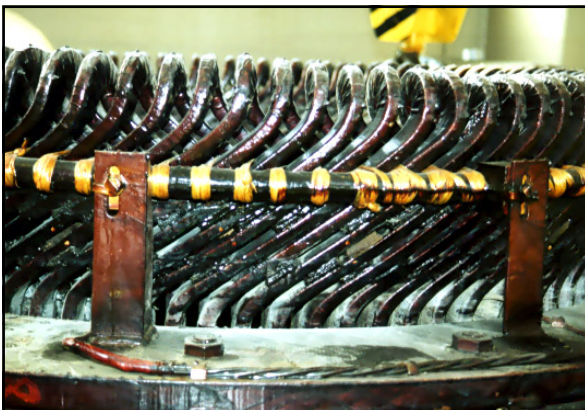
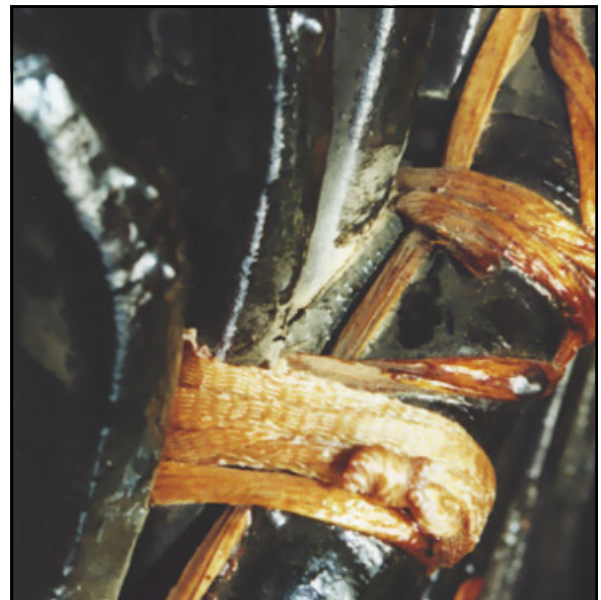
The support posts secure the surge ring to the stator frame. Ring placement just behind the coil knuckles is preferred. The felt blocks in this winding are irregular, reducing their effectiveness.

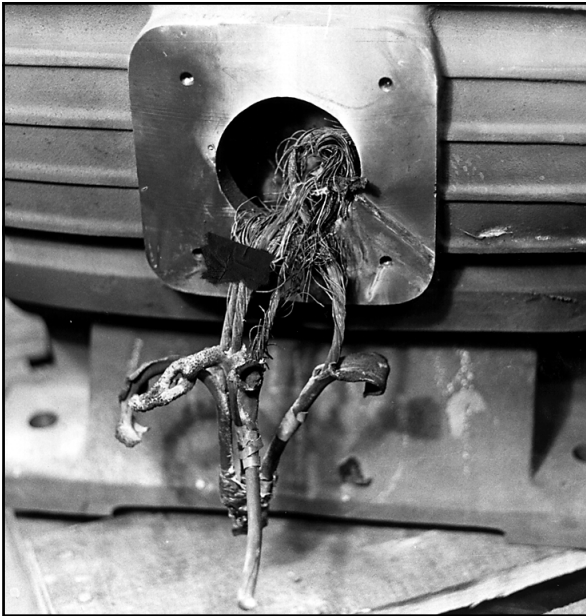
These leads failed during overload condition before the winding had a chance to fail. The leads were Class B while the winding was Class F. Upon changing to Class H leads, the winding then failed turn to turn under an overload condition. Some service centers oversize the leads to reduce the current density.

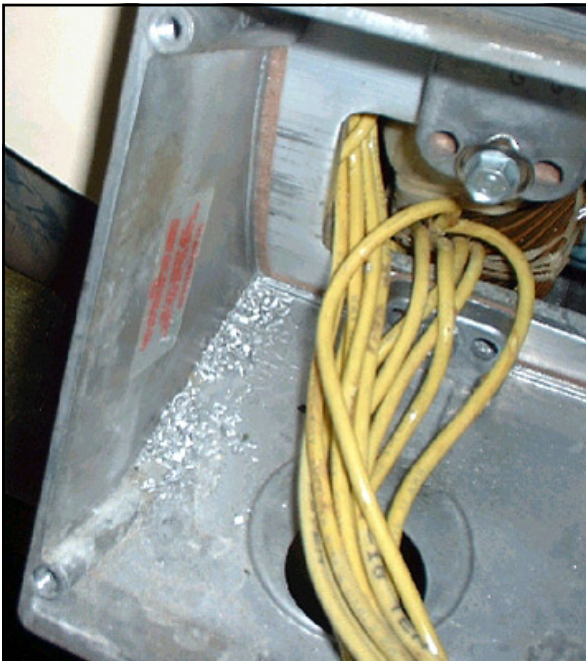
This nine-lead motor has several leads resting against the sharp corner of the frame. More leads equals more potential for grounds. Also note the metal chips left in the terminal box after conduit hole was drilled.

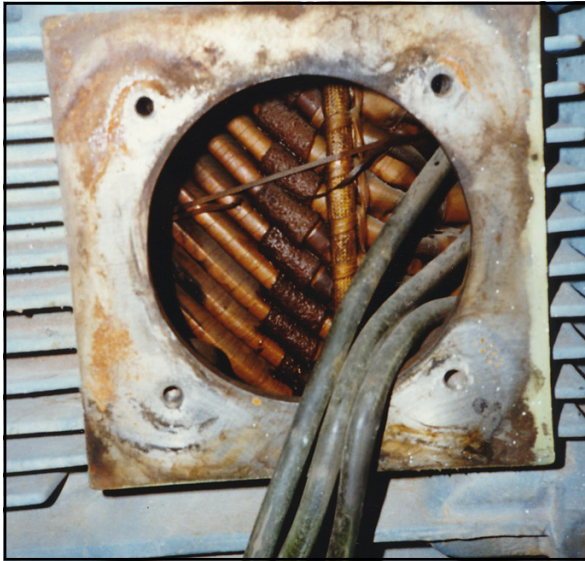
This winding has only three leads, which reduces the stress on the leads, but they are not sufficiently protected from the edge of the stator frame.

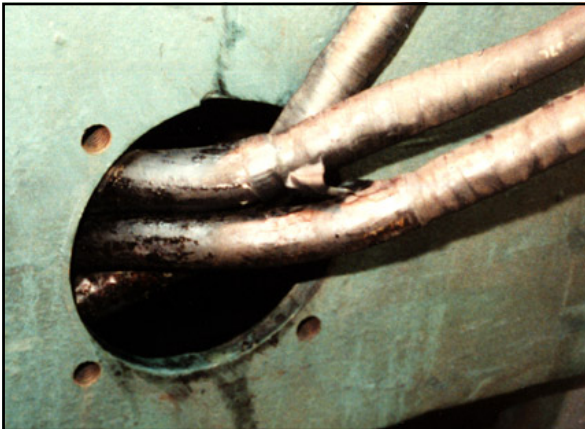
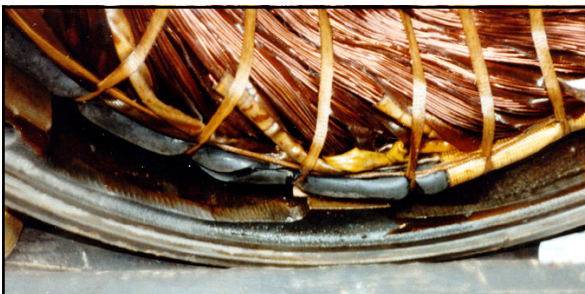
Oil chemically attacks some lead insulations, such as Hypalon, causing it to soften and swell. Cut through and cold flow properties are greatly reduced. When oil/petroleum products are present, Teflon or silicone lead insulations are preferred.

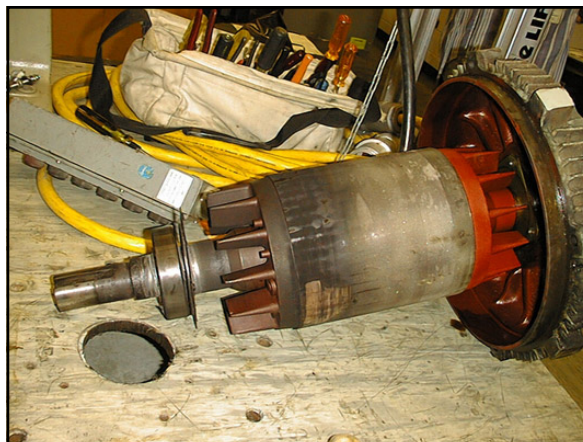
In this example, the bearing failure went unnoticed until the rotor dropped and came into contact with the stator. The damage to the rotor and stator could have been avoided if bearing resistance temperature detectors (RTDs) were installed to monitor the bearings.

The photographs on Pages 3-32 and 3-33 show the damage caused due to contact from the rotor. Eventual overheating from this condition would cause severe winding damage. The contact also can cause severe heating to occur on the rotor surface.

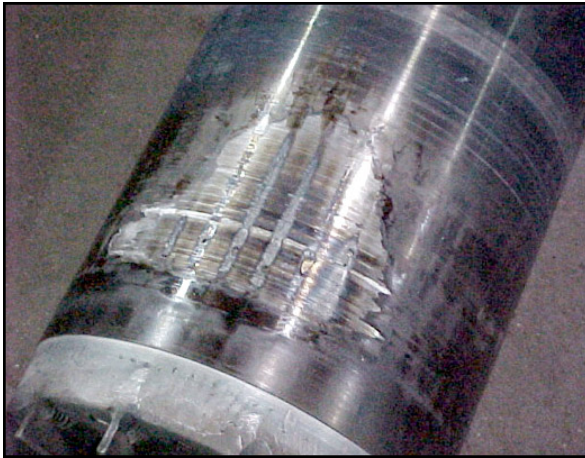
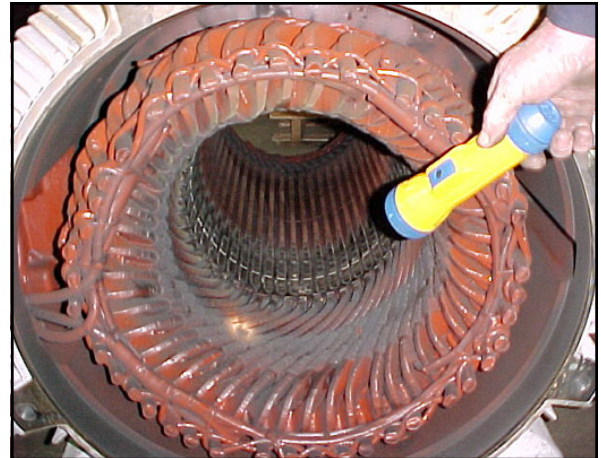
Evidence of a rotor strike on only one side of the rotor often indicates a bent shaft. This may result from a bearing failure or from a manufacturing/repair defect.

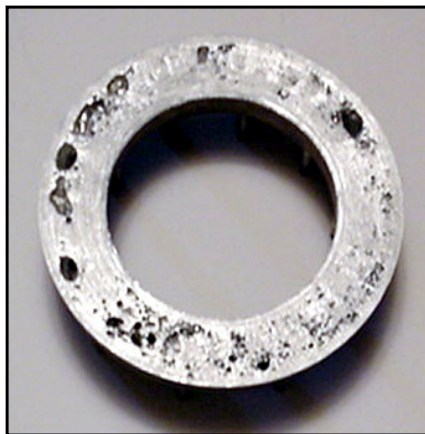
The porosity of this end ring weakened the balancing nib shown in the photograph at left. The nib and its weights broke away from the end ring, hit the fan blades and were thrown into the winding as shown below.

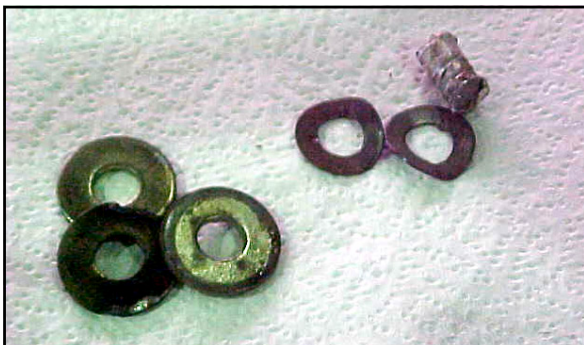
Broken balancing nib and balancing weights.

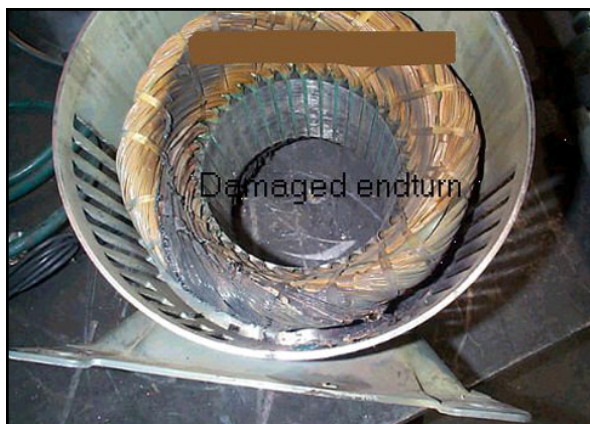
The balancing weight was not properly secured to the rotor nib and eventually was thrown into the stator winding causing a turn-to-turn short.

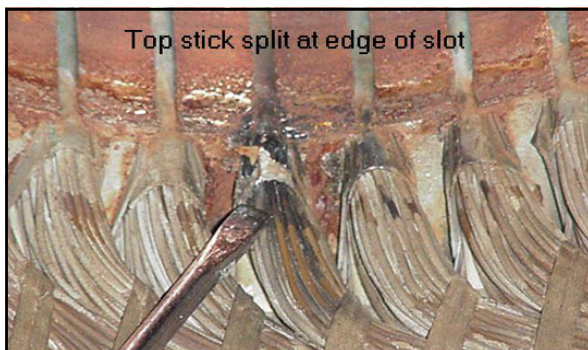
The wedge in the top photograph was damaged during insertion resulting in a ground failure. However, the root cause was poor workmanship. Driving a wedge in carelessly or using pliers may fracture the wedge. A sharp burr on the underside of the slot top may also have sliced the wedge. The bottom photograph shows a failure that progressed slightly further.

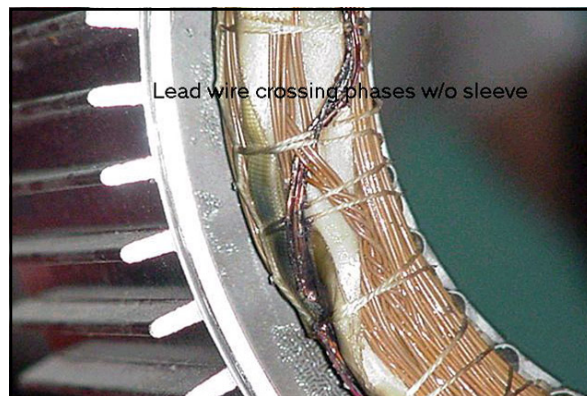
This photograph shows the aftermath of a crossover without proper insulation (missing sleeving). The voltage stresses are much higher than the designer intended.

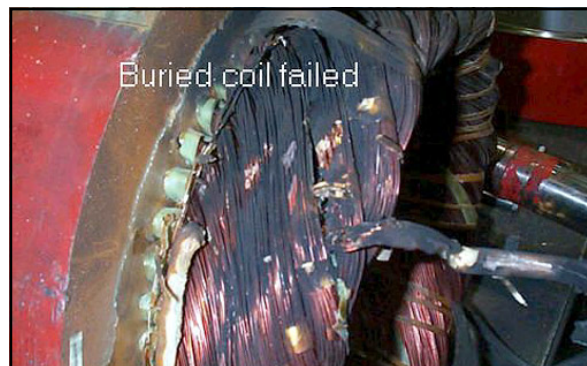
A less-obvious thermal problem is shown above. Airflow across the windings should be uniform. A buried coil cannot transfer heat as effectively. The same problem exists when a long winding extension is formed back with a mallet, resulting in a bulky coil extension. The mode of failure is this: The conductors deep within the coil extension cannot dissipate heat as effectively as those on the surface. Elevated temperatures weaken the bond strength of the resin allowing the conductors to move and chafe resulting in turn-to-turn or coil-to-coil failure. Movement may be caused by vibration over time, or a sudden event like across-the-line starting when the windings are hot.

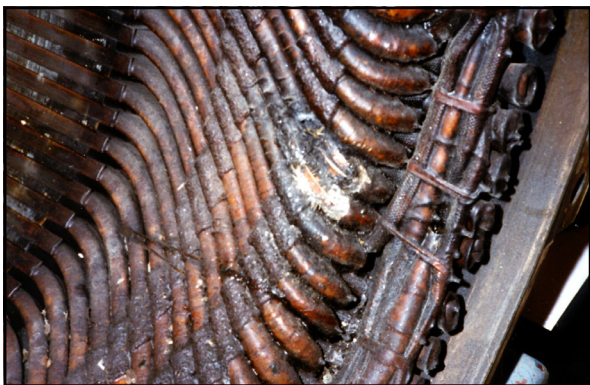
A common area of mechanical damage to the end turns occurs when the rotor bumps the stator during removal or insertion. Take measures to safeguard the end turns during this step of assembly or disassembly.

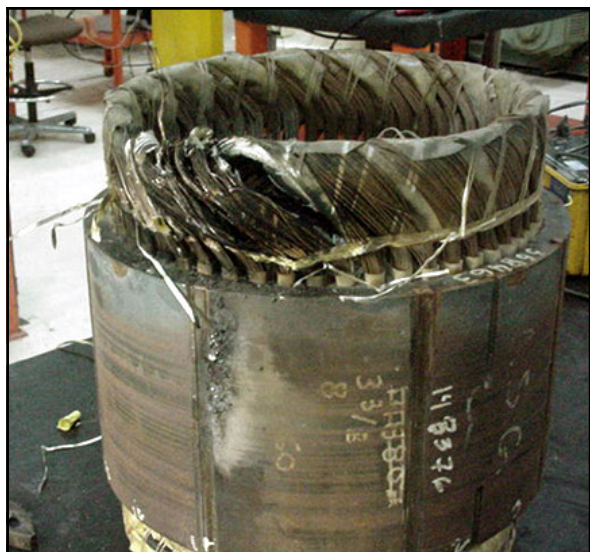
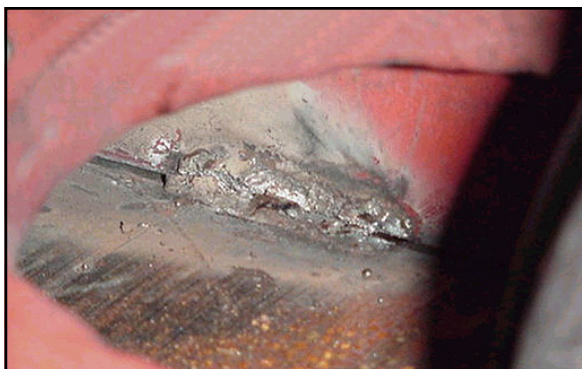
The factory welded the core (left) into the frame without protecting the windings. Weld splatter damaged the windings, resulting in a turn-to-turn failure. Above, this stator to frame weld broke allowing the stator to shift 1/8 inch.

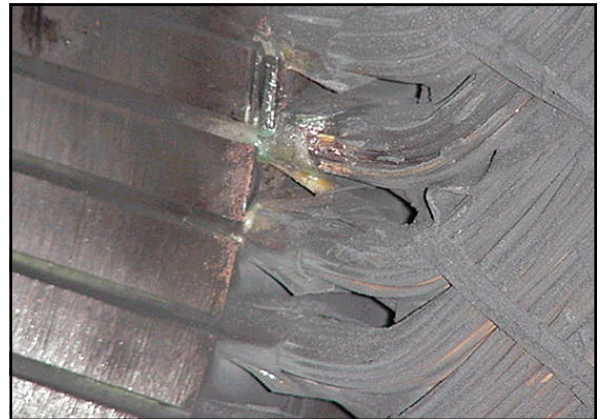
A lamination displaced during lacing (left) can vibrate and cut slot insulation causing a ground failure similar to the one shown at right.

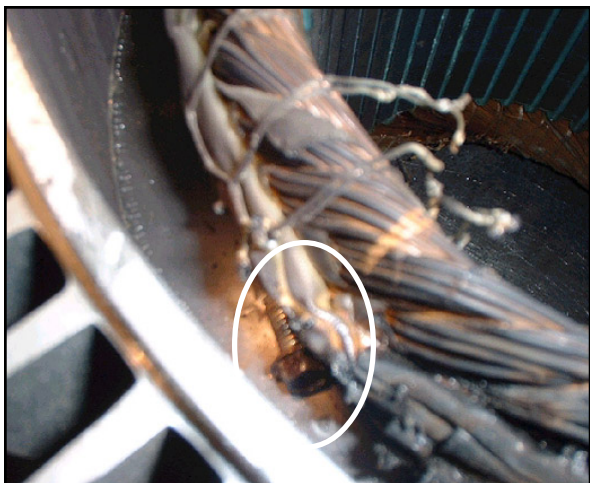
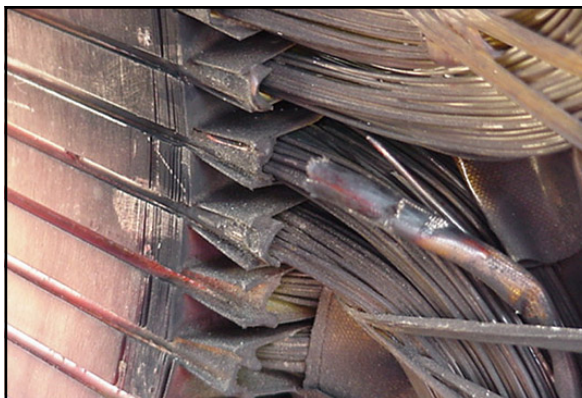
Loose laminations, low slot fill, phase insulation out of place and improper full-slot lap winding method.

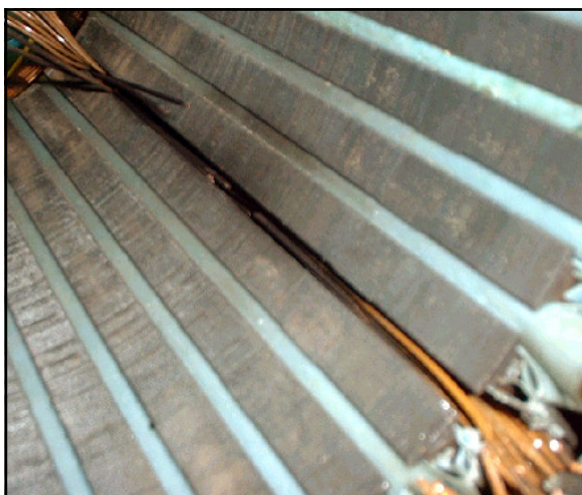
The conductor was improperly placed outside the cell wall/topstick so that it came into contact with the laminations resulting in a ground failure.

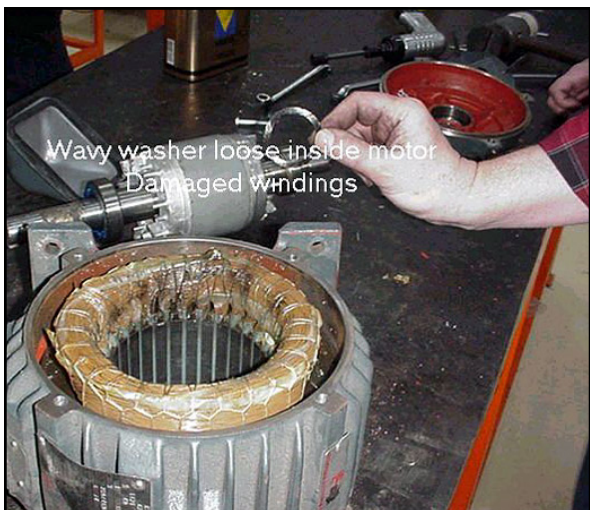
A bolt (top) or washer (middle) dropped during motor assembly, or a washer that comes loose during operation (bottom), can cause a ground failure. Be sure to account for all the bolts, nuts and other hardware.

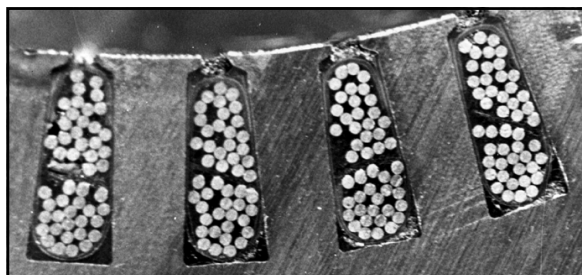
This stator shows signs of loose coils and low slot fill. Loose wires will vibrate in the slots causing chafed insulation and fatigue fractures. Note the poorly positioned separators, the extra space at the bottom square corners and the voids. Heat transfer also suffers. Filler spacers, more copper or better varnish retention would improve this winding.

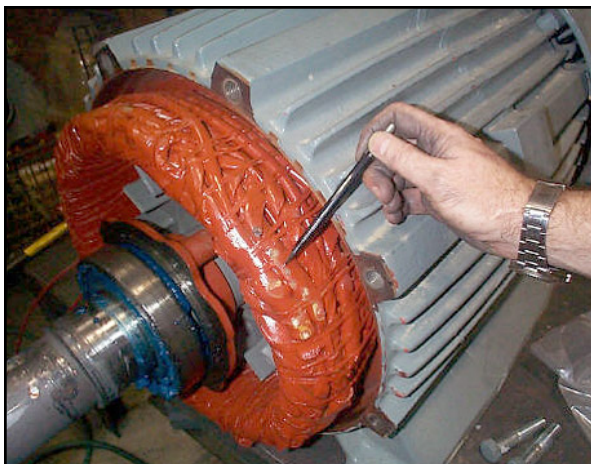
The winding extension is too long and actually was in contact with the end bracket when the motor was assembled. A ground failure is imminent.

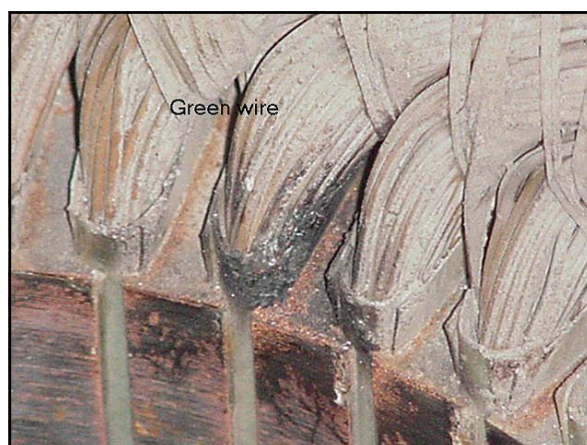
Severe moisture resulted in corrosion which attacked the insulation. Rust buildup on the laminations is strong evidence of this. Green coloration of the copper shows that the corrosion has been ongoing for some time.

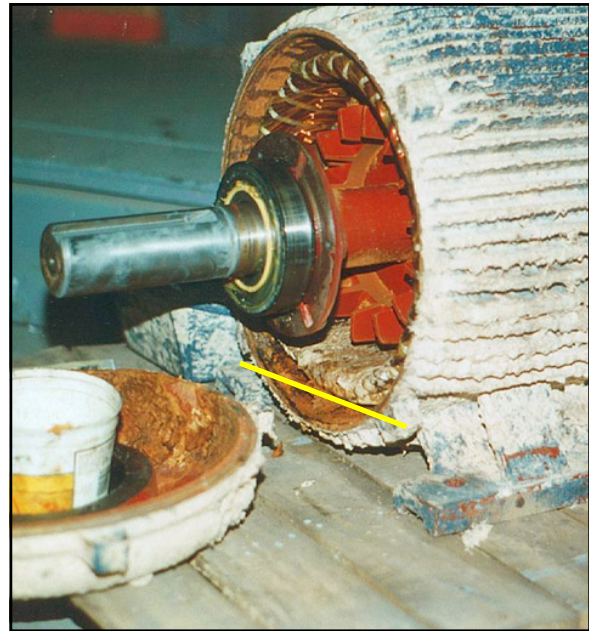
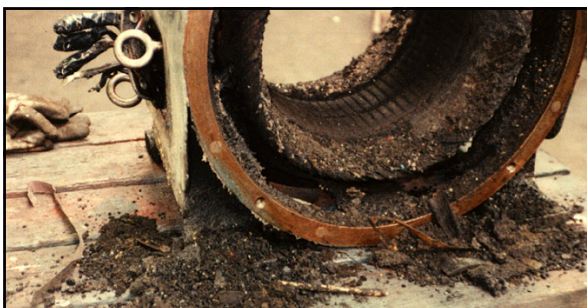
Contamination can come from within the motor. Overgreasing has led to contamination of the windings which in turn created thermal problems.

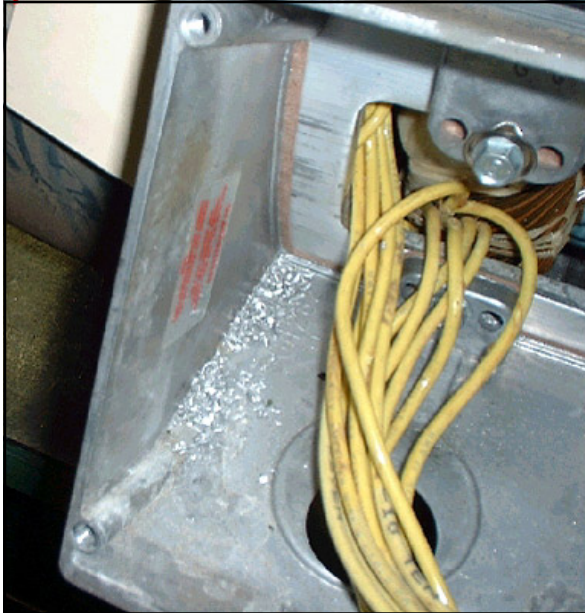
Foreign material: The conduit hole was drilled and filings were left in the terminal box.

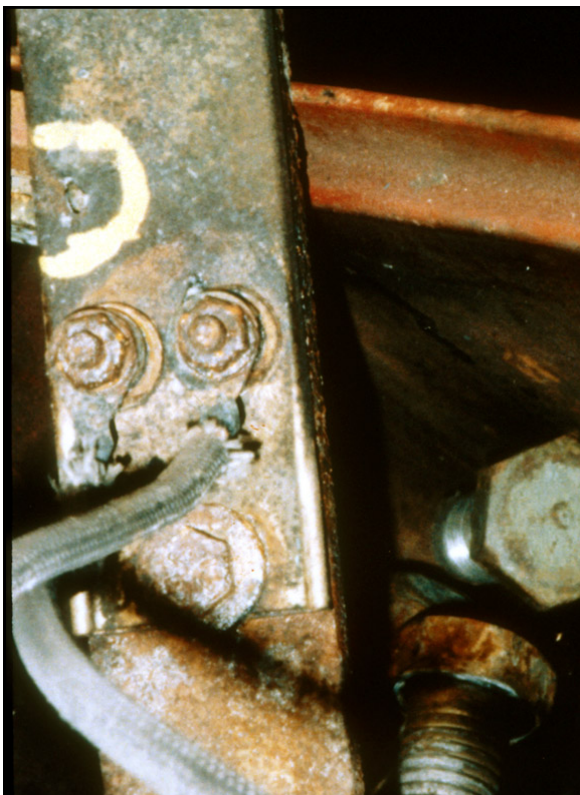
Thermal cycling of space heaters makes them susceptible to moisture and corrosion.

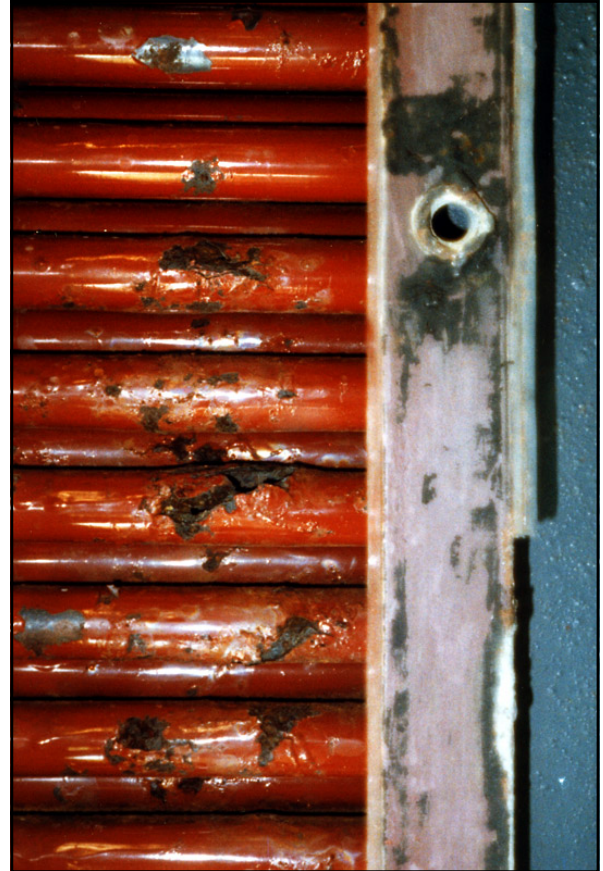
Cooling tube corrosion can occur inside or outside the tubes, wherever the atmosphere is most corrosive. Not only can the tubes leak, but oxidation is a thermal insulation.

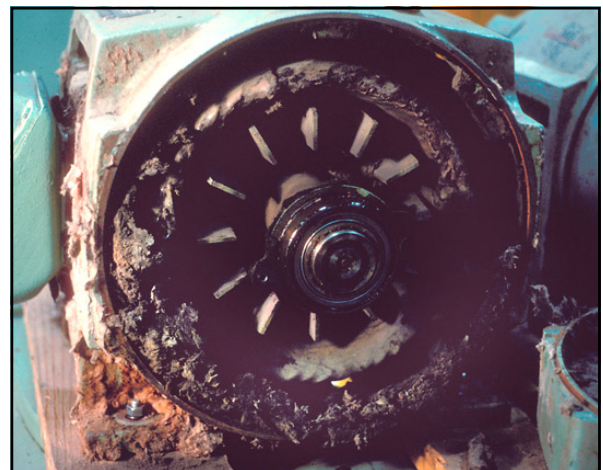
Moisture combined with foreign material can pack the windings or vent passages. This open motor is filled with pulp which restricts the flow of air. As a result, the winding overheated and failed.

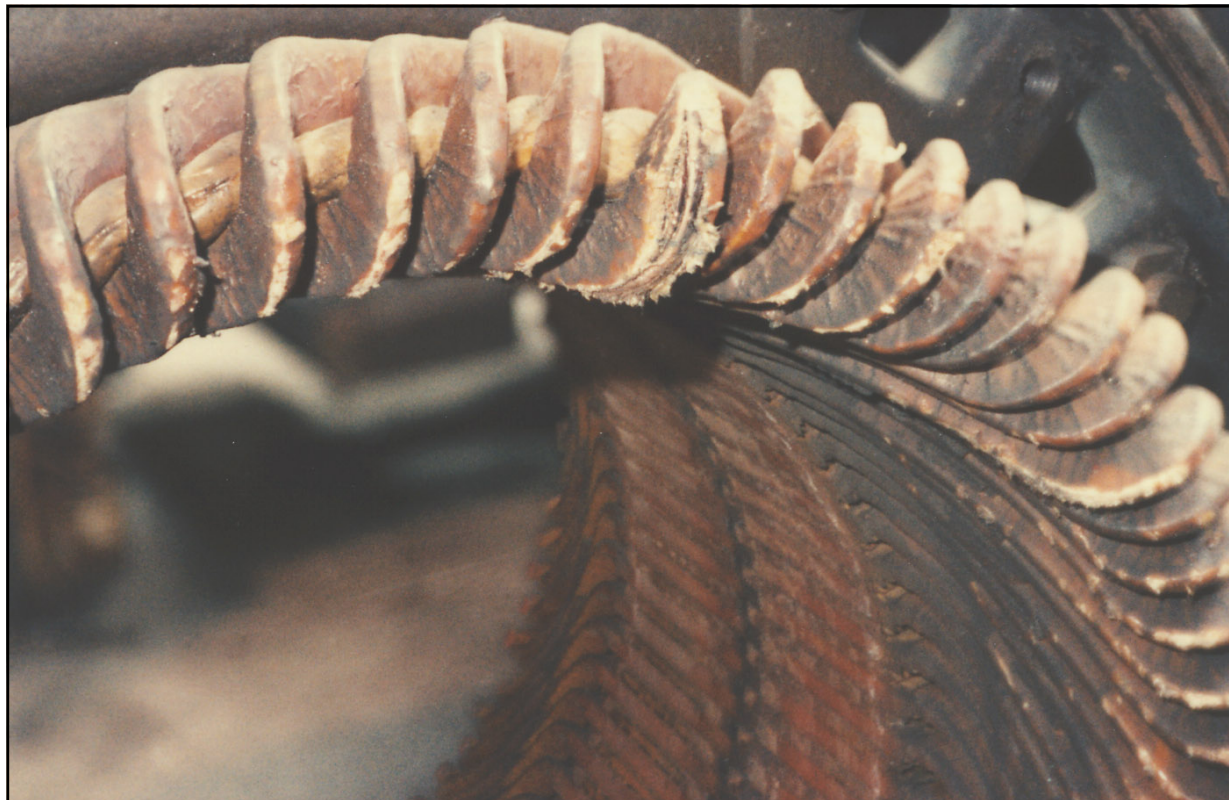
The coil insulation has been sandblasted through thus exposing the coil turns. Continued abrasion would remove the conductor insulation. The exposed turns are now susceptible to moisture, contamination and tracking.

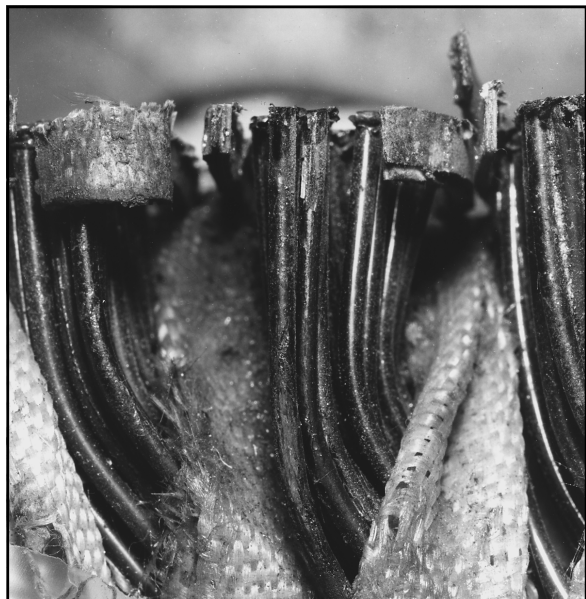
Abrasion has removed varnish and some of the enamel from the magnet wire. This is most often found in areas of high air velocity, usually in line with fans, vent ducts, etc.

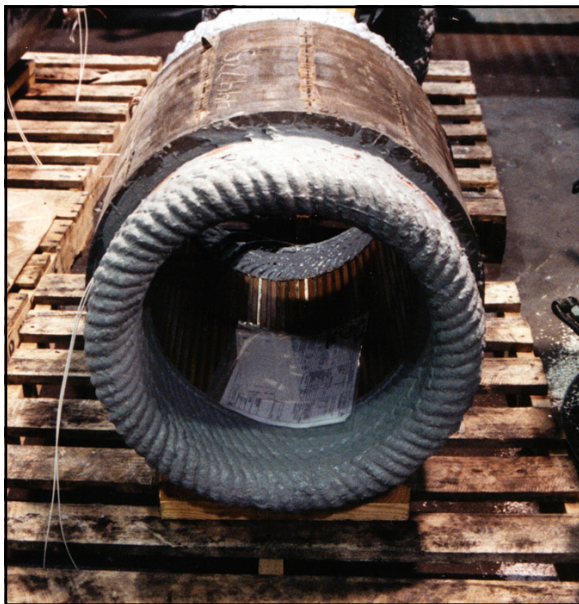
This stator has been sprayed with an abrasion-resistant silicone rubber to minimize the type of damage caused to the other windings pictured on this page.

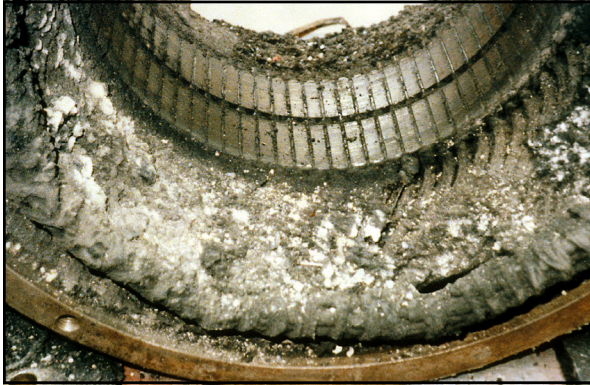
For the open dripproof motor, contaminants carried by the air stream build up on the windings, trapping heat and possibly absorbing moisture. This motor may have the wrong enclosure for the application.

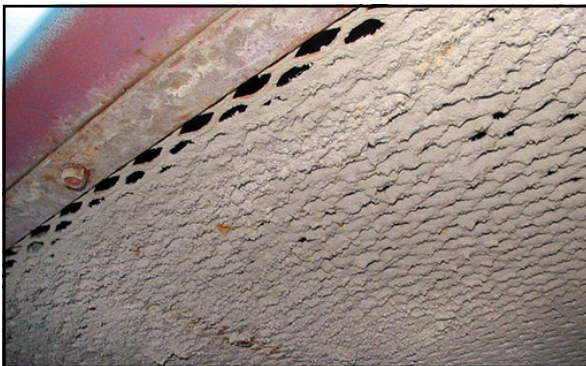
This expanded metal screen does not clog as easily as a screen with smaller openings, but contaminants can still build up, especially when moisture is present.

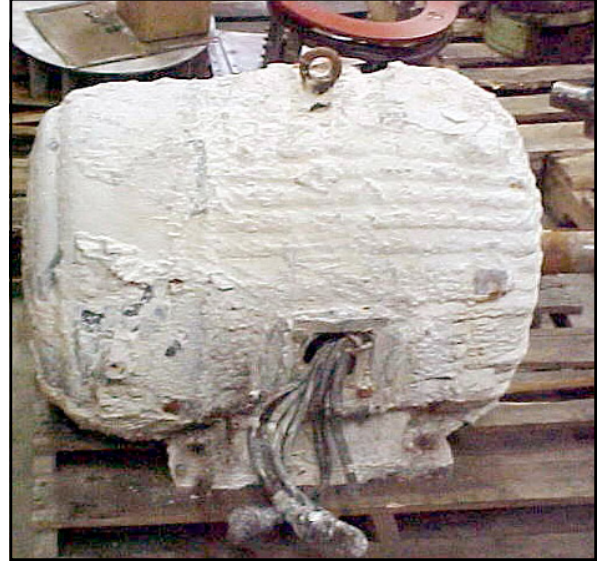
For the totally-enclosed, fan-cooled motor, the exterior plays an important role in cooling the motor. Cement dust, limestone, paper pulp and other product can collect and insulate the motor, drastically increasing winding temperatures.

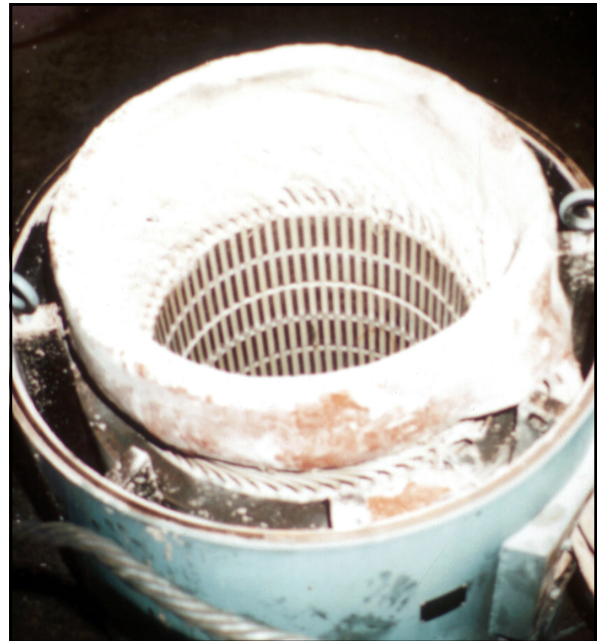
In a winding designed with a partly-encapsulated coil extension (for increased winding rigidity), ventilation among the exposed portions of coils is even more critical. The stator vent ducts in this motor, as well as the coil extensions, are blocked by contaminants.

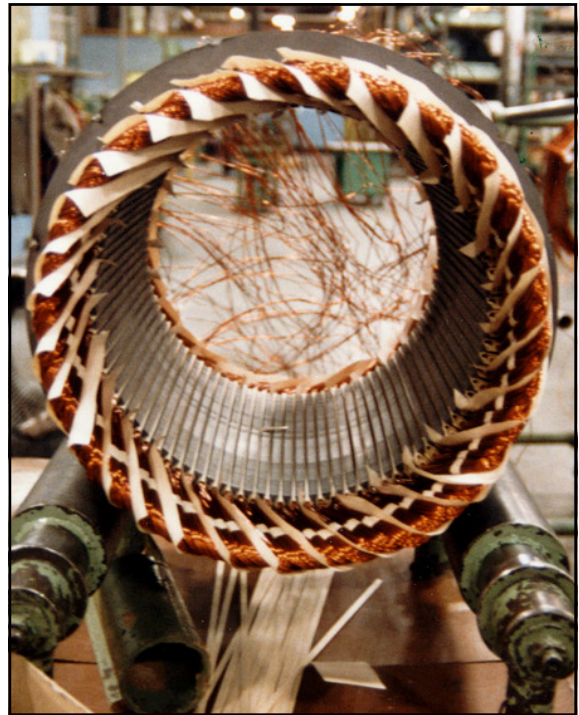
**FIGURE 22: PHASE INSULATION**

Phase insulation should protrude past the phase coils.

Phase insulation serves to separate the coils in different phases, and must be left long enough to prevent creeping during the process of handling, lacing the coil extensions, varnish treatment and curing, as well as movement during starting and operation of the motor. (See Figure 22.) If inspection shows that the phase insulation disappears in

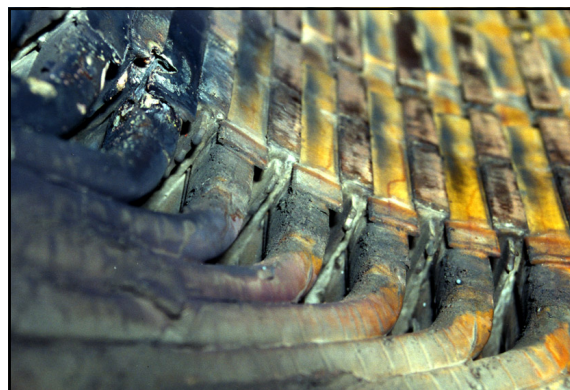
**FIGURE 25: GROUND AT END OF SLOT**

The end of each slot is the fulcrum to the leverage exerted by each flexing coil. Not only is this a point of mechanical stress, but it is also subject to electrical stress as ground potential for each line. The combination of electrical and mechanical stress make this the most likely place for ground failures.

The location of a ground failure in a new winding could be a clue as to the cause. If located at the end of a slot (Figure 25), or at a vent duct, a sharp edge or loose lamination could be the cause. If the failure is turn-to-turn within a slot, and the slot edges appear jagged, the magnet wire may have been scratched during insertion. A failure in the same location as a previous ground failure may indicate the presence of shorted laminations that were not properly cleared before the winding was inserted. Shorted laminations, whether welded or fused with copper from the earlier failure, cause localized hot spots that result in additional failures in the same area.

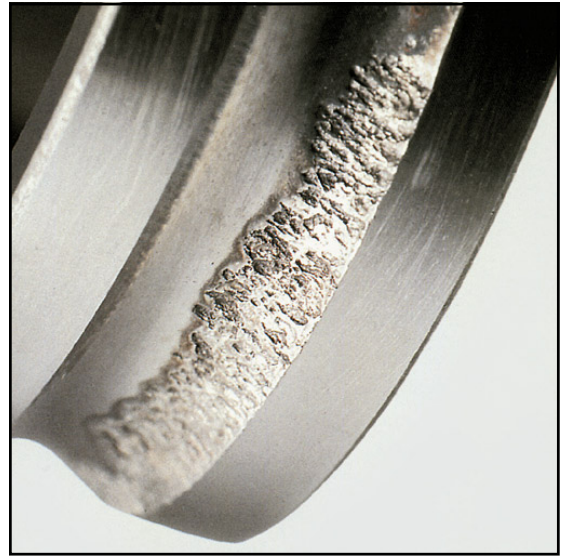
**FIGURE 14: SPALLING ON A BEARING RACEWAY**

The condition of the bearing can be a clue to the type and direction of loading on the shaft. This illustrates how excessive load can cause spalling on the bearing raceway. Spalling will normally occur as the bearing fails; however, the time to failure can be accelerated with an increase in load.

Axial fatigue is commonly associated with vertical shaft mounting, but also may describe a substantial thrust load. Typically, the bearing carrying the axial load will fatigue before the shaft. This is usually evidenced by spalling of the bearing raceways (Figure 14).

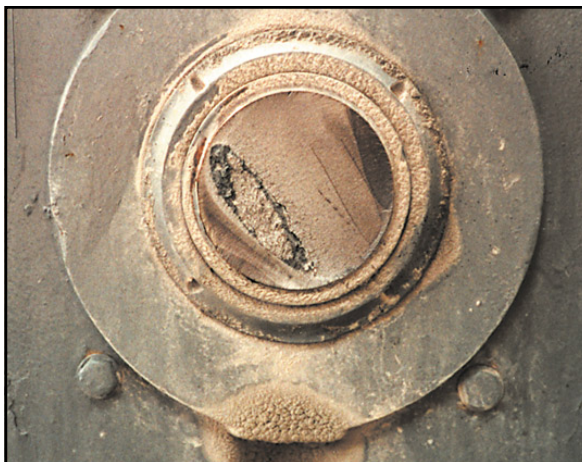
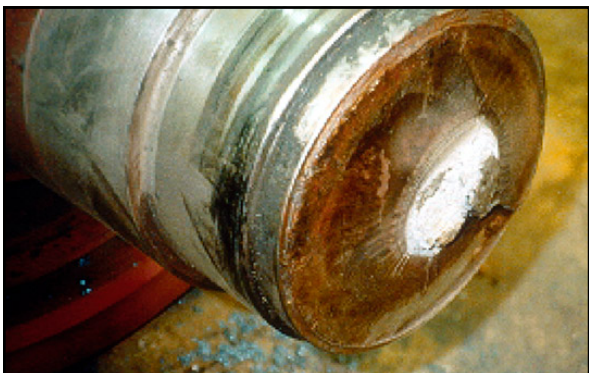
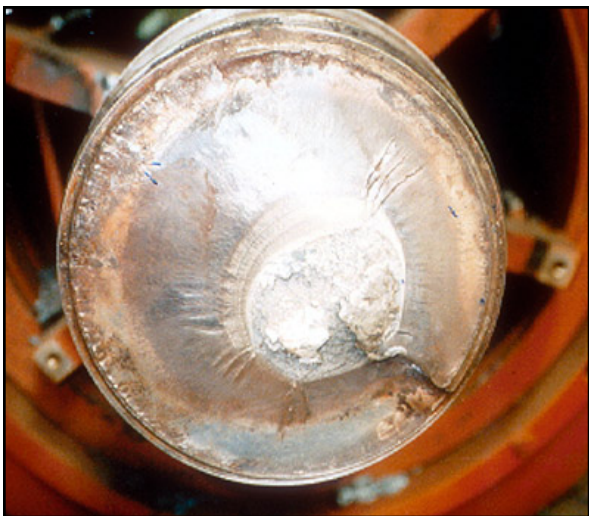
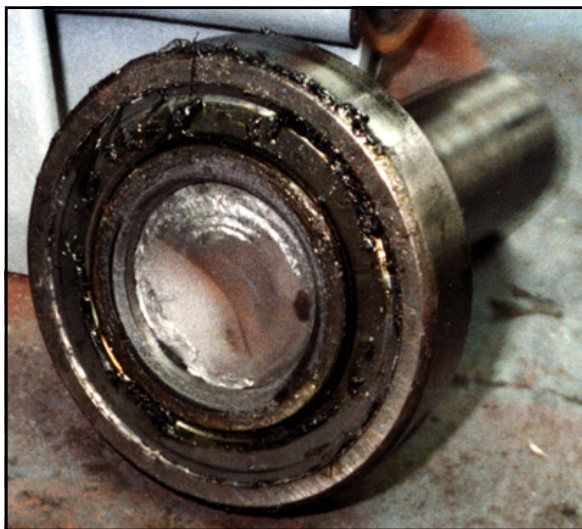
**DYNAMIC AND MECHANICAL STRESSES**

These are all examples of rotational bending. Each example clearly shows one or more points of origination, along with a region of growth before the ultimate failure of the shaft. Each failure occurred at a change in geometry of the shaft, which is a significant stress riser.

Note the ratchet marks (below) and the successive changes in shaft diameter (above).

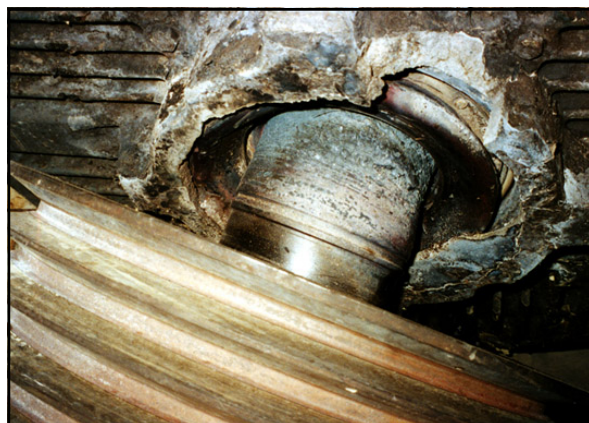
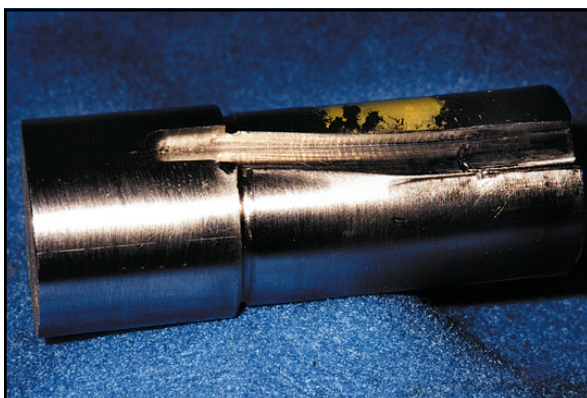
The keyway on this shaft extends too far back, past the step. Note the torsional bending.

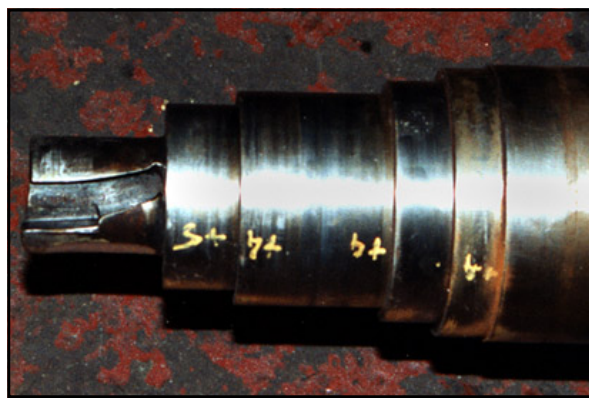
This shaft failed due to torsional bending. The “heads-up” service center marked the shaft as they checked for runout along each step, since there could be twisting further along the shaft.

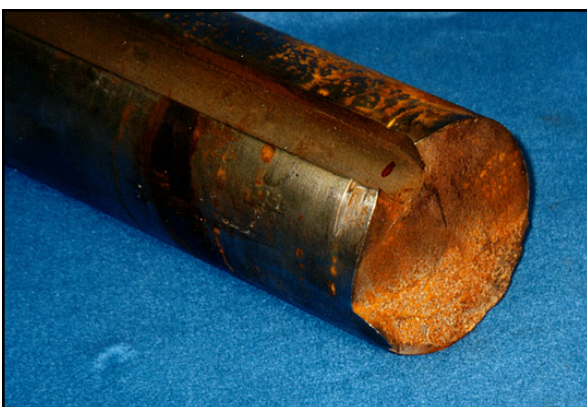
This fatigue crack began at the high stress riser at the keyway.

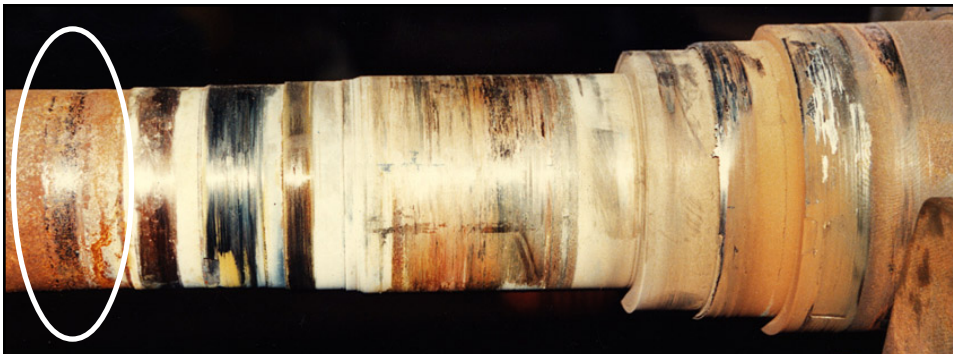
This close-coupled pump shaft shows considerable damage from corrosion. The formation of rust will reduce the fatigue life.

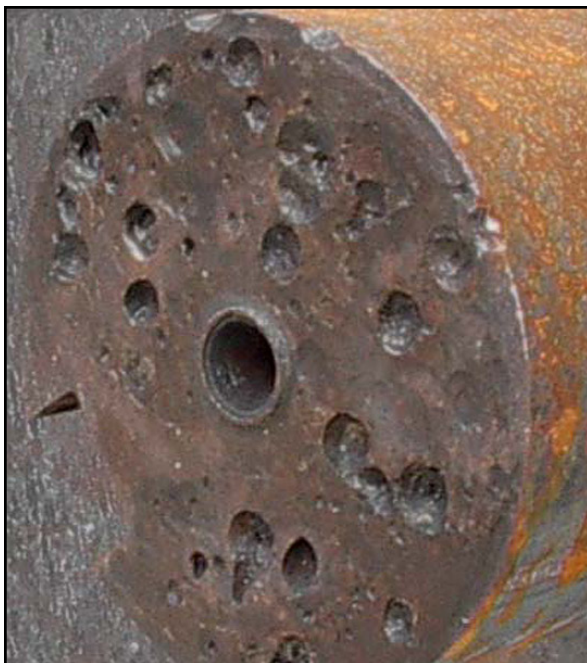
Contamination from moisture or chemicals trapped in the coupling arrangement eroded the surface of the shaft.

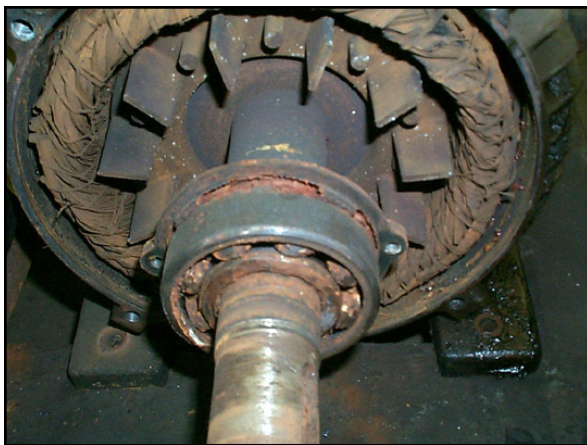
Severe rust has formed on the inside surfaces of this motor.

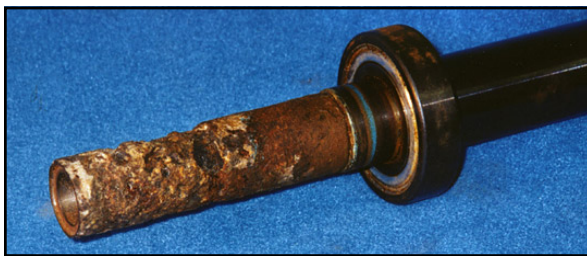
This pump shaft has been damaged by severe cavitation.

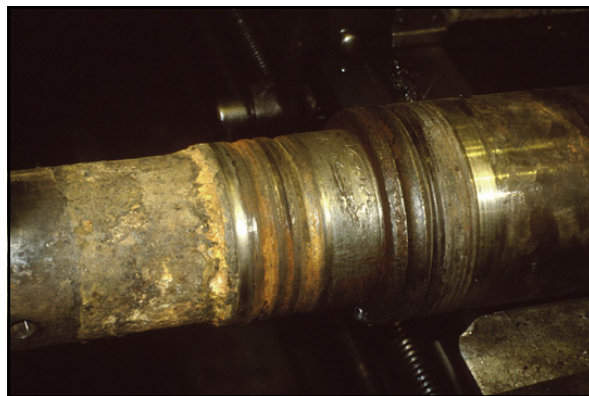
This is an example of severe corrosion on the shaft, due to seal failure. This allowed water to enter into the motor.

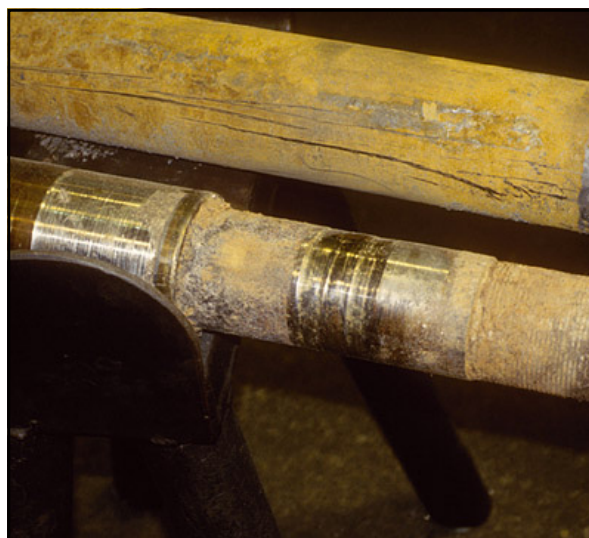
This is a pump shaft with considerable rust damage.

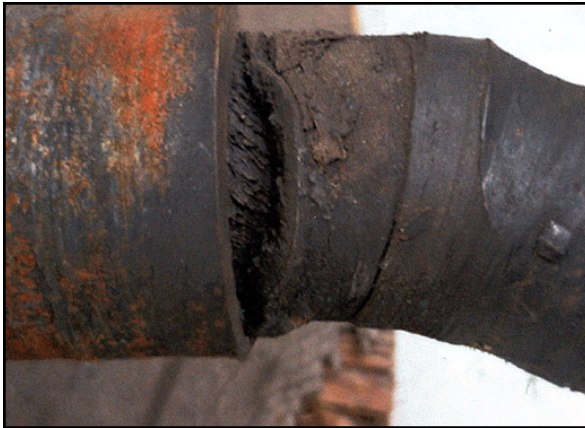
Either misalignment or vibration caused the bearing to fail which led to a loss of fit between the bearing inner race and the shaft. This generated an enormous amount of heat, bending the shaft.

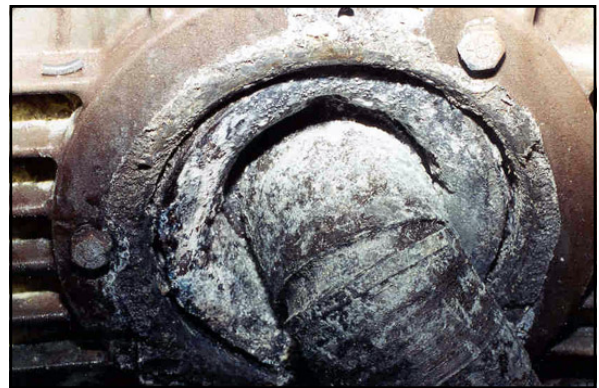
This shaft failure began when the bearing failed and led to a loss of fit on the shaft. The resulting friction caused the shaft to heat up very rapidly and bend almost 90°.
