# Root Cause Failure Analysis

**Pinpointing  
the true cause  
of electric motor  
failures**

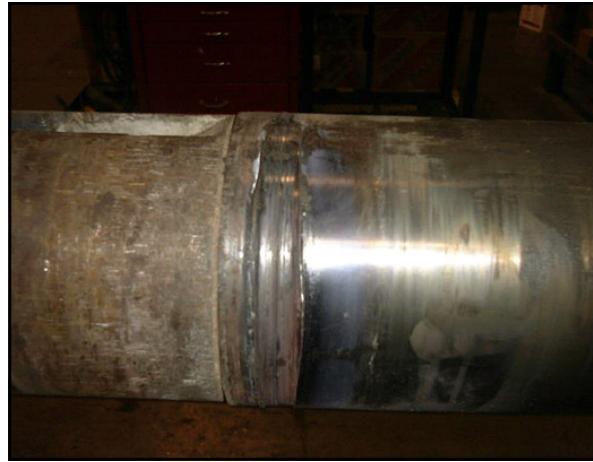
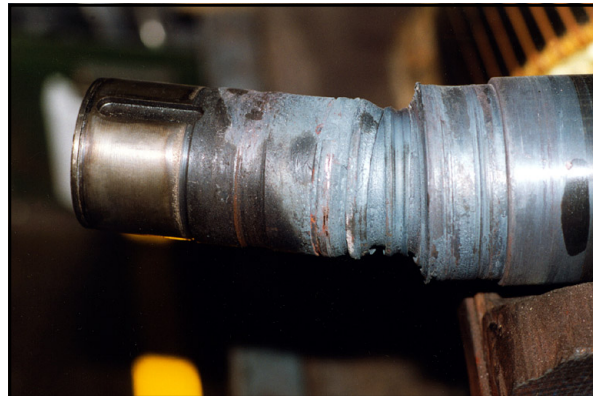
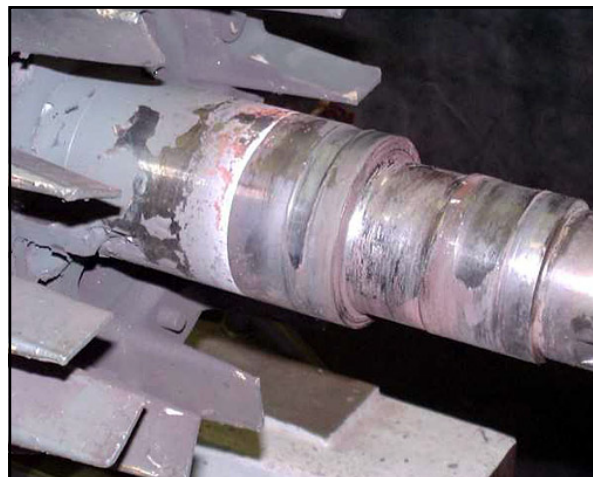
In all of these examples, extreme heat was generated between the stationary and moving parts of the shaft assembly. In each case, the shaft had extreme runout.

This shaft failed due to loss of clearance. The severe gouging/scoring on the shaft generated a tremendous amount of heat from the contact between the stationary and rotating parts.

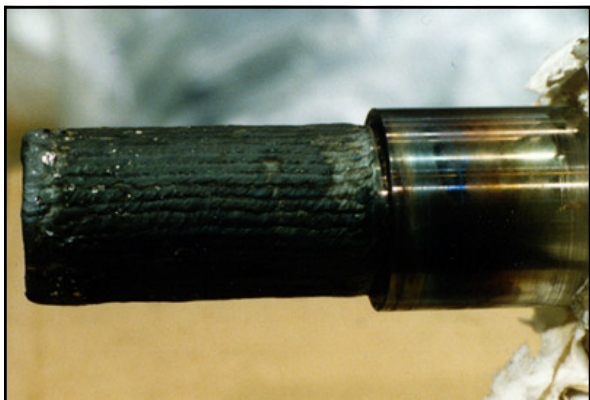
The shaft journals above were both welded. The shaft at bottom has also been machined. Axial passes with a stick welder are more likely to bend the shaft. Varying hardness is also more likely, resulting in a bearing journal that is not perfectly round. Irregularities will increase friction and cause difficulty when fitting the bearing. Machining processes will release some of the residual stresses caused by welding. For example, milling a keyway will usually result in a bent shaft, unless the shaft is properly stress relieved after welding and before machining.

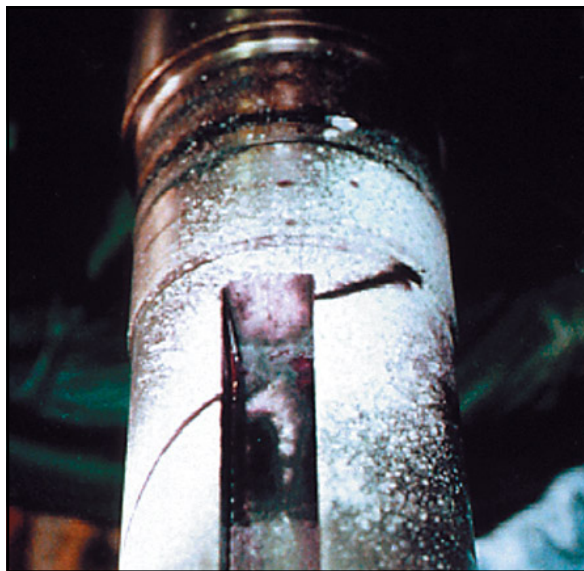
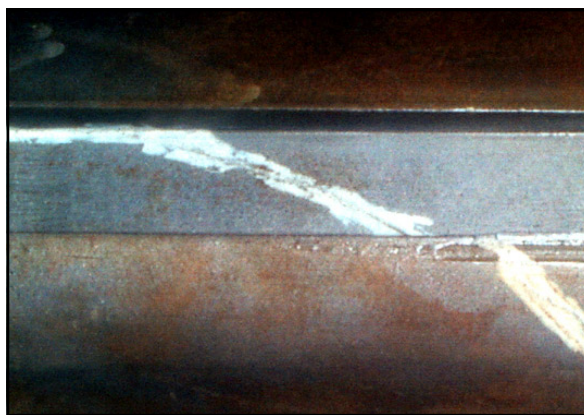
The photograph at top shows a crack that occurred at the keyway. In the photograph below, a crack repaired by welding. The welding process can introduce residual stresses into the shaft, thereby making the repair futile.

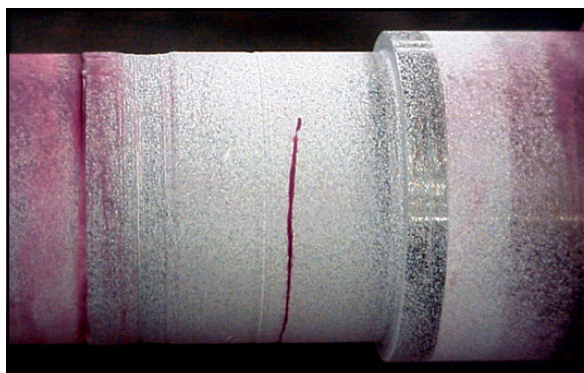
The crack on this shaft was detected with a dye penetrant.

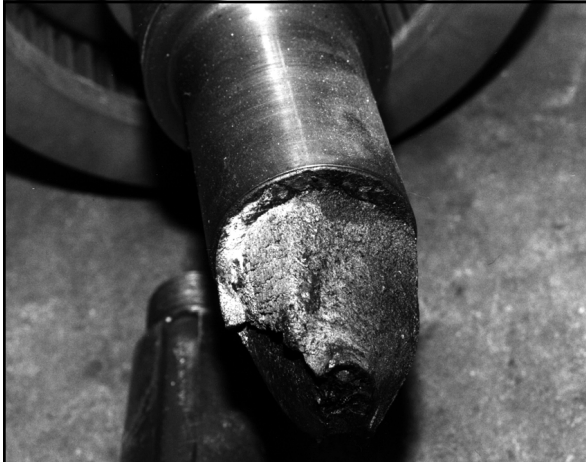
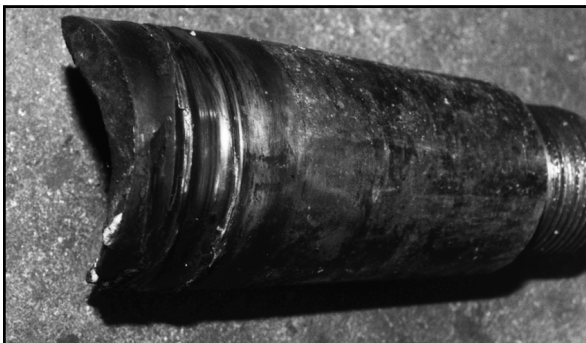
When a motor is subjected to a transient voltage, a very high amount of torque is generated. Shaft failures such as these shown can occur in cases such as a rapid bus transfers, lightning strikes, or out-of-phase reclosures. The torsional stress on the shaft can cause it to snap. The failure will be almost immediate, and the fracture will appear very brittle.

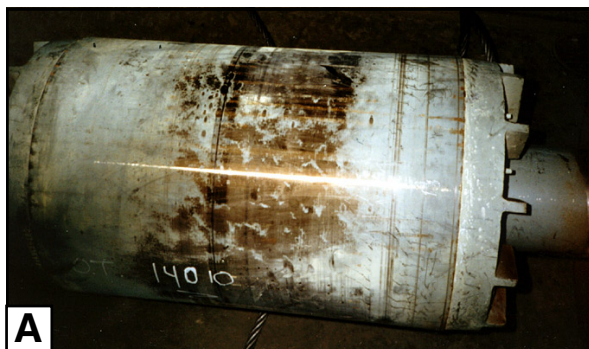
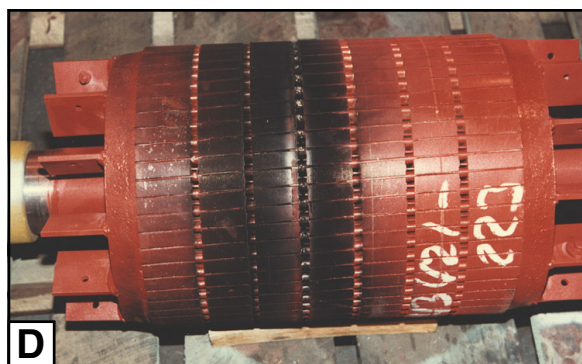
FIGURE 4: FAILURE PATTERNS

The rotor is designed to operate best with a symmetrical magnetic field. Failure to do so can create unbalanced forces that result in shaft deflection, vibration, noise and loss of air gap. Unbalanced voltage can introduce a negative sequence component of current into the rotor leading to excessive losses and heating. (See Example A.)

Often, the heat generated in the stator, or by failure of the cooling system, can give the appearance of a defective rotor. Also, failure of the stator to generate adequate acceleration torque can cause severe damage to the squirrel cage. (See Example D.)

Just like the stator winding, the rotor can be improperly designed, built or applied thus introducing rapid and incipient types of failures. (See Example E.)

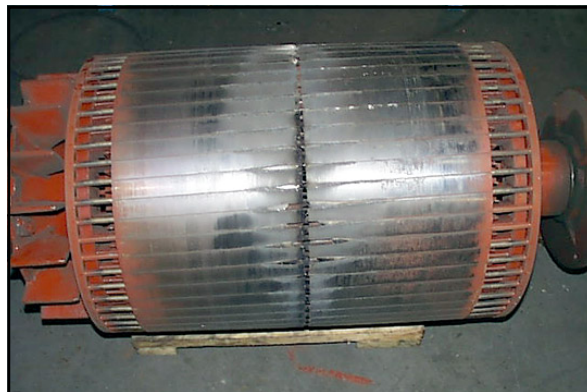
Thermal overload led to severe bar damage at the hot spot of the rotor and, as seen here, some of the bars have actually melted. Note that this rotor has a double cage. The upper cage failed, indicating that the failure occurred during starting or excessive slip.

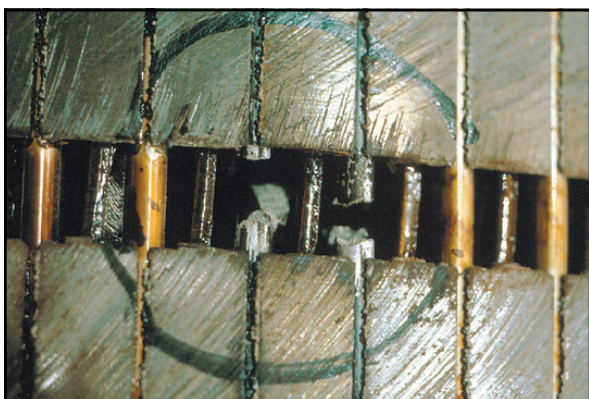
Aluminum rotor bars have begun melting in this thermally overloaded rotor. The failure occurred in the center air duct which is the hottest part of the rotor. Since the failure occurred in the vent duct, it likely took place during a stall condition.

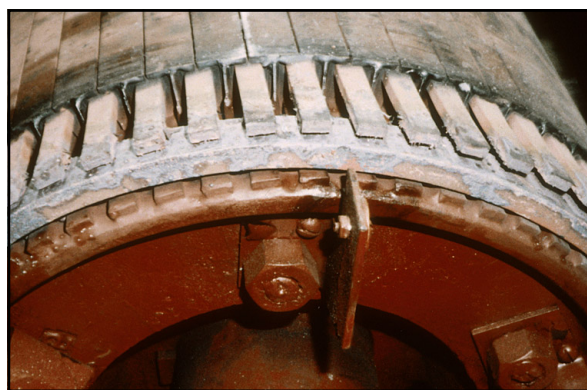
The thermal limit of the brazing material was exceeded in the upper cage during starting. This caused the upper cage to become an open circuit.

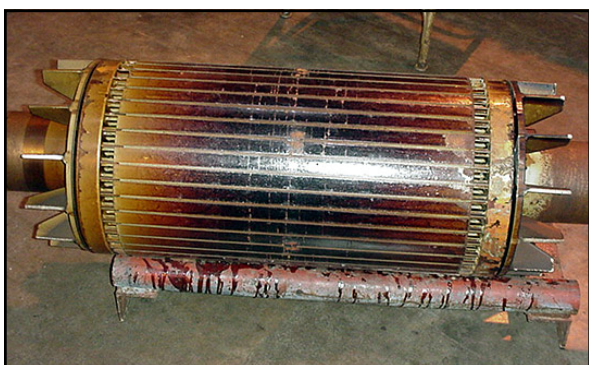
This is a classic example of overheating from excessive load.

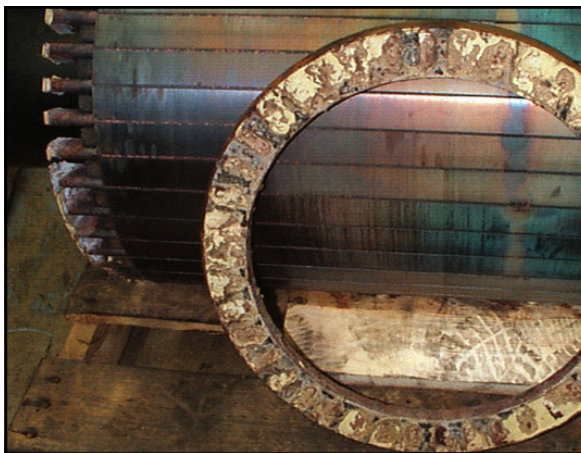
Excessive heat in the rotor cage during starting caused the brazing material to melt causing the separation of the end rings and rotor bars.

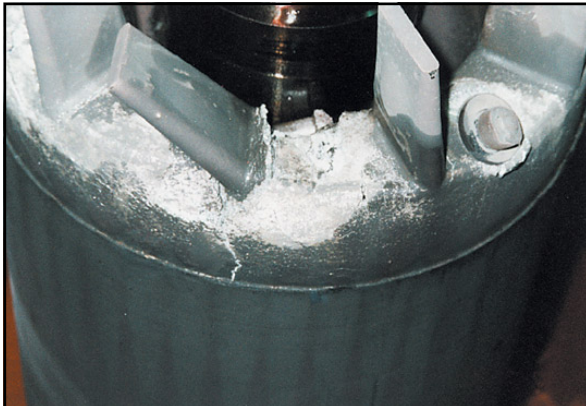
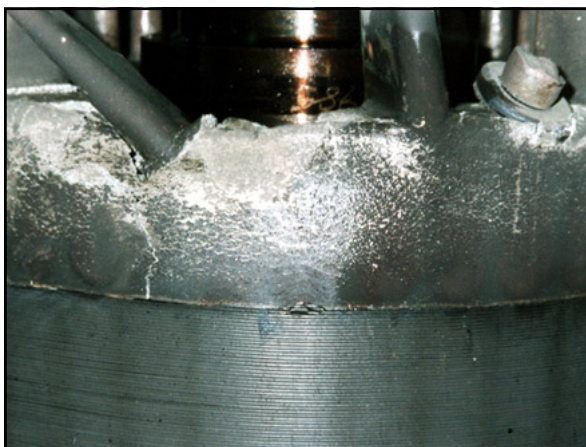
The end ring was the weak link in this rotor and melted during severe starting conditions.

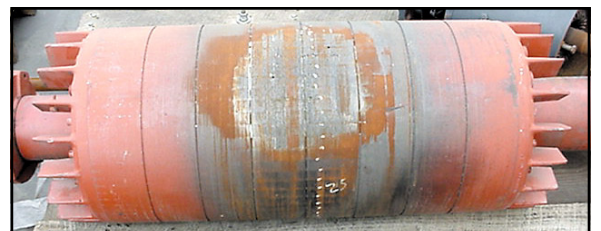
The center of the rotor is the hot spot and the hardest place to remove heat. Upon first inspection, the stator and rotor appeared in good condition. It was not until the service center removed the rotor that the damage was found.

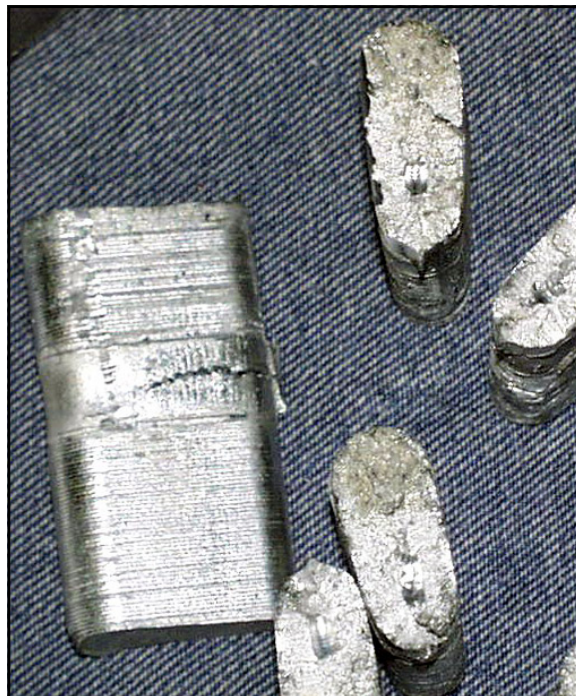
Note the cracks in the rotor bars in the region where the air duct spacers are located. These cracks were caused by nonsymmetrical thermal growth.

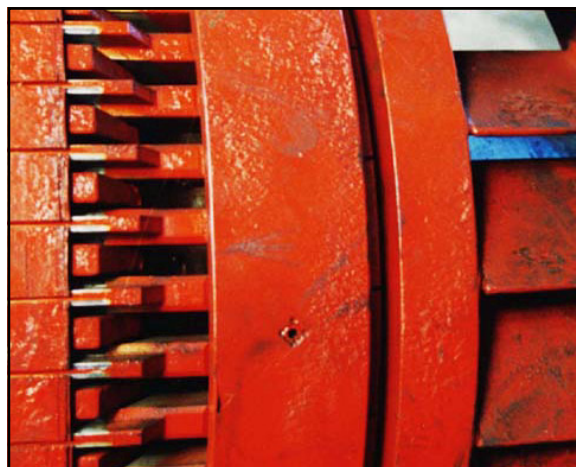
All the bars were loose in this 2-pole rotor. The complete cage moved axially until the shrink ring came into contact with the cooling fan. Note the lack of paint on the rotor bars showing how far the rotor cage has migrated.

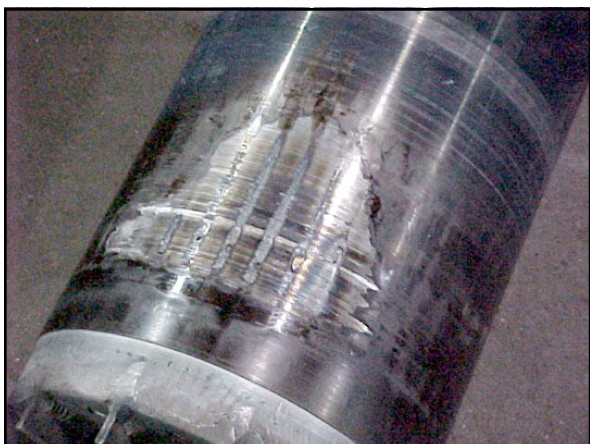
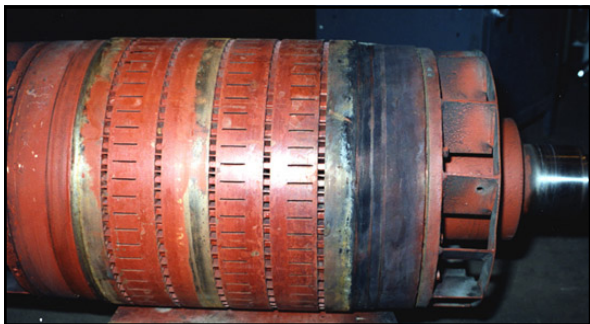
**IMPROPER ROTOR-TO-STATOR GEOMETRY (LOSS OF AIR GAP)**

All of the photographs on this page are examples of motors “losing” the air gap while running. At more than 30 revolutions per second and a rotor weight of several hundred pounds, a tremendous amount of kinetic energy is dissipated on the surfaces of the rotor and stator. The extreme amount of heat usually causes severe damage to the rotor and/or stator. The stator at upper right shows signs of contact.

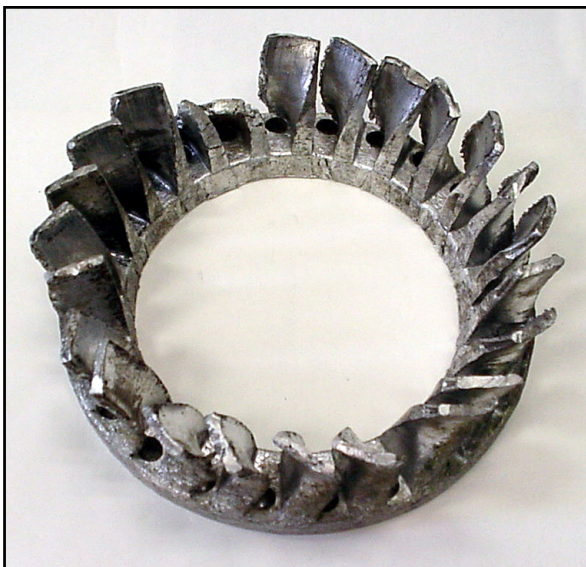
**CENTRIFUGAL FORCE (OVERSPEED)**

These end rings were removed from a 2-pole vertical pump motor that was driven overspeed (an estimated 10,000 rpm) when the check valve failed. The centrifugal force bent the fan blades over until they hit the stator end turns. The bending of the fan blades was more severe than shown since the fan blades needed to be straightened to remove the rotor from the stator bore. Note that the end ring on the left (lower end) showed more bending than the end ring at the right (upper end). More heat in the lower portion of the rotor made the aluminum in the lower end ring more susceptible to bending.

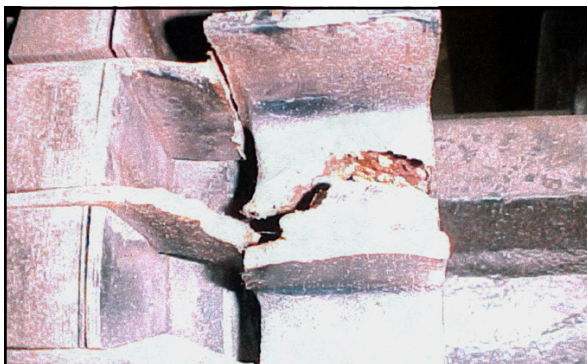
Centrifugal force due to overspeed caused the lifting of these end rings. The rotor at above was damaged by a faulty check valve or anti-rotation device. This damage can also be caused by redesigning the motor to a higher speed.

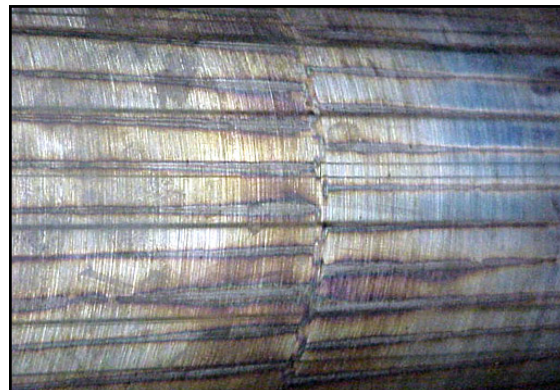
**FIGURE 13: OFFSET SKEW**

This rotor has a unique construction in which the bars are straight but offset in the middle of the rotor. This is equivalent to a one-half rotor slot skew.

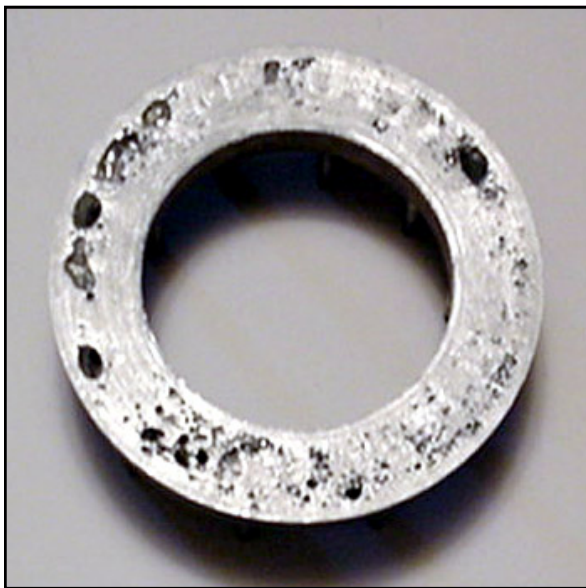
The porosity of this end ring weakened the balancing nib shown in the photograph below. The nib and its weights broke away from the end ring, hit the fan blades and were thrown into the winding.

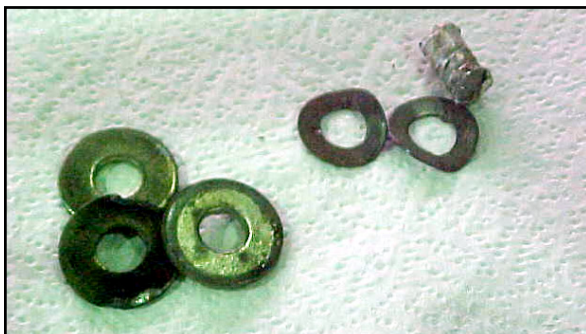
Broken balancing nib and balancing weights.

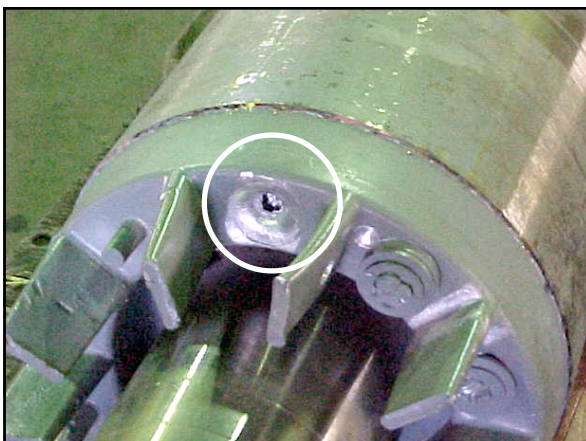
Balancing nib broke loose at the point highlighted above.

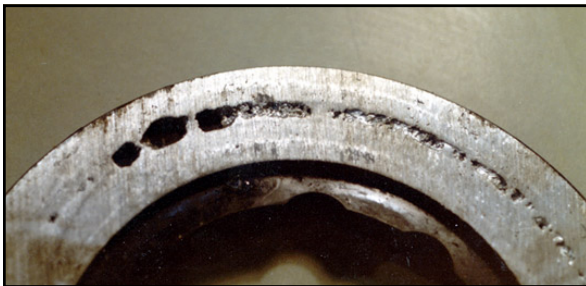
Voids located in an end ring.

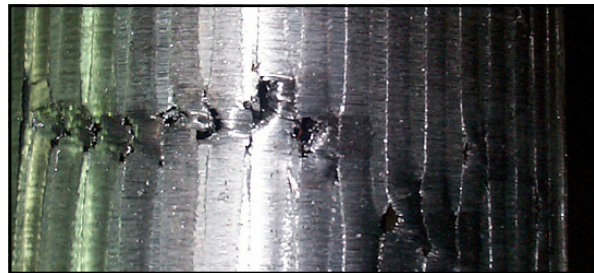
Voids located near the surface of the rotor. This rotor was machined to expose the voids.

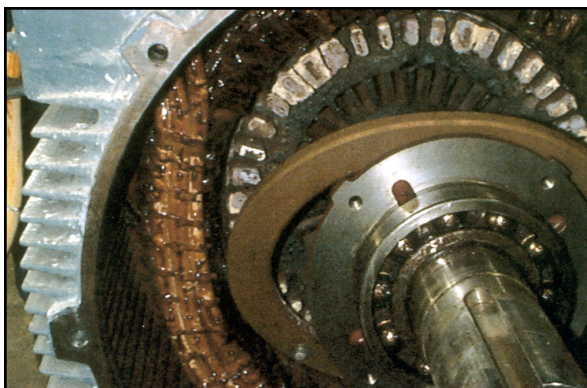
The rotor bars were not of equal length. This resulted in uneven amounts of thermal expansion, eventually breaking the brazed joints between the rotor bars and end ring. Further inspection also showed poor brazing evidenced by the appearance of the brazing material.

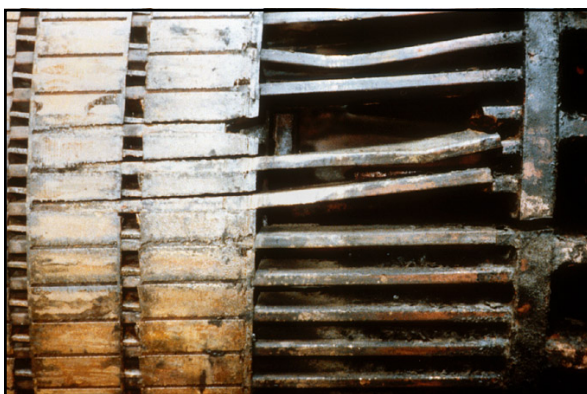
This design used long rotor bars to act as a cooling fan. However, the bar “overhang” was too long and the bending force caused by thermal stress fatigued the bars and caused them to fracture.

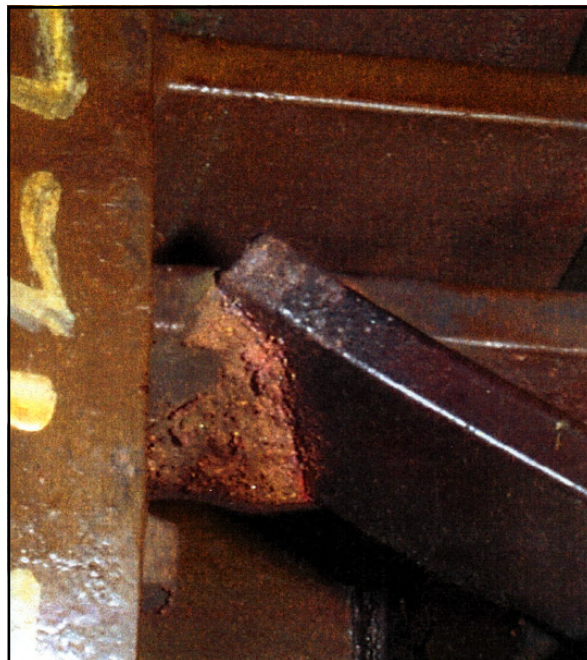
One rotor bar was too long and broke. Once broken, the rotor bar was forced over to the adjacent bar.

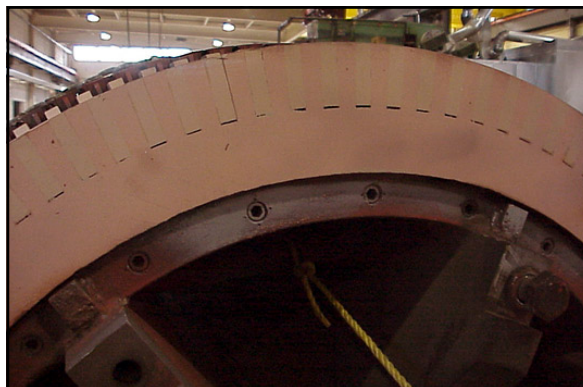
The rotor ends, above, are milled/indexed from copper plate. It is critical that the brazed joints be complete and free of voids. Note the gaps in the photograph below.

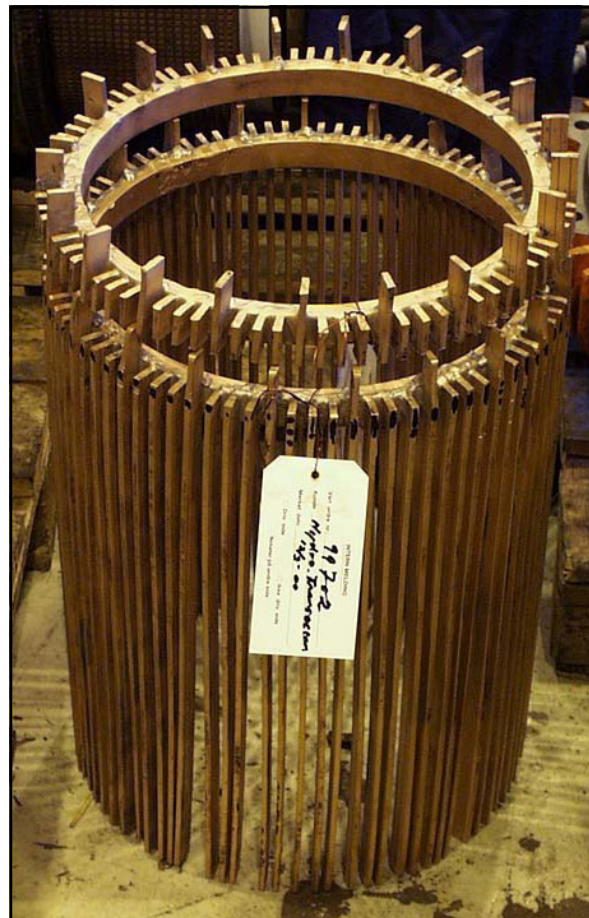
The rotor cage on this 12-pole rotor was loose enough that after one end ring was cut off, the remaining portion of the cage could be pulled from the rotor core. Note that the end ring that was cut off is sitting on top of the rotor cage.

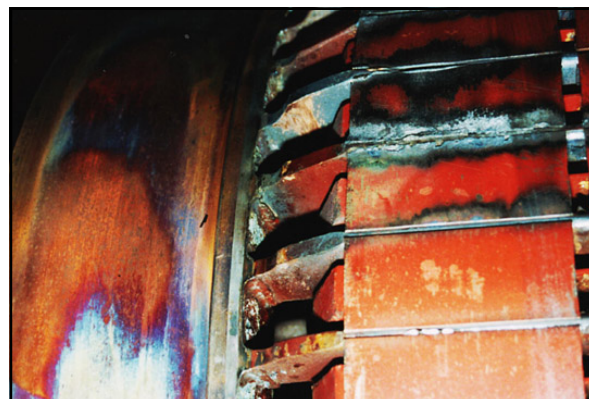
Improper swaging of some rotor bars caused vibration and shorting current to overheat the laminations.

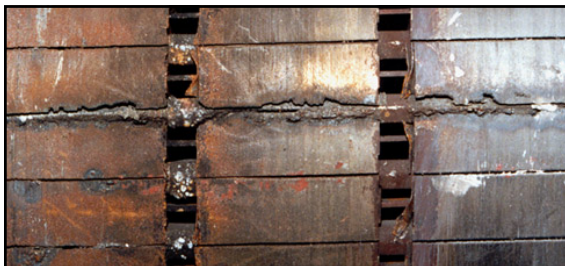
This rotor shows evidence of magnetic resonance which caused the bars to loosen and vibrate.

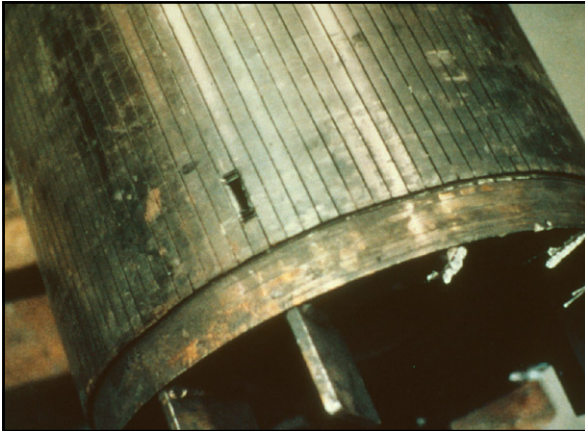
The rotor teeth fractured at the root due to resonance and were slung out into the stator, causing a ground failure.

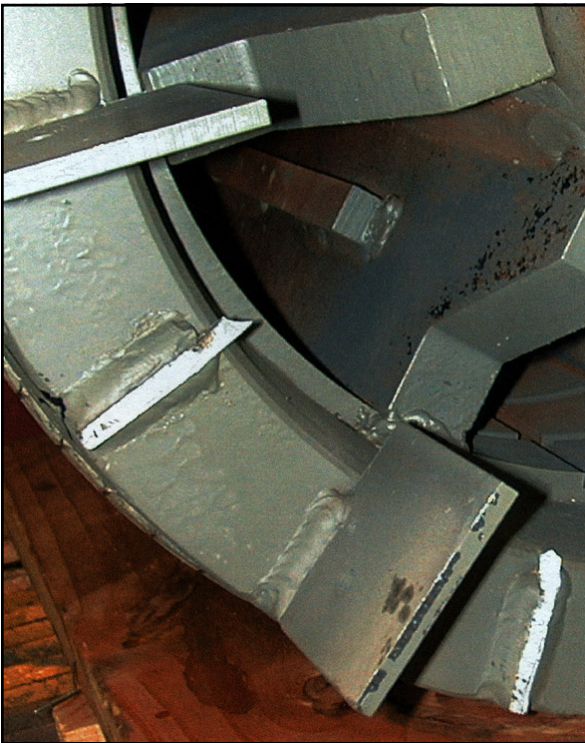
The rotor fan blades fractured above the welds due to cracks and vibration that resulted from fatigue in the aluminum.

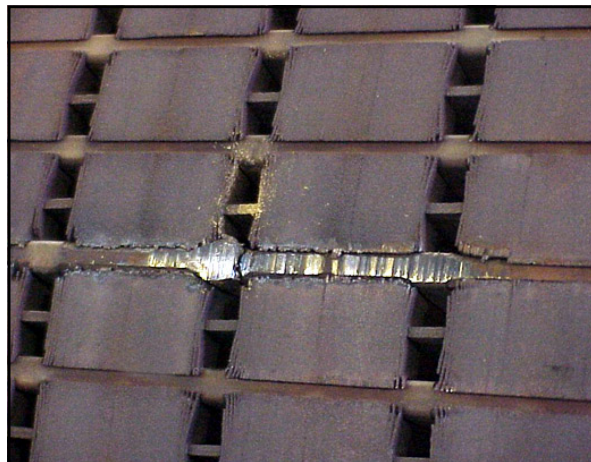
This loose bar was exposed due to severe vibration induced during a prolonged starting cycle.

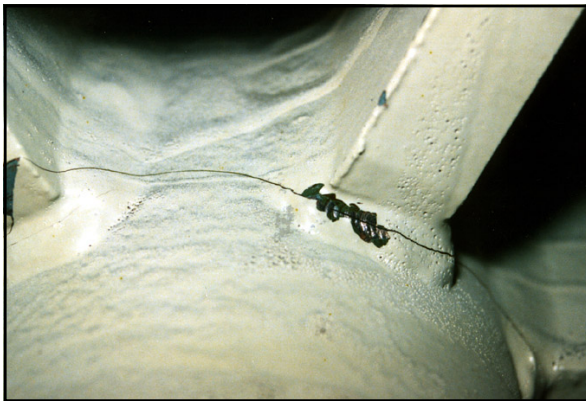
Many large rotors have spiders that are welded to the shaft. If not done properly, a residual stress can be introduced and cause the shaft to fracture. Spiders should not be welded at the ends as shown above. This will intensify the stress risers. Shafts of this size are often stress relieved (see photograph at bottom right) in order to minimize the stress risers caused by welding the spiders to the shaft. Failure to do so may cause fractures.

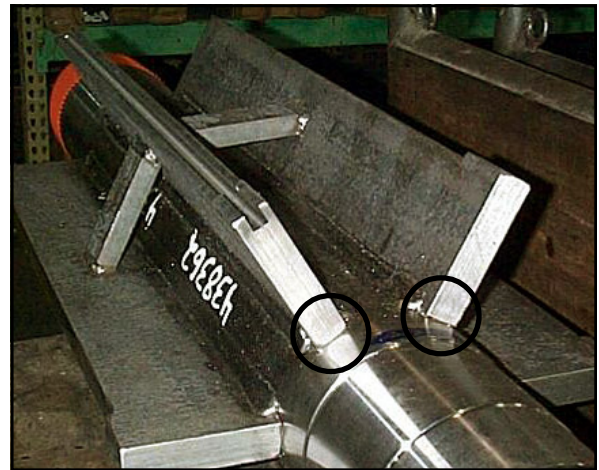
This shaft was not welded on the ends of the spiders. By not doing this, the stress risers shown in the photograph at left are eliminated.

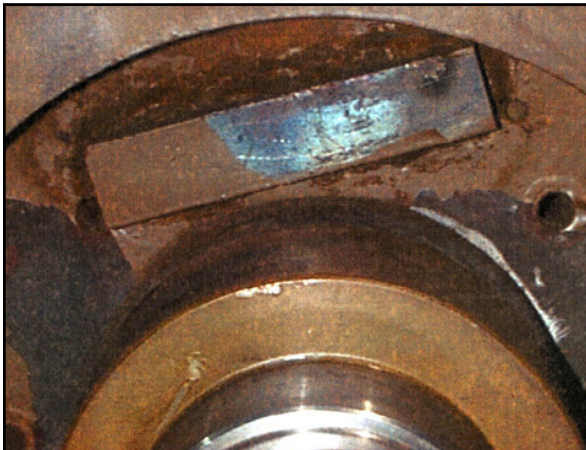
This rotor was balanced by the addition of a large balancing weight welded to the rotor clamping plate. When welding to a rotor, care should be taken to add weight where it will not cause distortion, and only to parts that are substantial enough to resist bending.

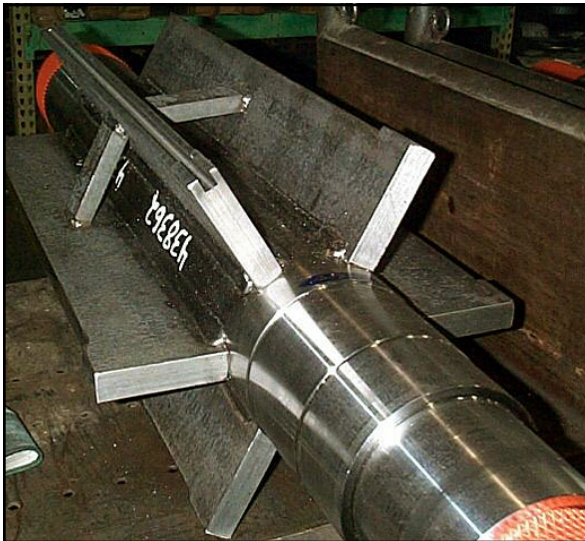
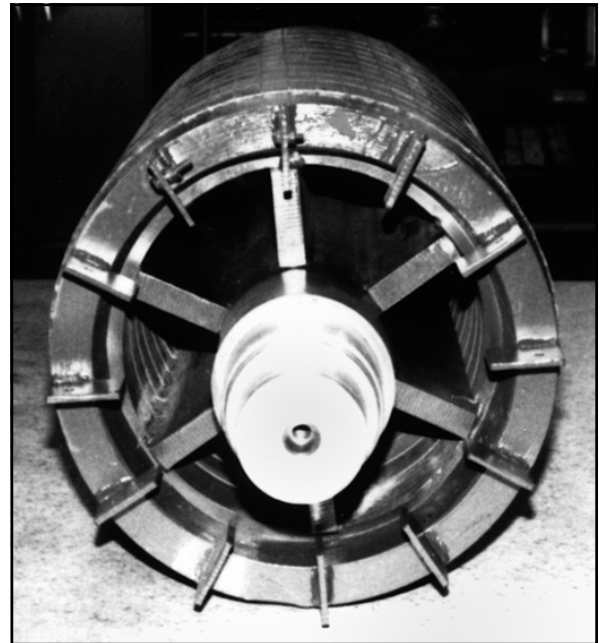
Loss of rotor core-to-shaft fit can occur for the following reasons including improper fits by design or tolerance, excessive thermal expansion, improper machining of the shaft, hoop stress capability of the laminations is exceeded as well as removal of the shaft resulting in a “shear off” of fit. The two photographs above are examples of spider shafts. The spiders on the shaft at left were undersized. When required to transfer torque under load, the shaft slipped within the rotor core.

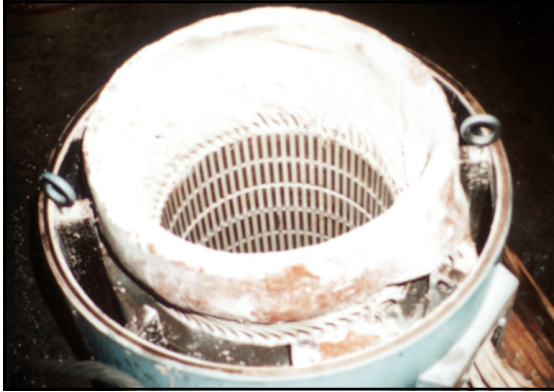
**FIGURE 4: CLOGGED STATOR END TURNS AND VENT DUCTS**

In a winding designed with a partially-encapsulated coil extension (for increased winding rigidity), ventilation among the exposed portions of coils is even more critical. The stator vent ducts in this motor, as well as the coil extensions, are blocked by contaminants.

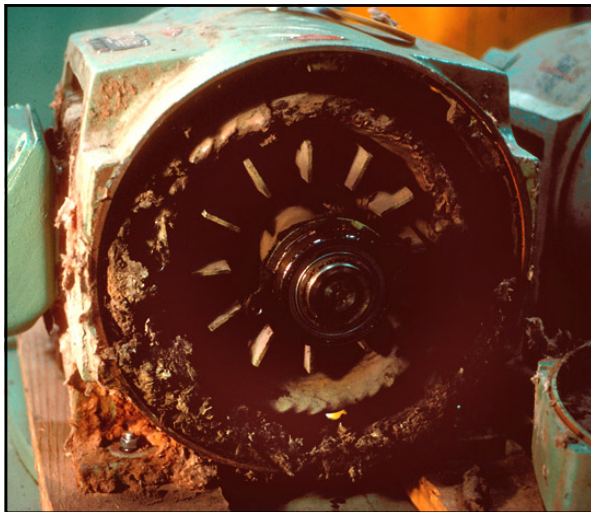
**FIGURE 5: EFFECTS OF CLOGGED AIR DUCTS ON MOTOR OPERATING TEMPERATURE**

Restrictions that impede the flow of cooling air through the motor are quite common in applications where significant amounts of foreign materials (dirt, fibers, process materials, lint, dust) are present. The stator above is from a 4 pole, open dripproof motor from a paper mill application. The pulp packed in the stator caused the motor to operate almost 30° C hotter than normal. This would cause a reduction in the insulation thermal life from 20,000 hours to 2,500 hours.

temperature to increase drastically and the thermal life of the insulation to be significantly reduced. (See Figure 5.) The operating temperature of the bearing system may also be affected.

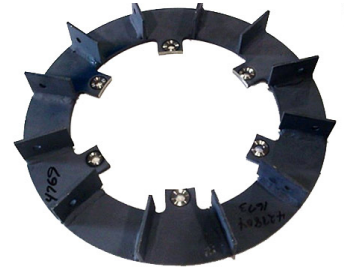
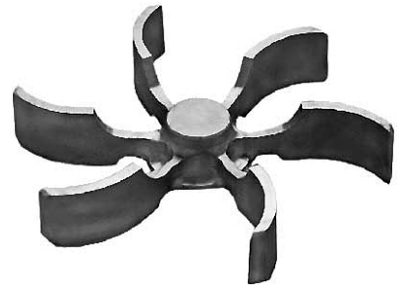
**EXAMPLES OF MOTOR COOLING FANS****BIDIRECTIONAL FANS**

**UNIDIRECTIONAL FANS**

ducted stators and rotors, the fan and baffles divert airflow over the bearings and through the stator and rotor. Page 6-6 shows some of the many varieties of fans in use.

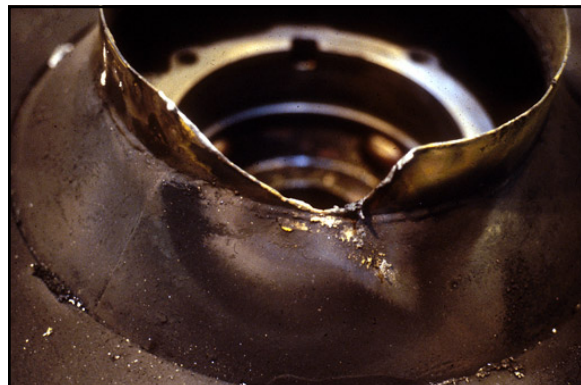
**FIGURE 11: FAILURE OF AIR DEFLECTORS**

The cone of the 2 pole air deflector fatigued due to severe vibration induced by magnetics during starting. Fabricated steel air deflectors sometimes crack at the welds.

Fabricated steel deflectors can crack at the weld points and require careful inspection (Figure 11). These air deflectors are located in a strong magnetic field which increases by several magnitudes during starting. Defective welds will usually break under severe stress over time.

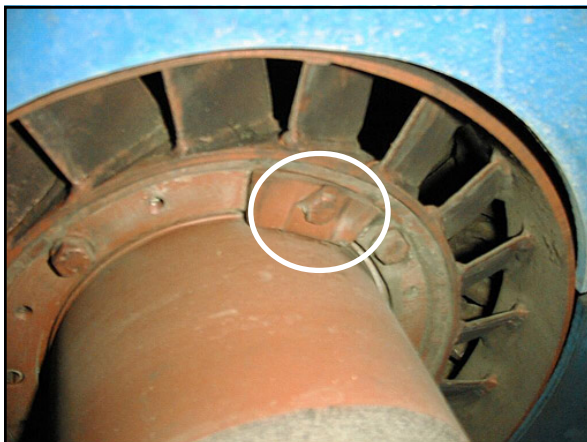
A locking plate (or tab) is necessary to secure the balancing weights on this 2 pole motor. If it were missing, the fastener would be able to “work” loose and could eventually cause severe damage to the rotor or stator. The photographs at right show the damage caused to an identical motor by a balancing weight not secured by a locking plate. The outer ring and almost all of the blades were sheared off the fan. While manufacturers like locking plates, which are “dog-eared” over the flat surface of the screw head, they are prone to become weakened during subsequent repairs.

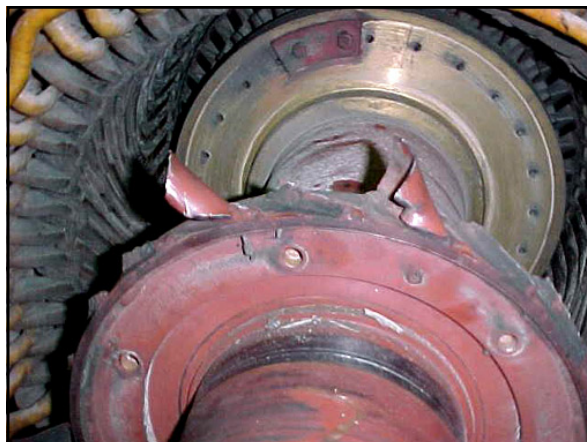
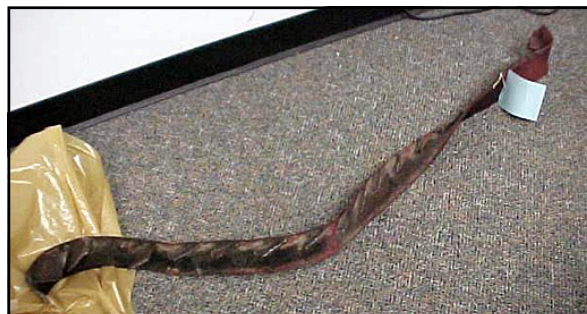
The shaft key was too shallow allowing this fan to climb over the key. This failure occurred on a large motor driving a crusher in a quarry.

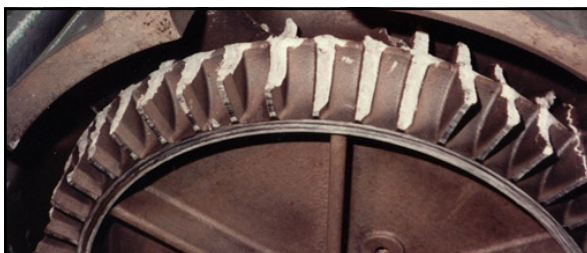
Generator/alternator fans are sometimes abused by personnel while aligning the equipment.

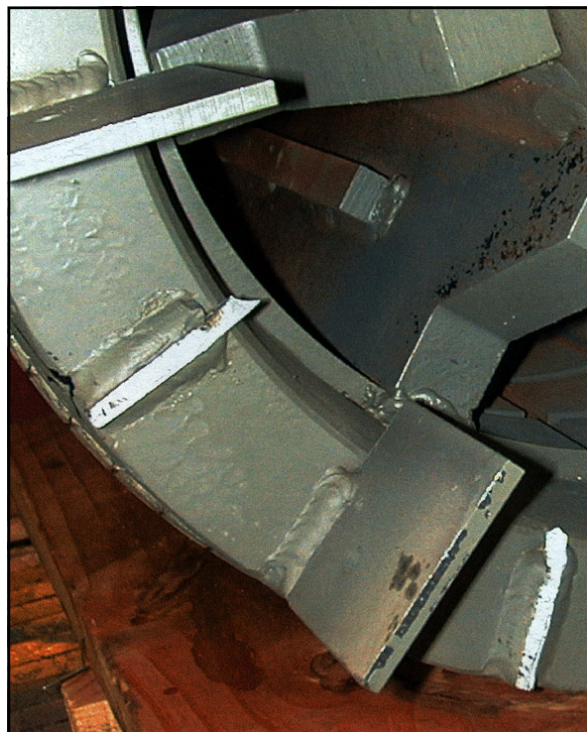
A fatigue failure just above the weld caused several aluminum fan blades to break.

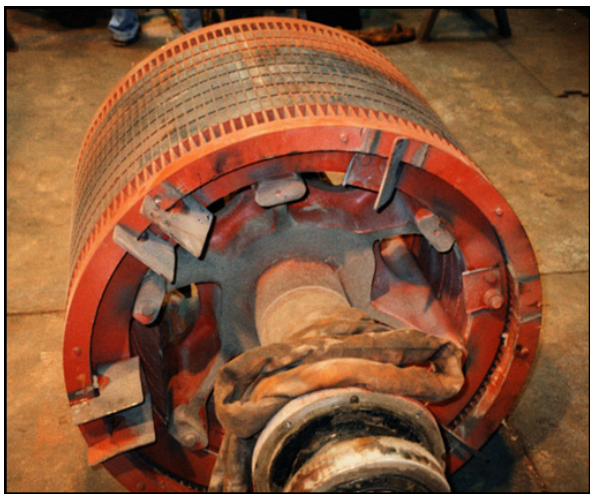
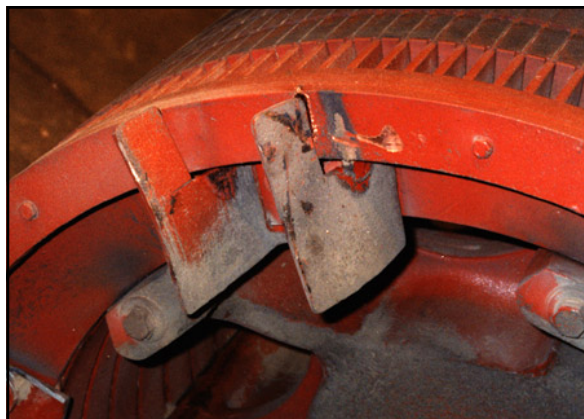
The bolts that held these fan blades in place on the end ring “worked” loose.

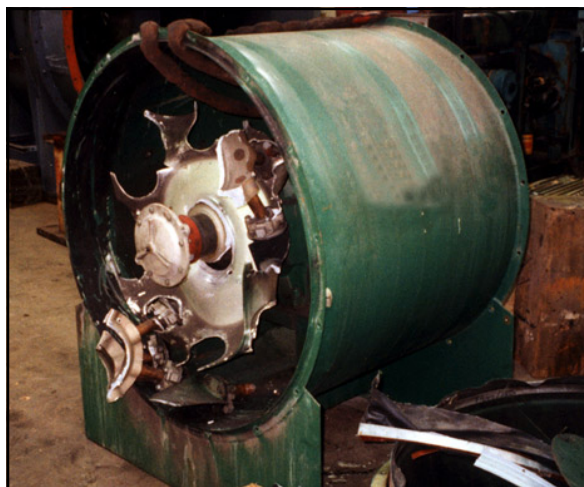
A foreign object entered the cooling air intake and damaged the blades of this fan.

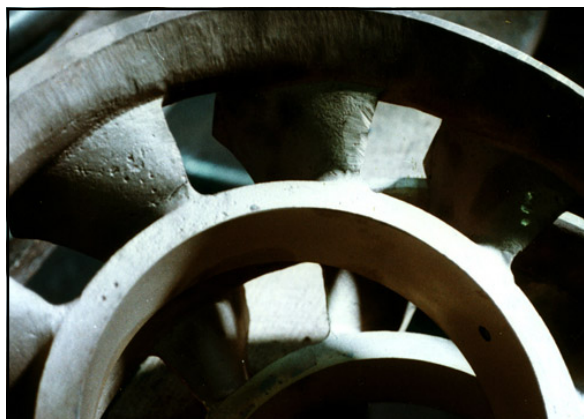
The blades on this unidirectional fan are being worn down by abrasion/corrosion.

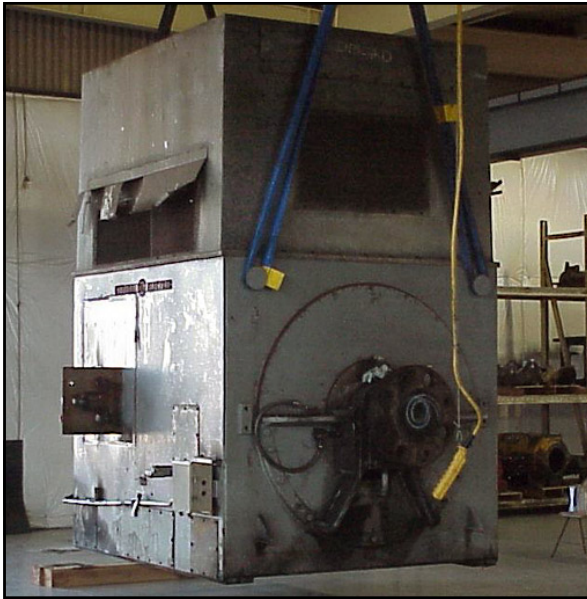
These filters were added incorrectly. A filter reduces the cross-sectional area of airflow. The rain defectors further block airflow.

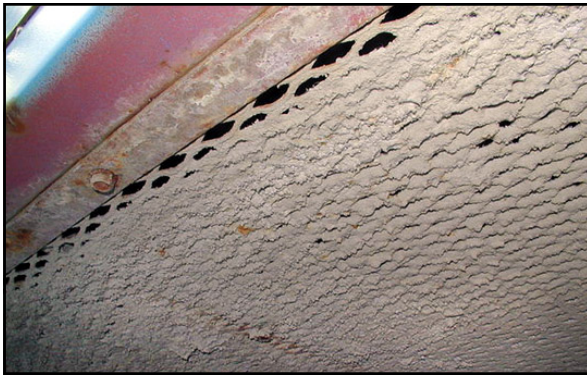
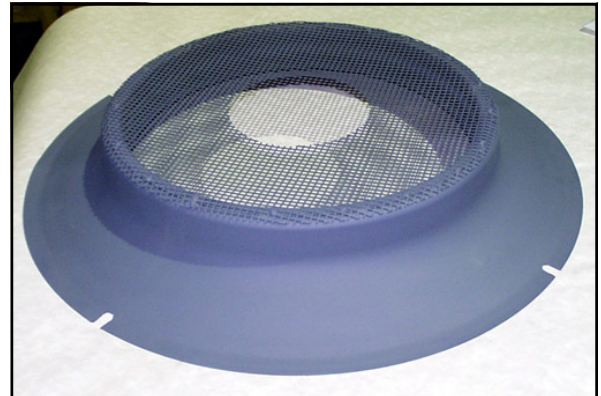
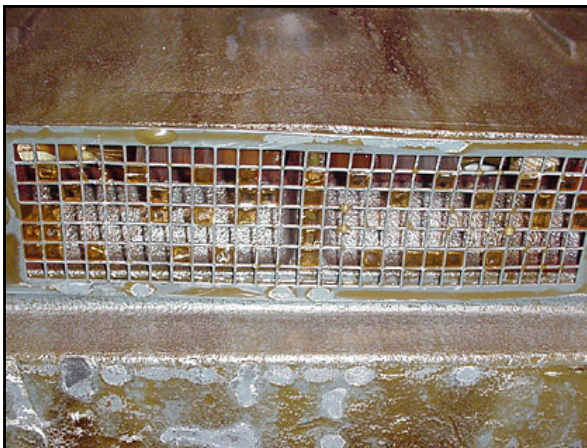
These types of screens are very susceptible to clogging.

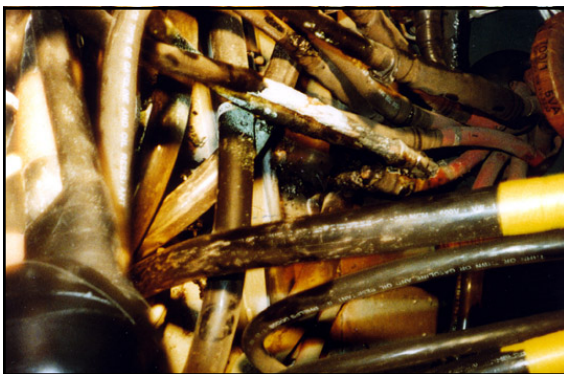
**FIGURE 12: HAZARDOUS TERMINAL BOX**

This chaotic mixture of high- and low-voltage leads can lead to the deterioration of the insulation when moisture is present. This is a terminal box accident waiting to happen.

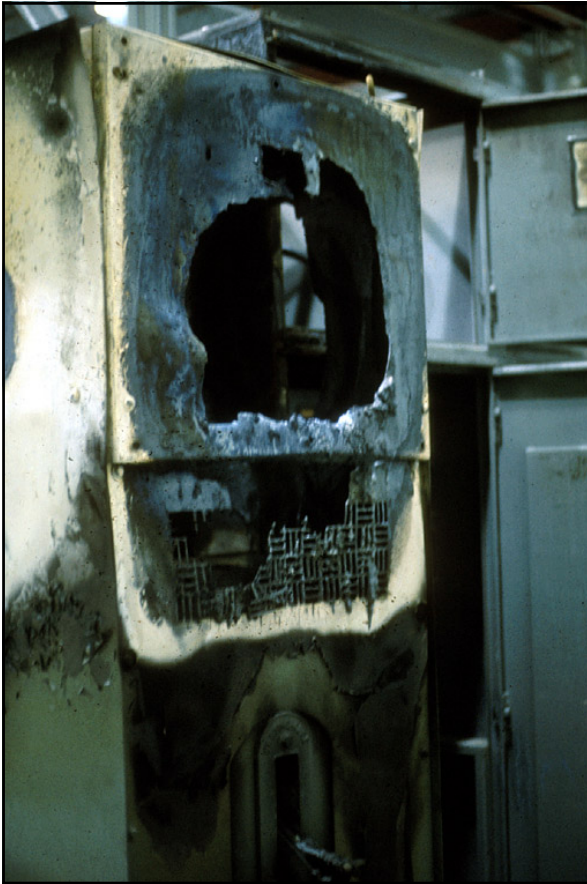
The damage to this terminal box shows the results of improper grounding. Arcing between the box and motor frame eventually caused a fire.

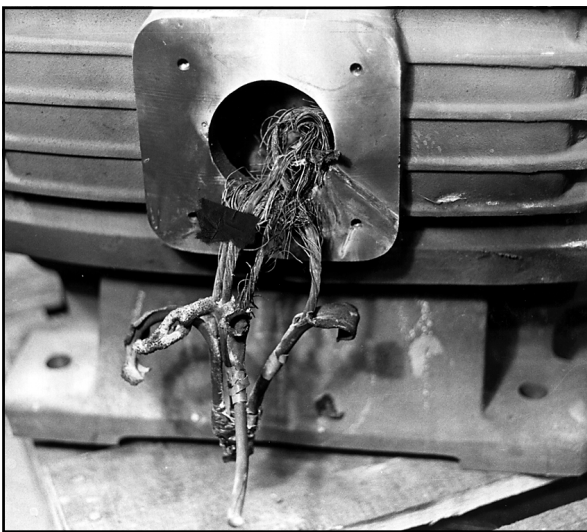
These leads failed during an overload condition that did not result in a winding failure. The leads were Class B while the winding was Class F.

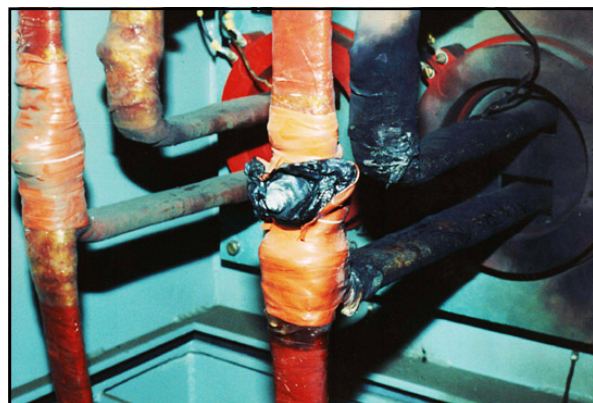
Failure to correctly tighten this bolt on a line connection generated heat that destroyed the insulation leading to a ground fault.

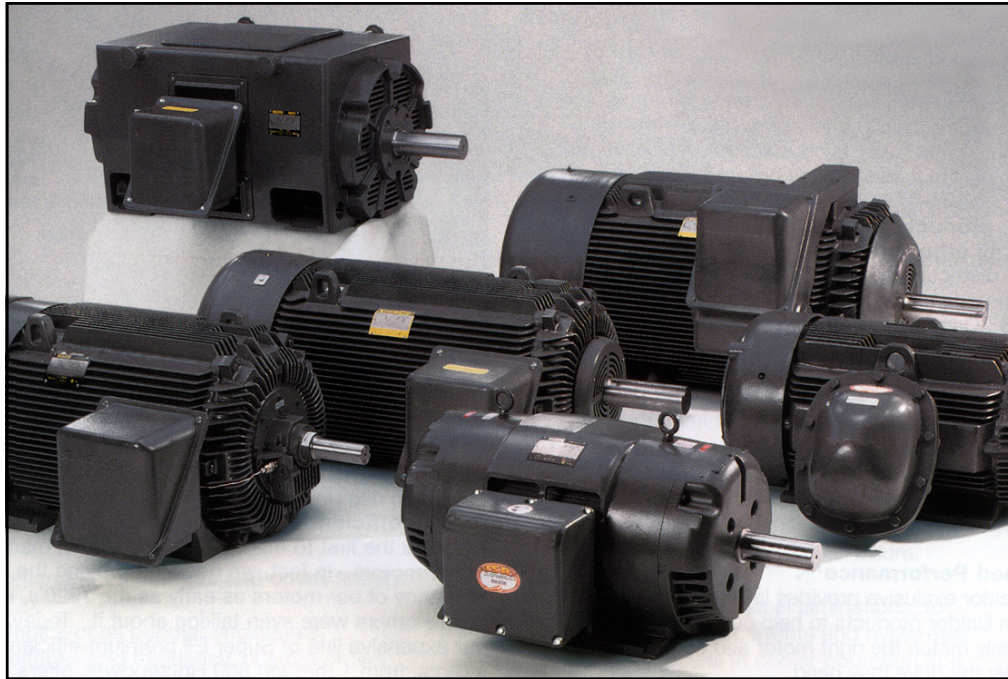
FIGURE 15: LIFTING DEVICES

Figure 15 shows a variety of lifting methods used for horizontal motors. Note that in some cases the lifting devices are cast into the frame; and while some are offset, others are in line. Further, some eyebolts are shouldered, while others are not; and some are cast eyebolts, whereas others are forged.

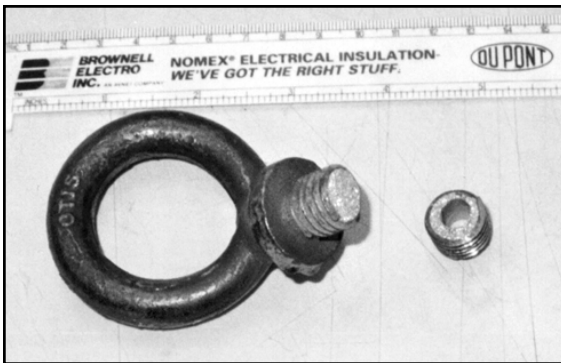
FIGURE 17: BROKEN EYEBOLT

Shouldered eyebolts are not effective unless they are turned down tight against the frame. This broken eyebolt caused a stator to be dropped, almost severing a technician's finger.

The eyebolt illustrated in Figure 17 was broken as a result of the lifting angle being too great (it was installed in the horizontal direction for a vertical lift) and the eyebolt was not shouldered. The stator that fell as a result of the breakage

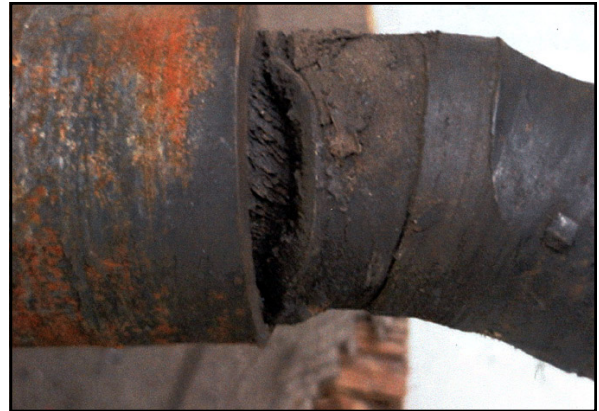
**MISALIGNMENT FAILURES**

The rotor output shaft in these photographs was bent nearly 30° from its original centerline. This could have been caused by misalignment. Note that the shaft material has weakened due to the strain and heating, resulting in tearing and twisting of the steel at the drive end bearing shaft shoulder. This type of bending is usually associated with belted applications, where there is always a high radial (side pull), or overhung load, but can also occur on direct-coupled applications with severe misalignment or vibration.
