# Root Cause Failure Analysis

**Pinpointing  
the true cause  
of electric motor  
failures**

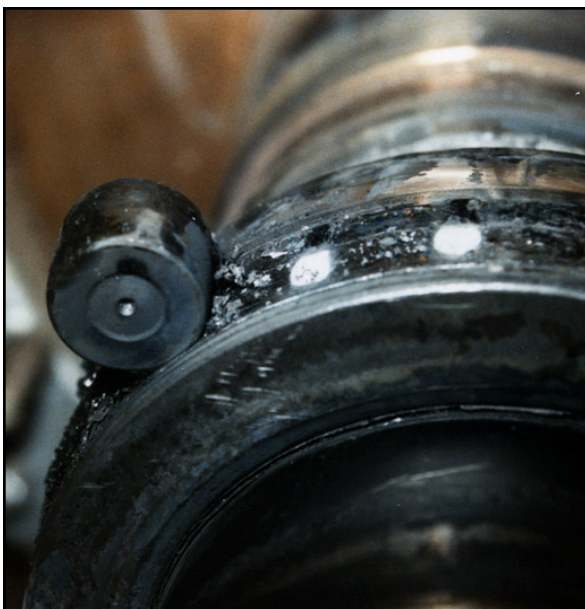
Boiler feed pumps operate at temperatures much higher than most rotating machines, therefore thermal growth has a significant effect on alignment. The initial cold alignment offset should always be obtained from the pump manufacturer and used during alignment. In the case shown here, it wasn't a thermal offset, but a soft foot that led to a bearing failure. As shown, a dial indicator can be used to check for vertical movement as each foot is progressively loosened and retightened. The cylindrical roller bearing on the drive end of the motor failed because it's housing seat had an angular distortion caused by the strain of pulling down on a soft foot. It is worth noting that cylindrical bearings are not usually well suited to direct coupled installations because, without appreciable radial load, the rollers tend to skid (i.e., stop rotating) while sliding around the bearing races.

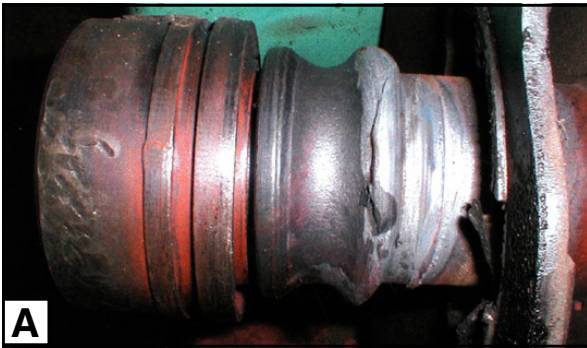
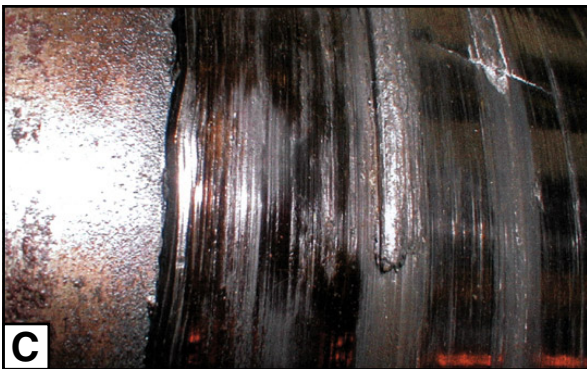
**MISALIGNMENT FAILURES**

These photographs illustrate that misalignment often affects the opposite drive end (ODE) bearing more so than the drive end (DE). The ODE bearing and bearing cap (A and B) have been wiped out, so much so that the bearing inner race has lost its hardness and mushroomed out. The rotor core (C) has rubbed the stator core, causing lamination damage. On the DE, the inboard bearing cap (D and E) has rubbed the shaft due to the ODE bearing failure causing the rotor to drop down in the frame. This is a classic example of what may be found when misalignment results in a bearing failure.

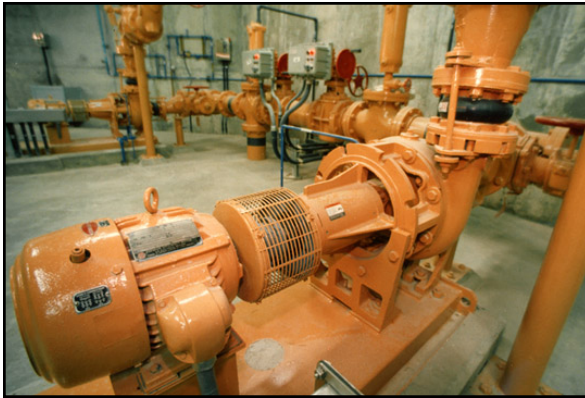
The shaft alignment of this motor and pump has the potential to be complicated not by just thermal growth, but by contraction as the pump is handling cold potable water. Being a pump installation, pipe strain is also a possible factor that should be checked. Note that the support base for the motor is not substantial. That could lead to vibration, particularly if the vertical elements are not cross braced.

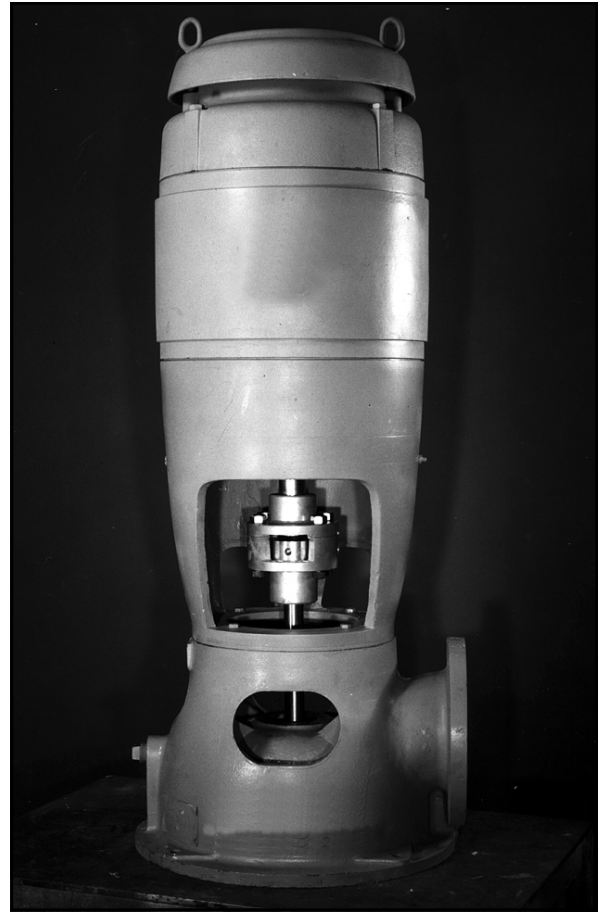
Note the tall slender body of the motor and companion column adapting it to the pump. If the stiffness of the motor and column are not adequate, a “reed frequency” resonant vibration could cause the motor to sway, thus continuously going in and out of alignment. The coupling for this unit has a jackscrew device built into it to raise or lower the pump shaft. By inserting a rod into the holes in the center of the coupling, the pump shaft can be adjusted to set the impeller clearance to the bowls (volute). A word of caution: Some motors are coupled to pumps designed for higher capacity, with a future increase in capacity in mind. While the motor might be a 200 hp, the driven pump could require 300 hp. The pump cost may be about the same as for the smaller rated unit, while the larger motor cost is proportionately higher. Installing the smaller motor allows the user to simply change out the motor to increase capacity at a later date. To compensate, while the smaller motor is coupled to the pump, the impeller shaft is lifted more than the standard 0.125” (3 mm) clearance, thus reducing the pump efficiency so that it only requires the 200 hp motor. The danger comes when no one remembers that this smaller motor is driving a 300 hp pump, and normal alignment procedures are used. The motor tries to deliver the capacity of the pump, and fails prematurely, if it operates at all.

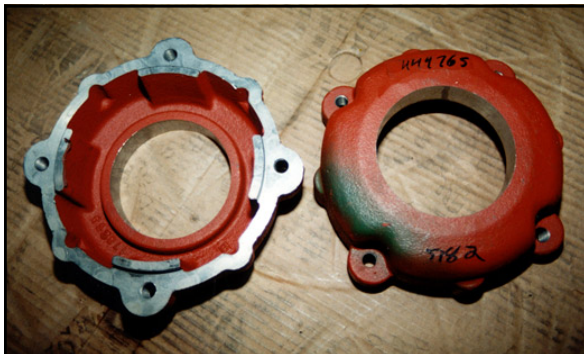
Note the contrast between a proper fitting bearing cap that is in good condition (left) and those that are no longer functional (right).

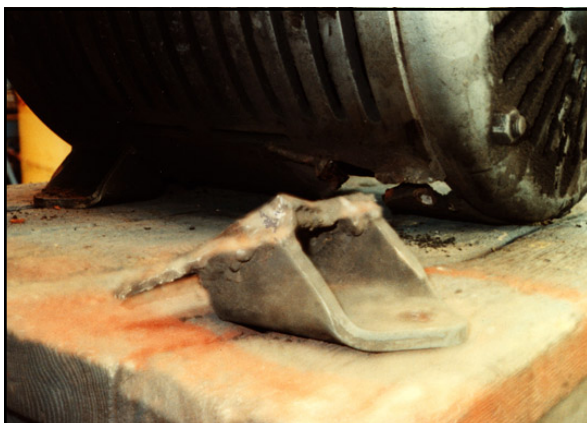
The foot weld did not penetrate into the stator frame properly.

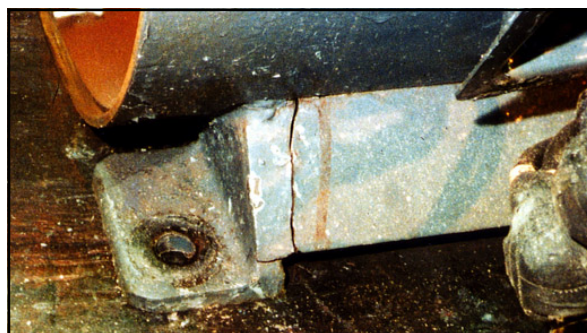
A severe soft foot condition caused this frame to crack.

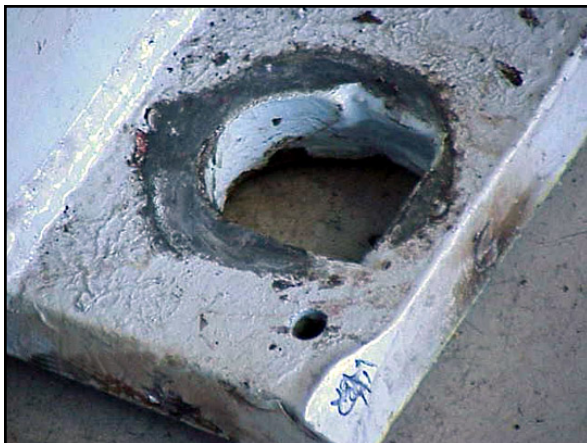
An unacceptable method was used to enlarge a frame foot hole.

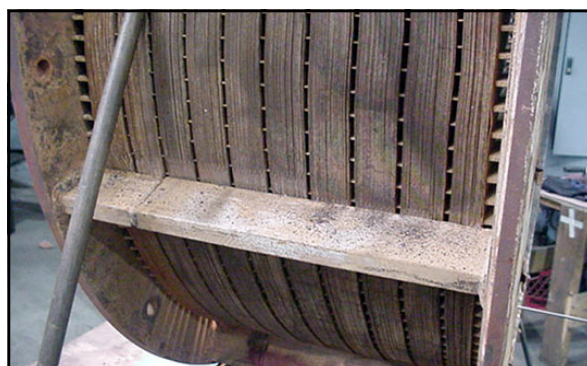
The axial ribs of the fabricated frame that retains the laminations were previously cut to disassemble the core for restacking. After restacking, the frame was held together in a press and welded. The welding of the ribs resulted in uneven pressure retaining the laminations. The result was that some the lamination packets became loose and rotated, causing ground faults in the winding. The repair of this motor will require another restacking, as well as rewind.

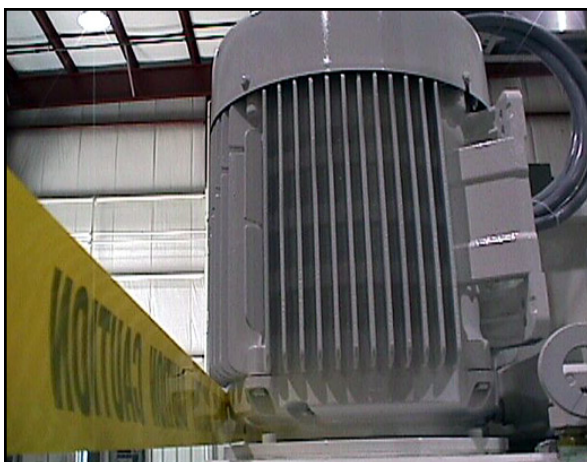
The crack in this frame was caused by an interference fit between the stator and frame that was too tight. This resulted in excessive hoop stress. When the stator expanded during operation, the frame split.

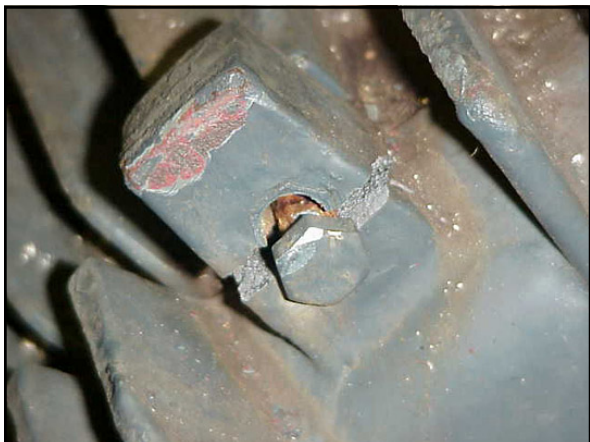
Due to excessive force, the ear cracked at the bolt circle.

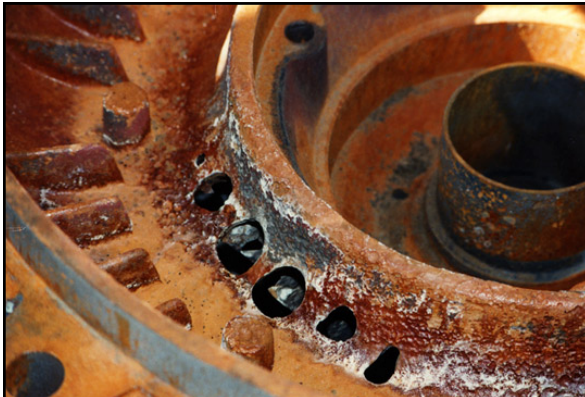
Severe corrosion in the lower end bracket due to a clogged drain hole.

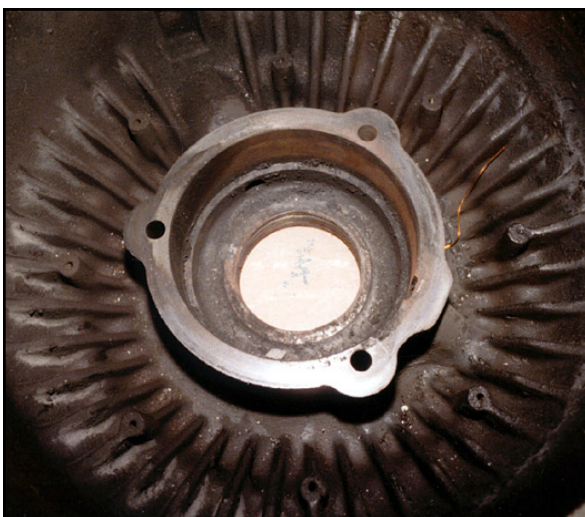
This end bracket lost the running clearance with the shaft.

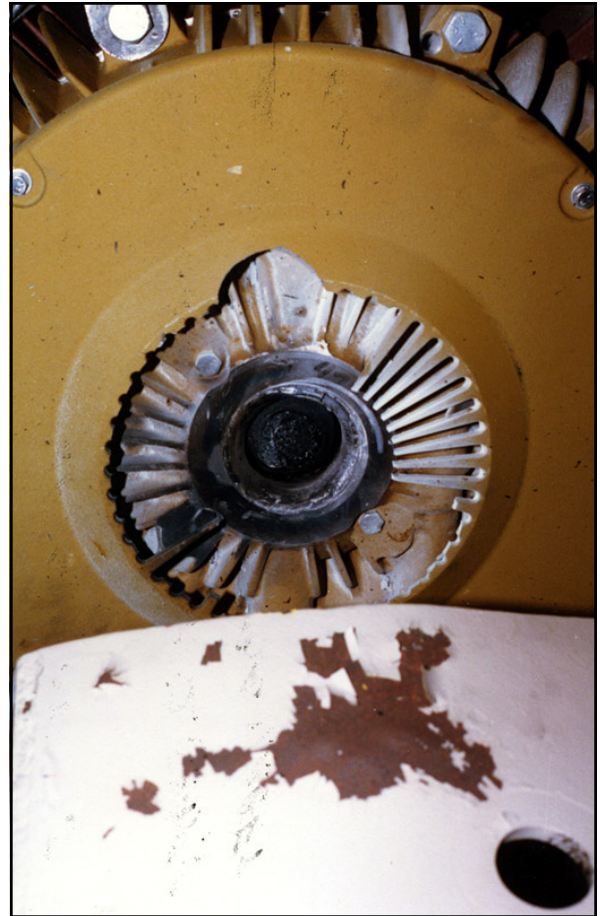
This motor's shaft, end bracket (above) and the finger fan/heat sink housed within the end bracket were damaged when a universal joint (below) failed due to a transient voltage.

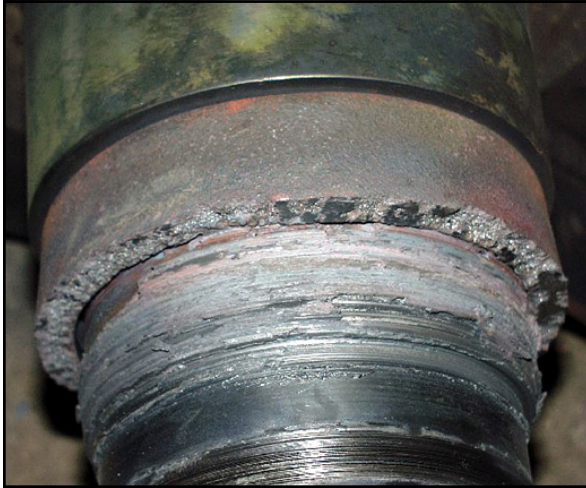
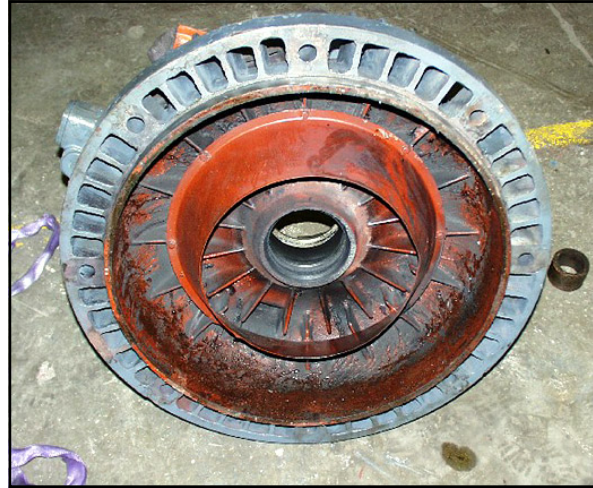
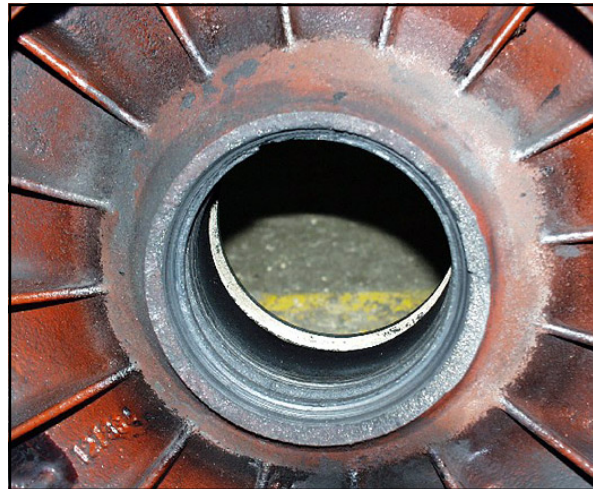
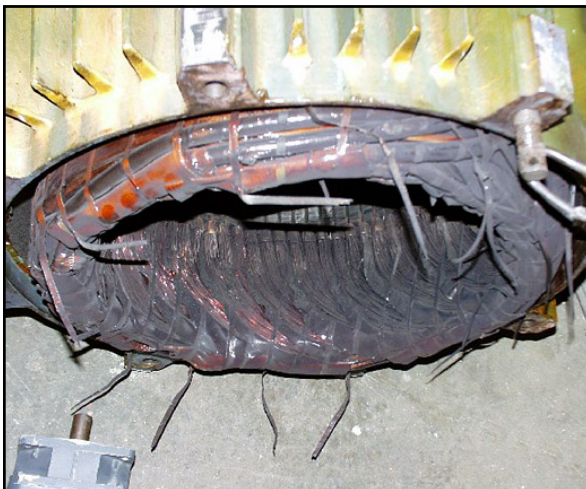
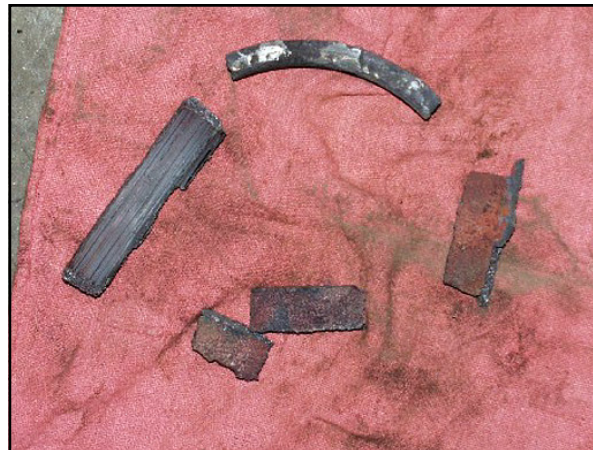
These photographs illustrate how the simple mechanical failure of a part can lead to a catastrophic motor failure. In this vertical motor, a simple bearing resistance temperature detector (RTD) or vibration detector could have protected this motor. Instead, the shaft, end bracket and winding were damaged.

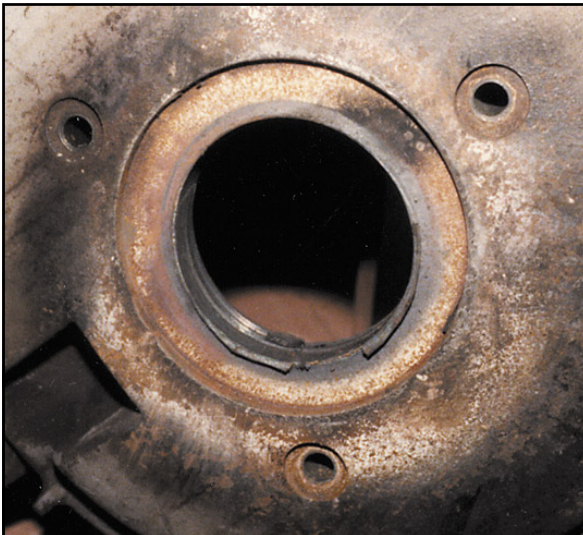
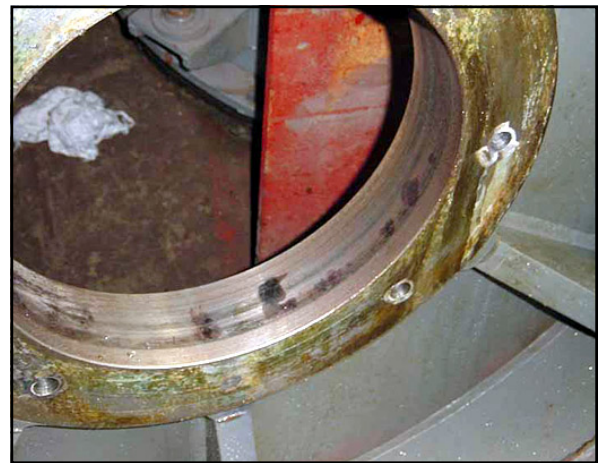
These bearing housings are oversized and out-of-round due to a loose fit which caused fretting.

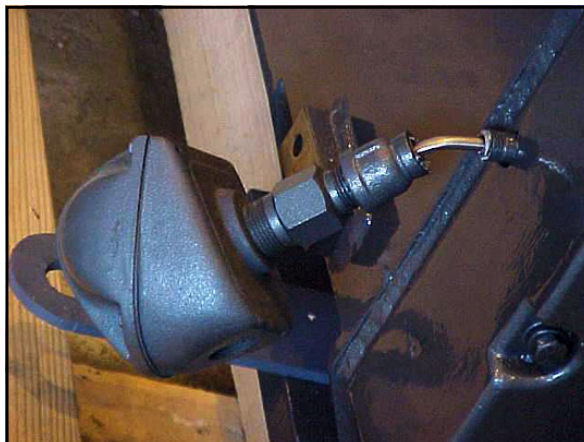
This bearing resistance temperature detector (RTD) was damaged during shipping.

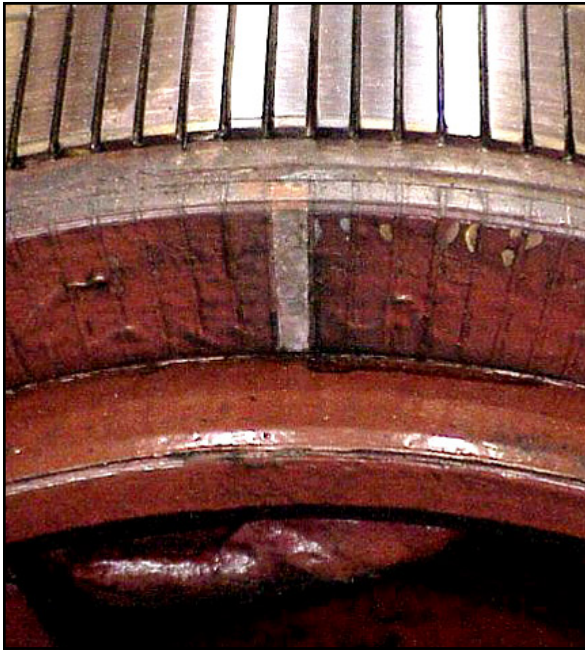
This banded commutator has an uncommon failure. Carbon or moisture trapped under the band has completed the circuit to ground of the affected bar.

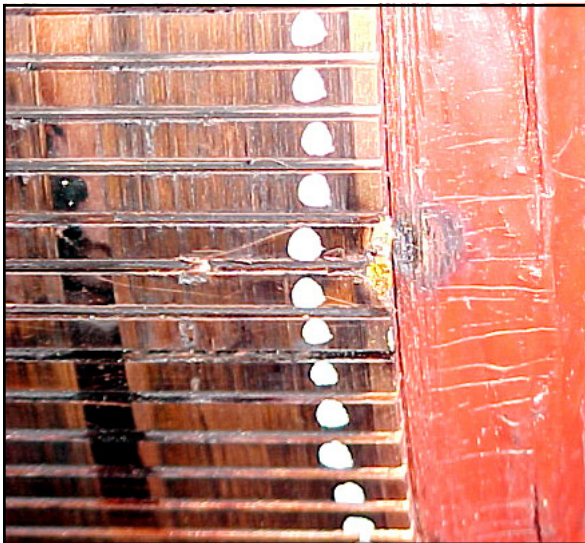
Shorted bars where copper melted.

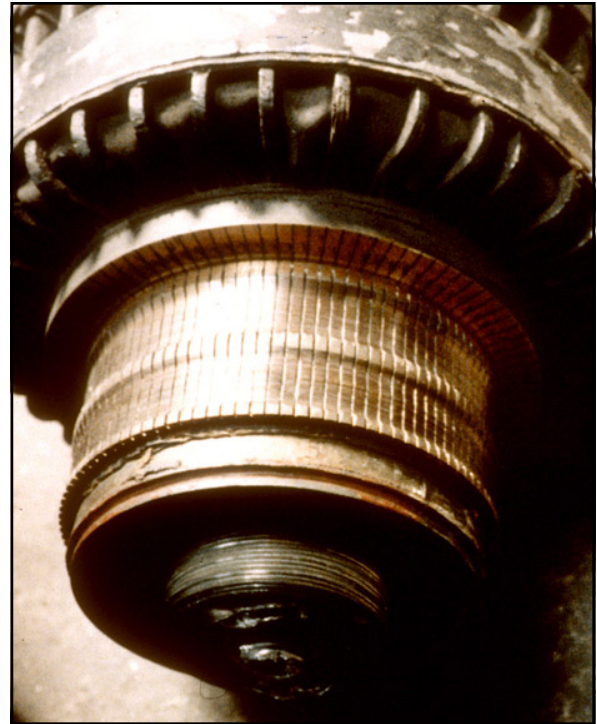
Grooving is caused by abrasive wear by either dust in the atmosphere or too abrasive a brush grade. The two major problems associated with grooving are:

- It diverts pressure from the relatively flat bottom to the radiused sides of each groove. Reduced brush pressure increases the brush temperature.
- Rapid wear reduces the commutator to its minimum diameter more quickly. Commutator life may be reduced by years.

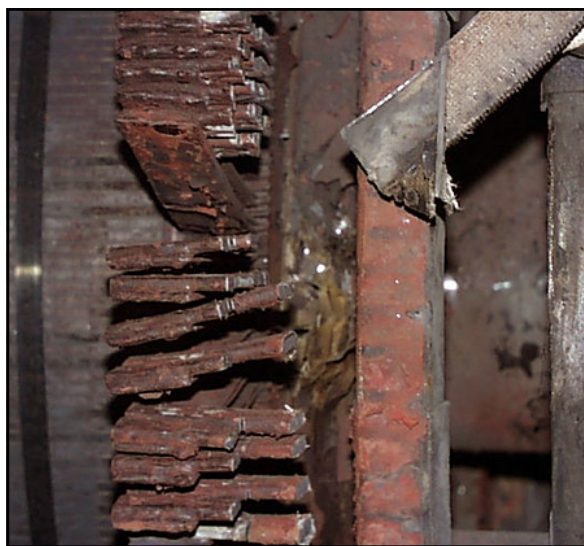
This commutator was cycled through the burnout oven with the armature. This should only be done when the commutator will be refilled.

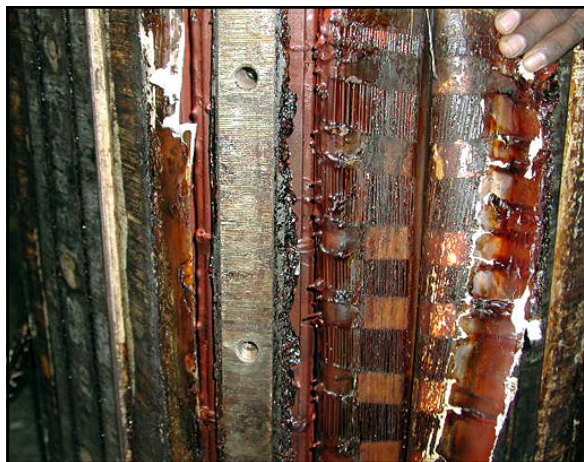
Coil insulation sometimes masks thermal damage. Inspection may require careful removal of coil insulation. The tape can trap heat.

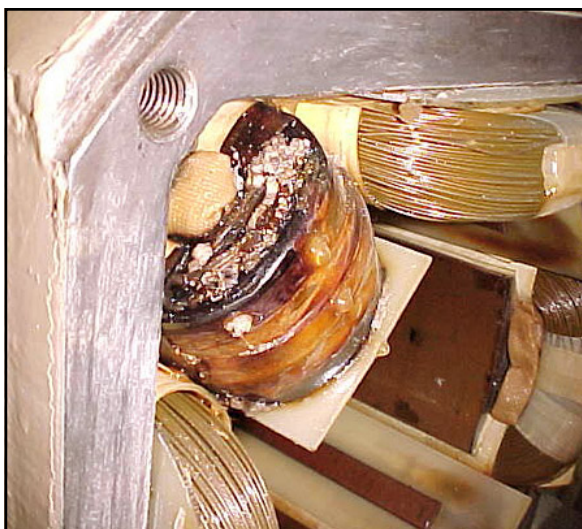
When interpoles show a marked difference in thermal stress, parallel circuits might not be balanced. The cause may be missing equalizer jumpers.

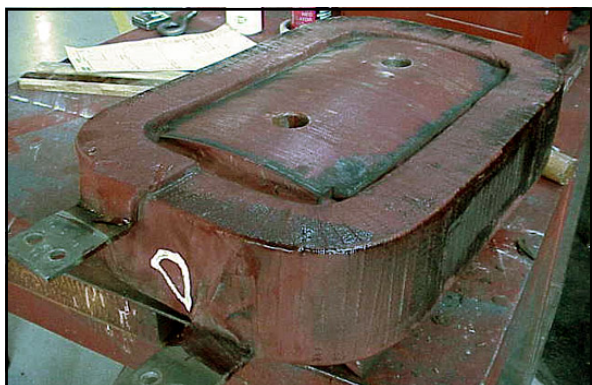
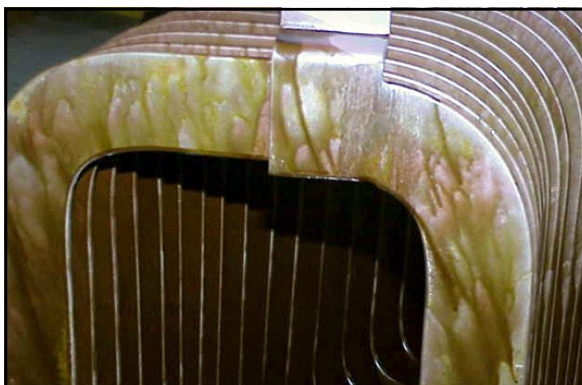
This series field is potted to the pole iron to reduce mechanical/shock stress during operation. The series coil (right) has been reinsulated and is ready to be taped and installed on the pole iron.

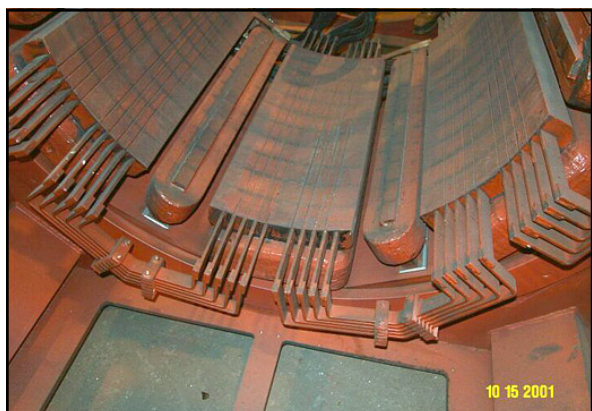
These interpoles are augmented by the addition of compensating windings.

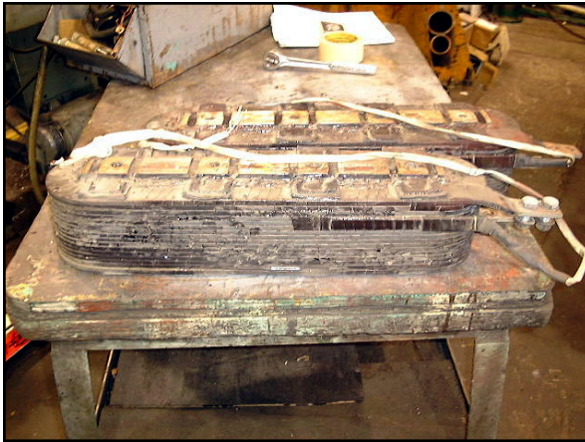
These interpoles exhibit obvious thermal stress. The epoxy insulation has charred due to heat, probably caused by excessive current through the interpoles. This could result from overload, incorrect connection (wrong number of parallel circuits), restricted ventilation, or related problems.

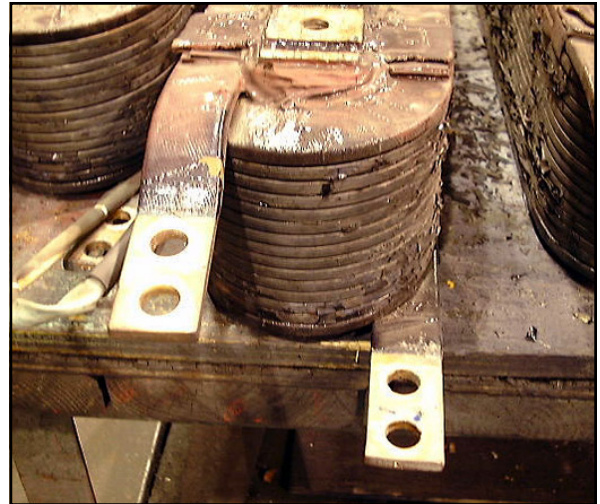
Note the offset in the lead. Interpole placement has to allow room for connecting leads/bus bars. This style is often connected using bus bar; separation and bracing are critical.

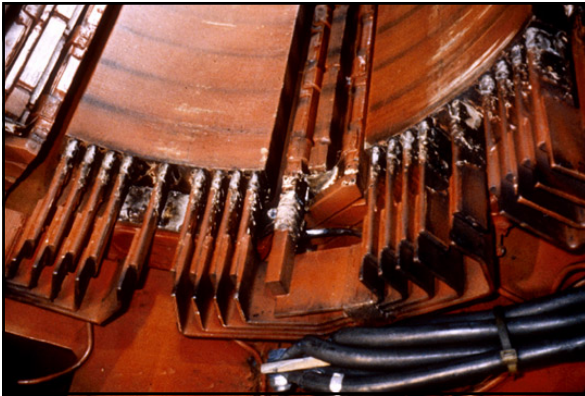
These compensating windings show signs of thermal stress and deterioration of the insulation.

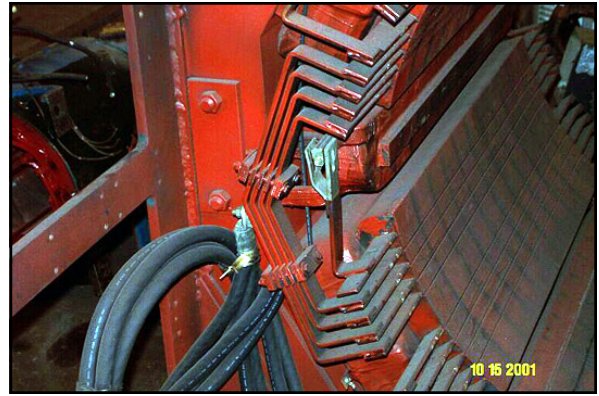
The connections may be bolted or welded (as shown).

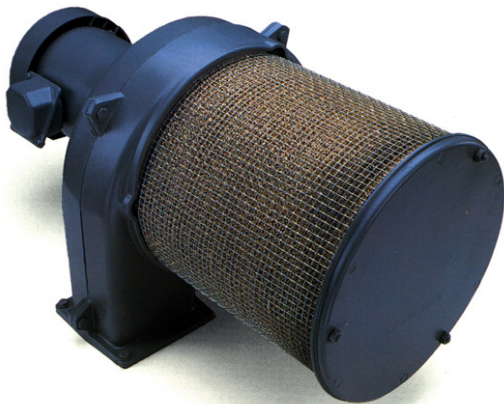
**FIGURE 15: AUXILIARY SQUIRREL CAGE BLOWER**

The auxiliary blower has several potential problems. It is usually a squirrel cage blower mounted on a small 3-phase motor. (See Figure 15.) A 3-phase motor can be reversed by interchanging any 2 leads. Operating backwards, a reversed squirrel cage blower still moves air in the correct direction. The shape of the blower housing establishes the direction of airflow. While the direction of airflow will be unchanged, a squirrel cage blower will move approximately one-third the volume of air, at a reduced static pressure. When a DC machine has been recently installed, and the armature appears to be overheated, a reversed blower is often the cause.

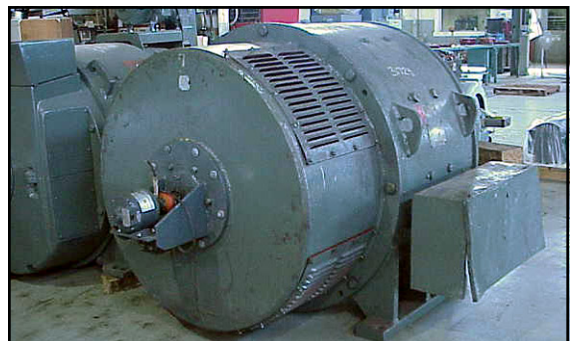
**FIGURE 18: LOUVERED COVERS**

Note the orientation of the louvers. Their orientation varies depending on the mounting position of the motor and specific environmental threats.

Louvered covers (Figures 17 and 18) are made in a variety of styles, including some that are stamped. If the motor is bumped, or the cover is removed and accidentally flattened by a passing forklift, the louvered cover is no longer louvered. It will restrict airflow, and the motor will overheat. A heavy coat of paint may even bubble over some of the louvered openings, especially those protected by rodent screens. If a motor is installed in a nonstandard mounting, the louvers may act as funnels to channel debris or moisture into the motor.

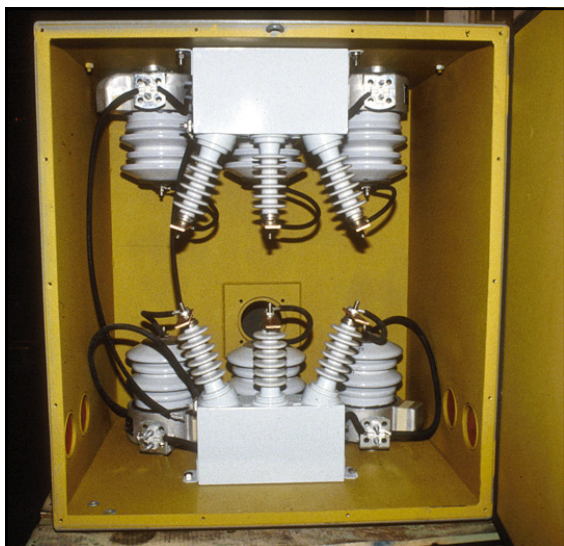
**FIGURE 1: SURGE PROTECTION**

The surge protection shown here is typically used for medium voltage (2300v - 4160v) motors.

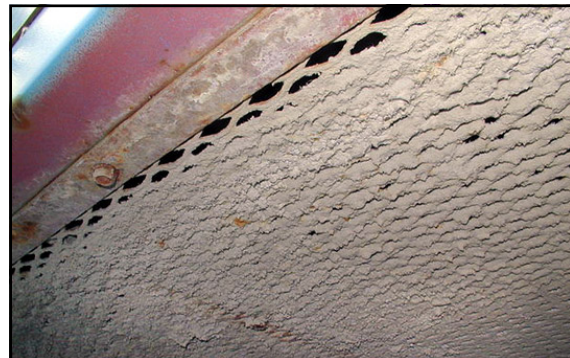
**FIGURE 6: CLOGGED SCREENS**

This expanded metal screen does not clog as easily as a screen with small openings, but contaminants can still build up. Sensors can be used to detect decreased airflow.

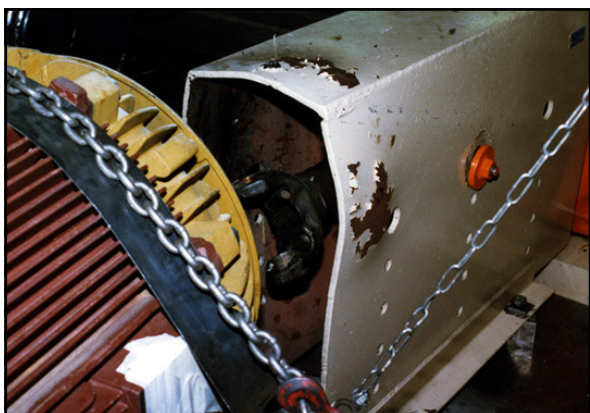
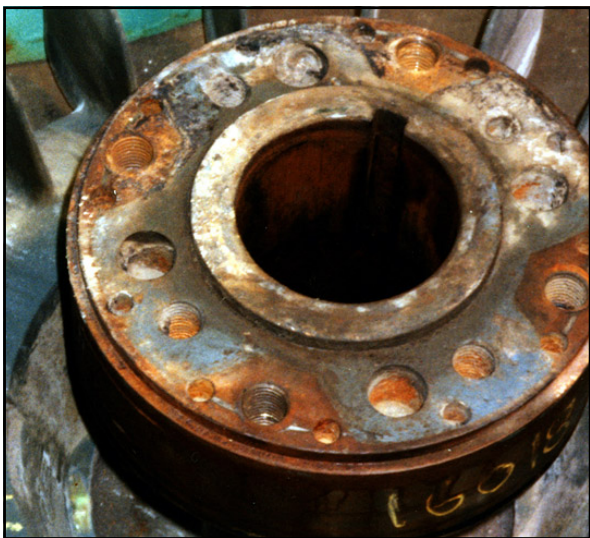
This coupling/bearing carrier for a vertical hollow shaft motor shows a lot of rust and corrosion. Vertical motors need adequate an rain bonnet/drip cover.

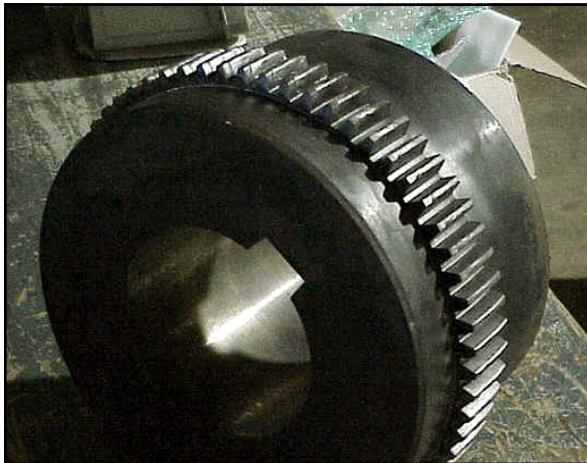
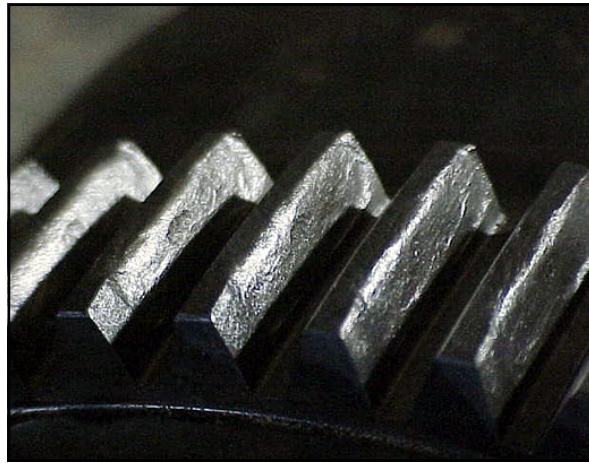
The teeth on this coupling show evidence of fretting (see closeup at right). Couplings are only surface hardened; once visible wear develops, the rate of wear accelerates.

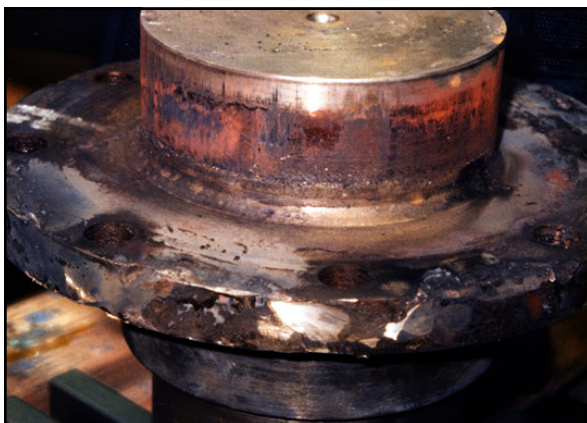
Generator coupling. Note the fretting on the guide.

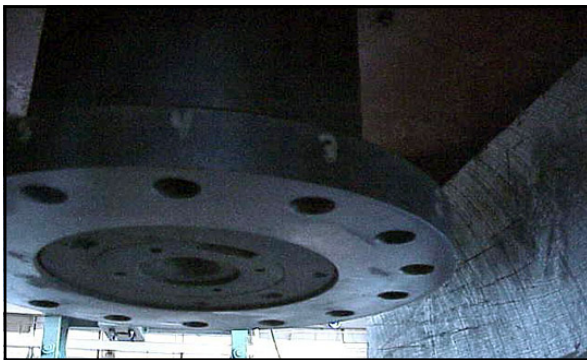
Vertical couplings are often retained by a "nut" or drop keys to prevent the load from pull the coupling down the shaft.

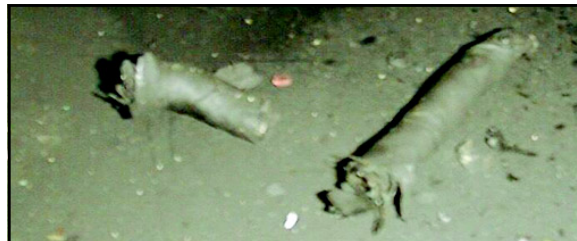
This is the first phase coil of C phase. The magnet wire connection was blown open and partially vaporized by the fault. This area is approximately 120° from the A phase coil damage.

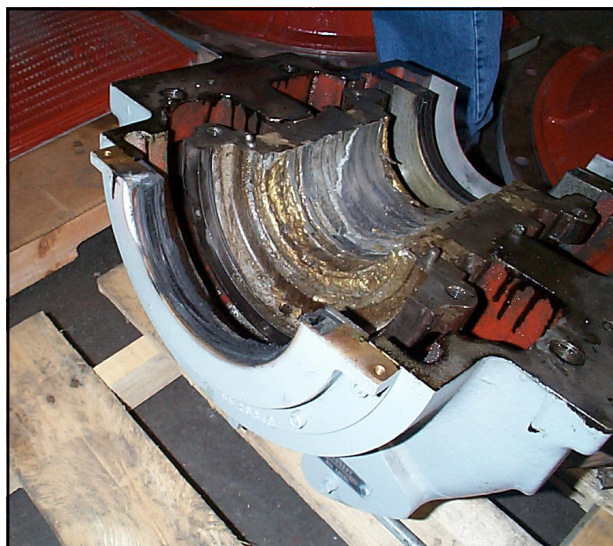
The failed drive end sleeve bearing.

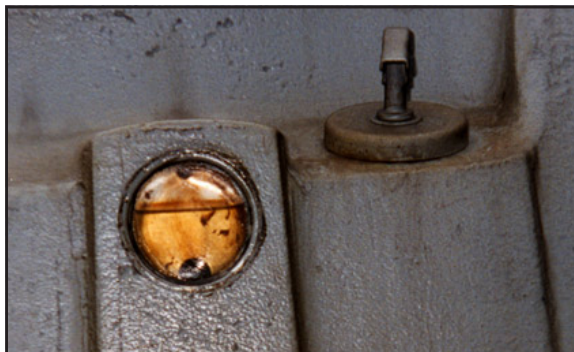
**FIGURE 1: SIGHT GLASS WITH SINGLE LINE**

This design uses no oil level marks. The operator assumes the correct level to be the midpoint. No distinction is made between running and standstill oil levels. This press-in design is also prone to leaks.

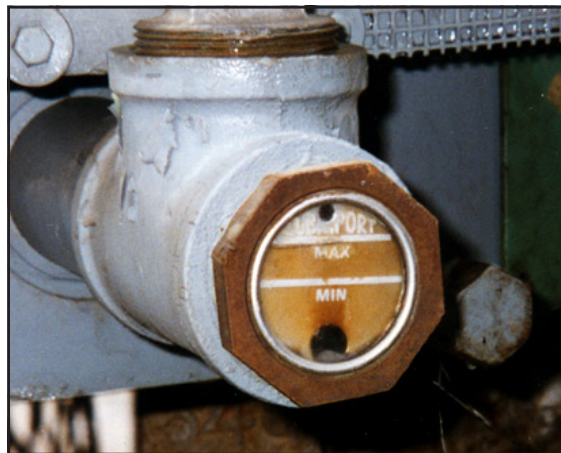
**FIGURE 2: SIGHT GLASS WITH TWO LINES**

The oil level is identified as “MAX” and “MIN” rather than “running” and “standstill.” When the standstill oil level is at the upper line, the running level surges even higher and oil leaks are likely.

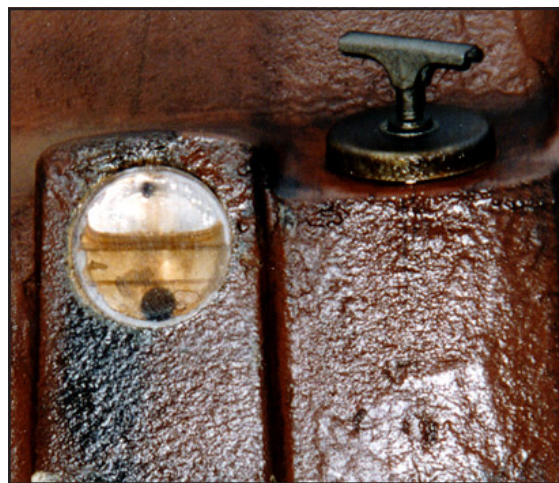
**FIGURE 3: STAINED SIGHT GLASS**

When an oil level is maintained for years the site glass may become stained, indicating oil when none is present. The boat plug style fill works well and is very convenient for operators, but it may leak if not tightened.
