Troubleshooting Fluid Sealing in Pump Systems for Safety and Reliability

Compression Packing

Troubleshooting and Failure Analysis of Pumps with Packing

Expansion Joints

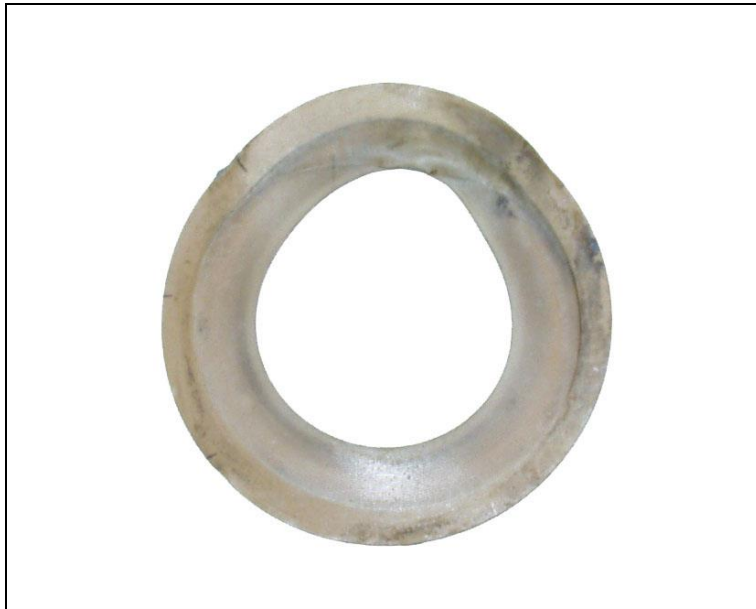
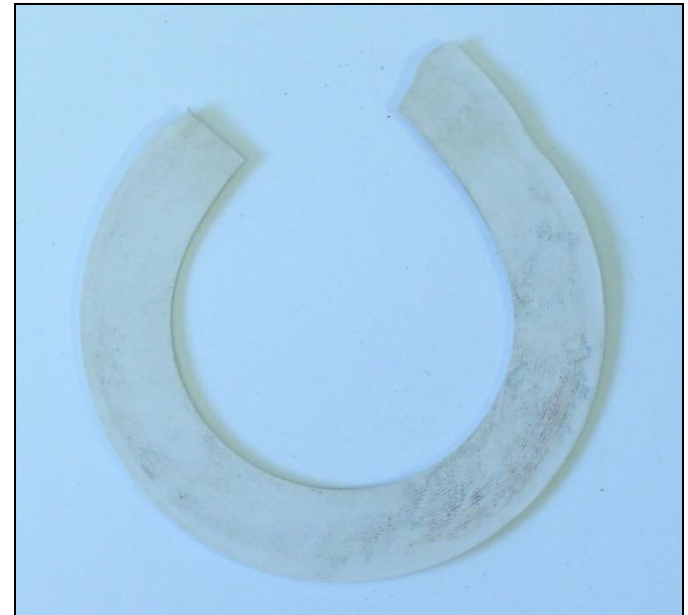
Gasket Failure Analysis – Blow-out

- » Gasket blow-out is probably the most common gasket failure and has the most causes
- » Identification: Usually most of the gasket remains in place and either part of the gasket is pushed out past the sealing area (egg shaped), sections missing, or split and gasket open

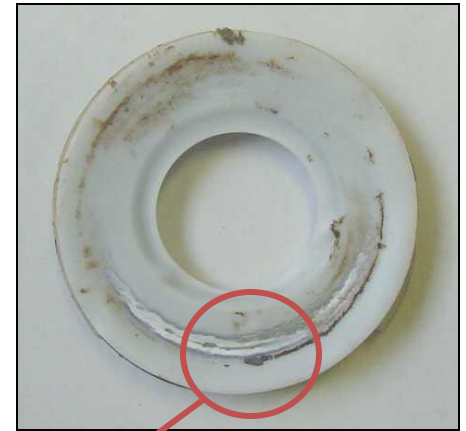
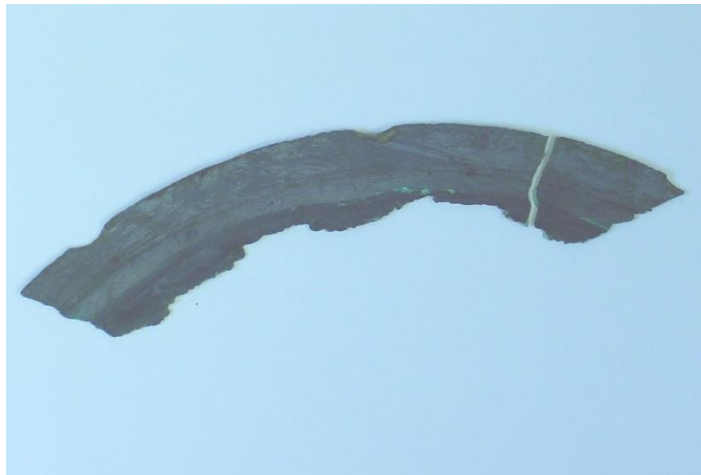
Gasket Failure Analysis – Chemical attack

Identification

- » Gasket frayed or missing (jagged) at ID where gasket in contact with media
- » Extremely soft or disintegrated appearance

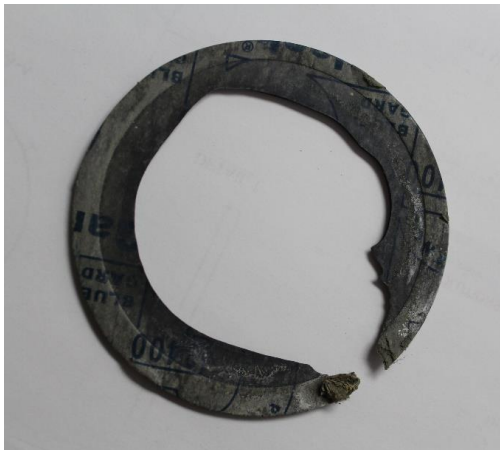
Gasket Failure Analysis – Erosion

Identification

- » Gasket missing at ID (smooth cut away)

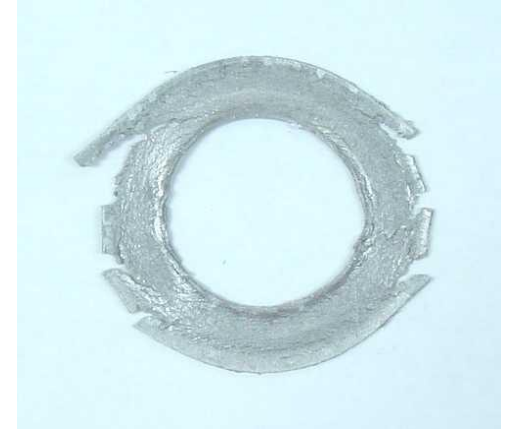
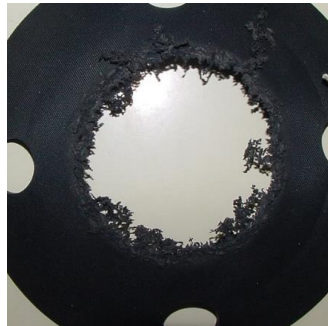
Gasket Failure Analysis – Crush

Identification

- » Gasket is cracked or split in concentric fashion
- » Rubber gaskets may be shredded at ID
- » Possibly liquid present on gasket (shiny)

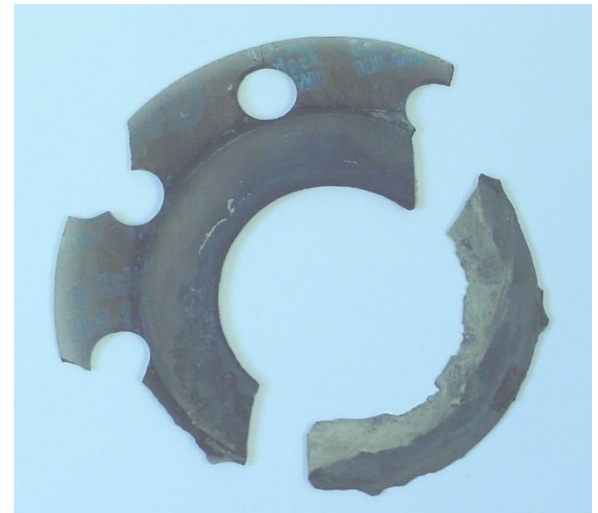
Gasket Failure Analysis – Under compression

Identification

- » No to little notable compression on gasket
- » possibly blown out

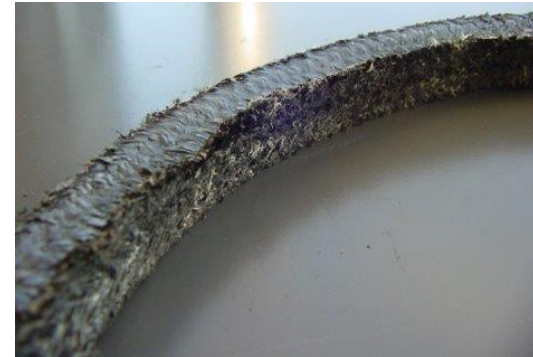
Abrasive Wear

Occurrence:

- » Abrasives in media enter the stuffing box getting inside the packing, in between the shaft sleeve and the packing
 - » Generating wear on both packing and sleeve, thus increasing the clearance and leakage.

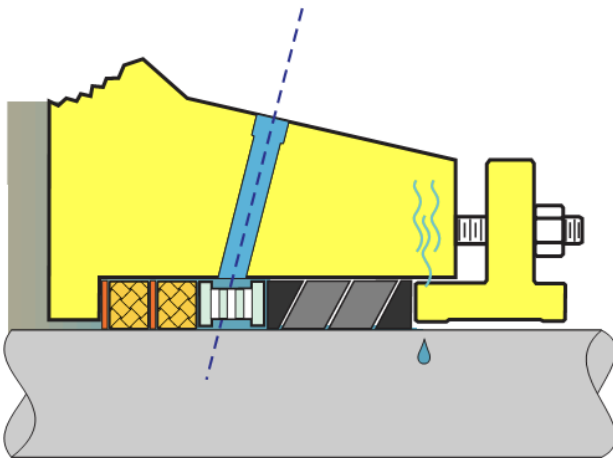
Style 98/GYLON 3510 Ring Set

Low Solid Option
= **Water conservation**
Leakage control

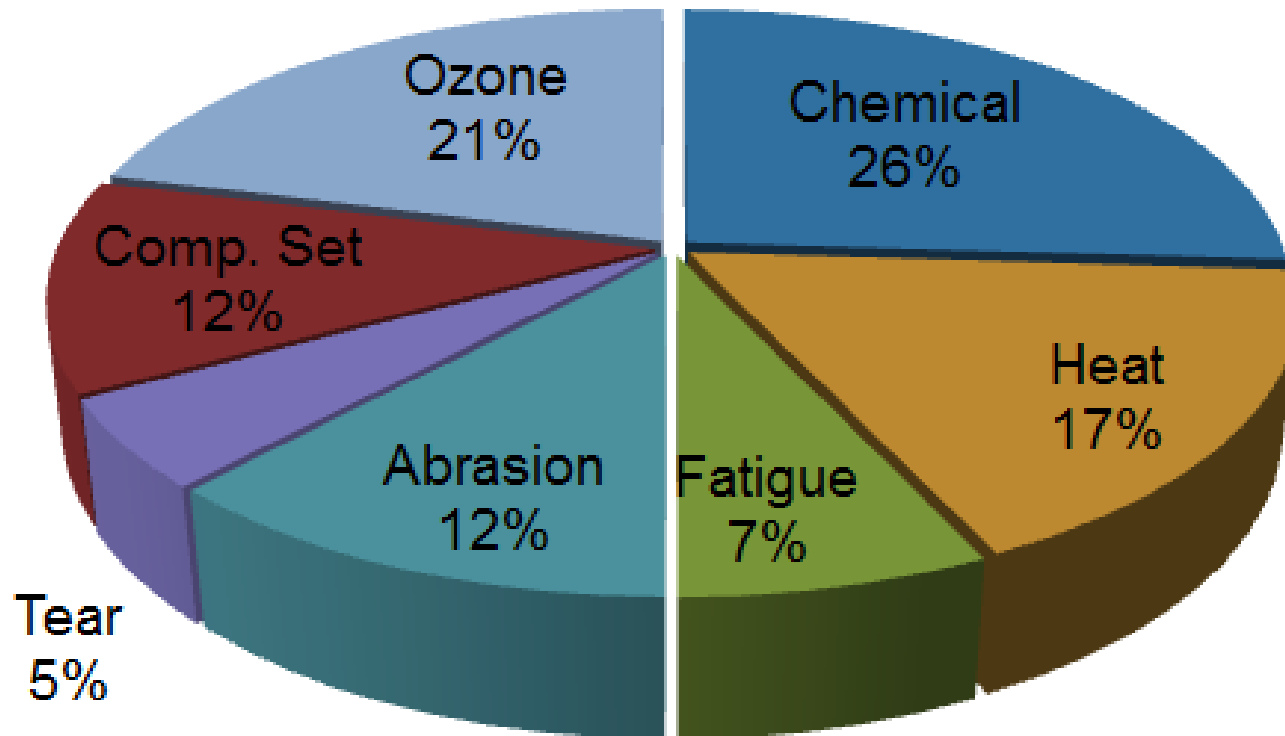
Reasons for Failure

Common Service Related Causes of Failure

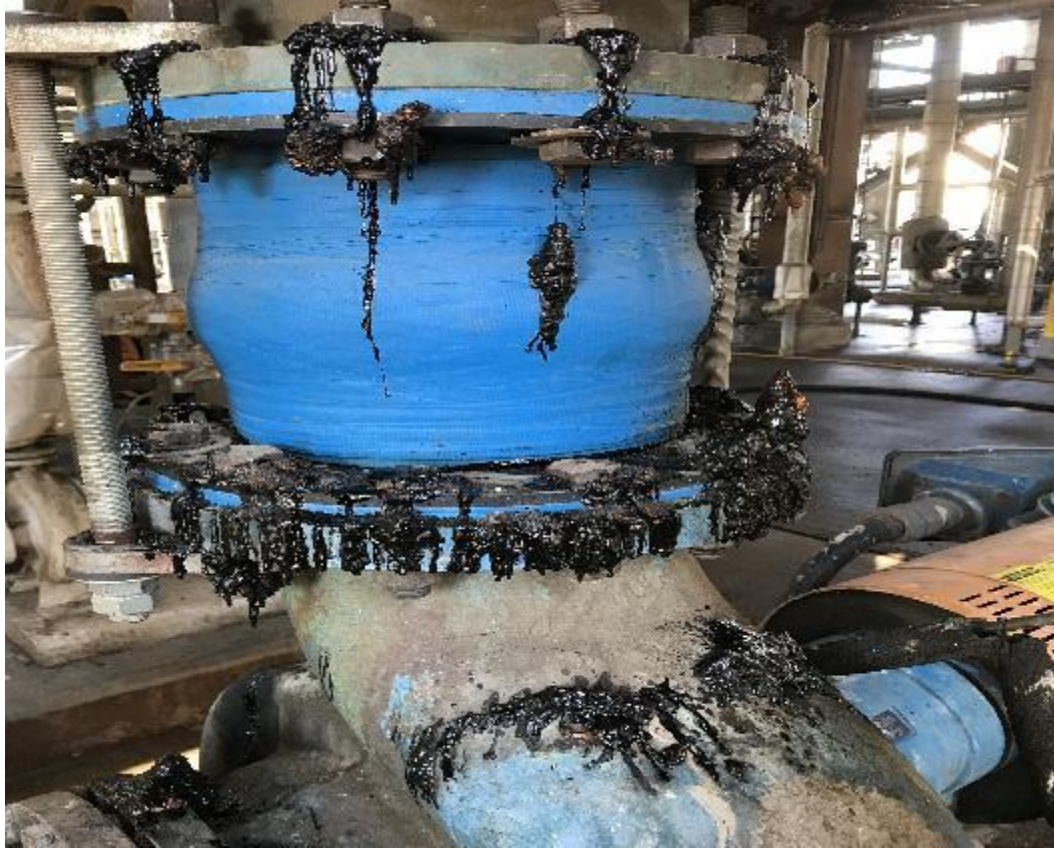
Insufficient Torque on Installation

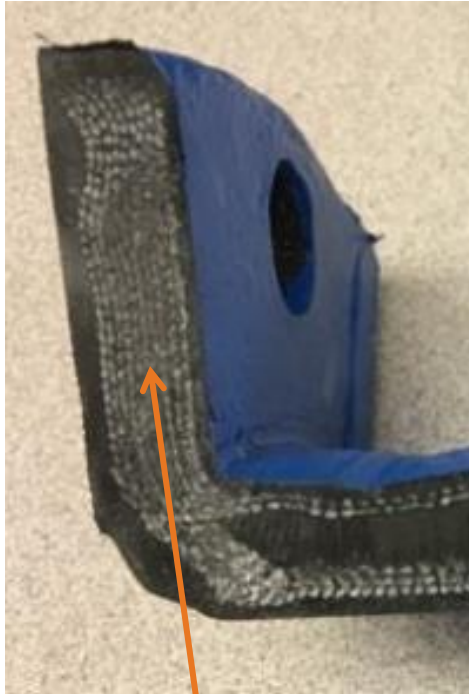
Multiple Plies in Flange

- » Increase Sealability
- » Reduce Bolt Load Creep

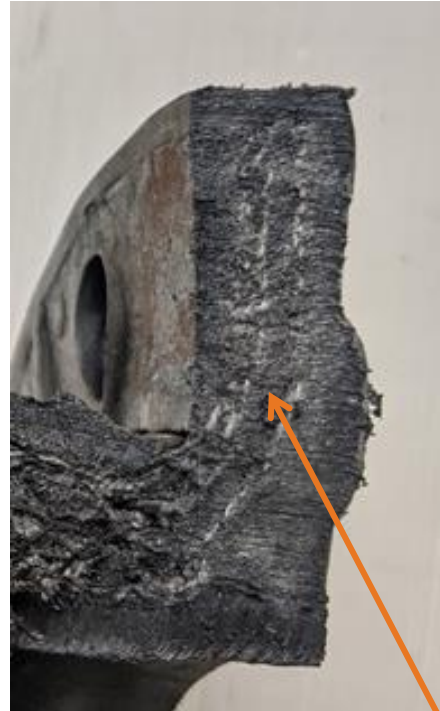
Very Little Fabric

- » Poor Sealability
- » Rubber Creeps and Bolts Loosen

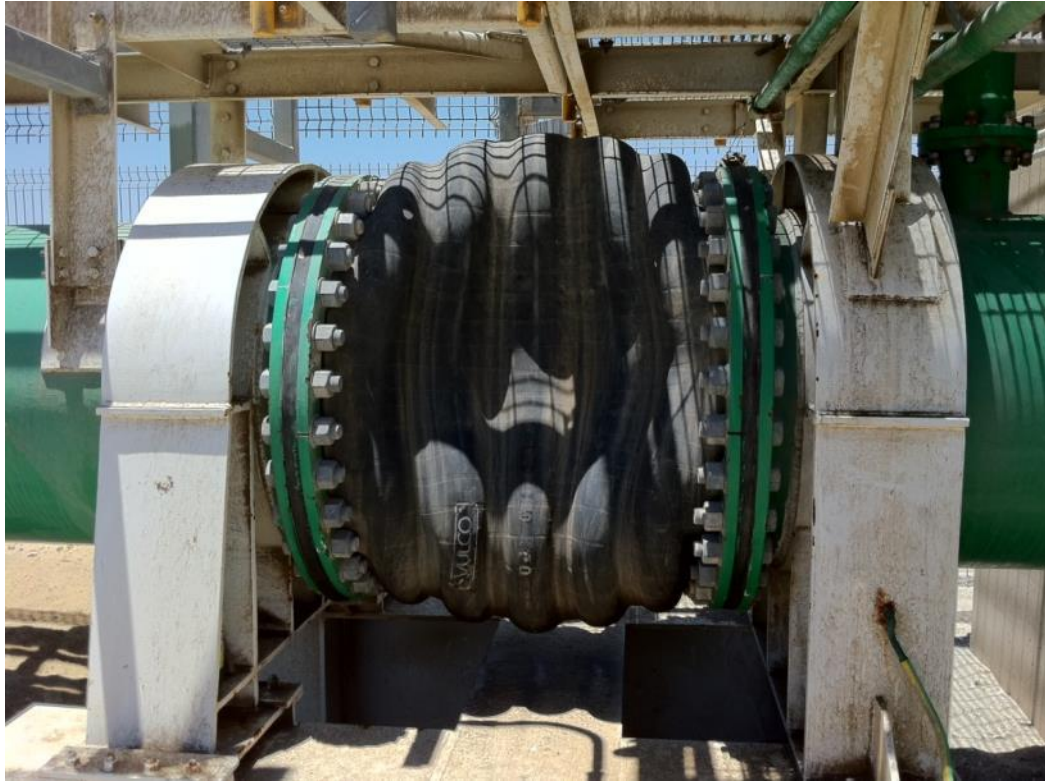
Insufficient Vacuum Support

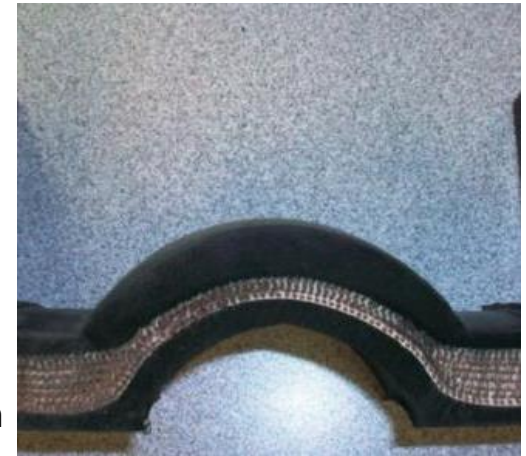
Joint Type

- » Wide arches are more geometrically susceptible to collapse due to vacuum forces
