# Utrasound for **Slow Speed Bearing Monitoring**

Part 1: Program Logistics

#### **Dakota Gasification Company**

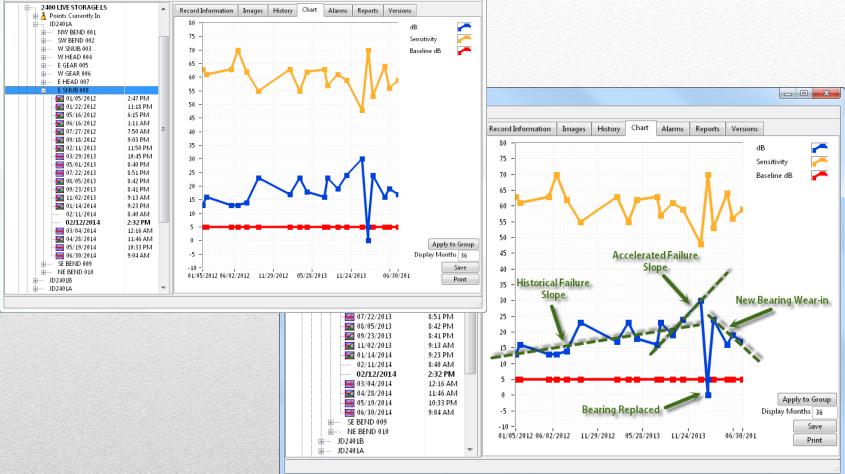
# DMS - Trend Analysis

Ultratrend DMS

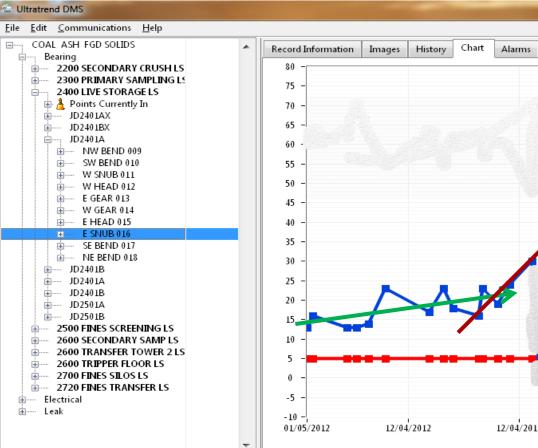
#### A SUCCESS STORY: PLANNED BEARING REPLACEMENT

JD2401A East Snub Pulley Bearing

#### • E HEAD 015 40 ±---- E SNUB 016 35 ..... SE BEND 017 . NE BEND 018 30 ..... JD2401B ..... JD2401A 25 ..... JD2401B 20 . JD2501A ..... JD2501B 15 immed 2600 SECONDARY SAMP LS 10 2600 TRANSFER TOWER 2 LS 5 im 2600 TRIPPER FLOOR LS 2700 FINES SILOS LS 0 2720 FINES TRANSFER LS -5 Electrical 🖮 .... Leak -10 -01/05/2012 w. **Trend History**

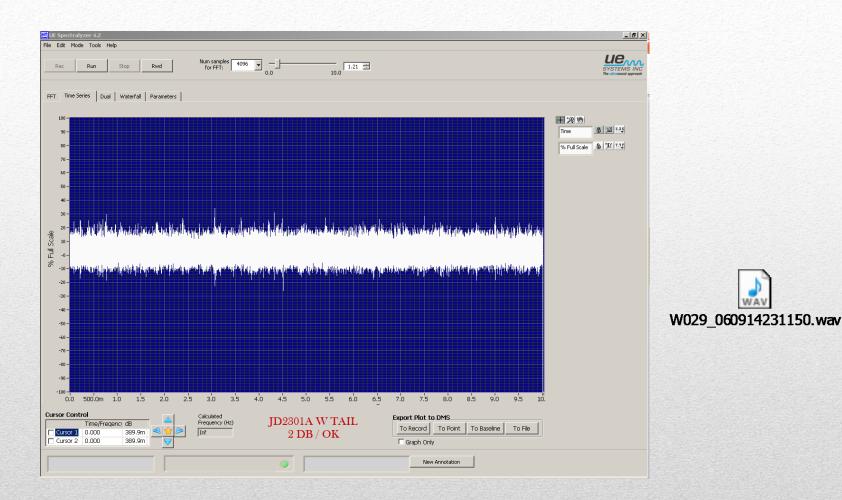
## **IMPACTING FAILURE CYCLE**

Spectrum / Signature

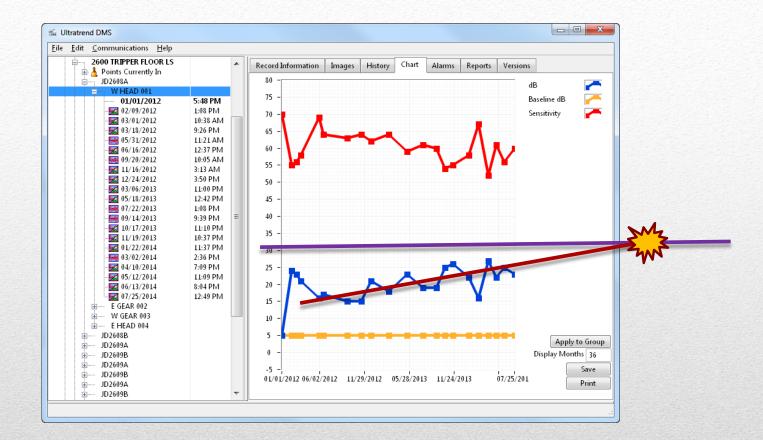
#### Trend -Predicted Risk / Replacement 55

#### -Past History / Current Health -Future Predicted Risk

- Current DB Value
  - Current risk of failure
- Historical Trend Values
  - Change in bearing health (other conditions remaining constant)
  - Slope is rate of failure
  - Extended becomes the future / predicted risk of failure
- Marker for bearing replacements
- Replaced bearings have a wear-in period
- View 24 to 36 months

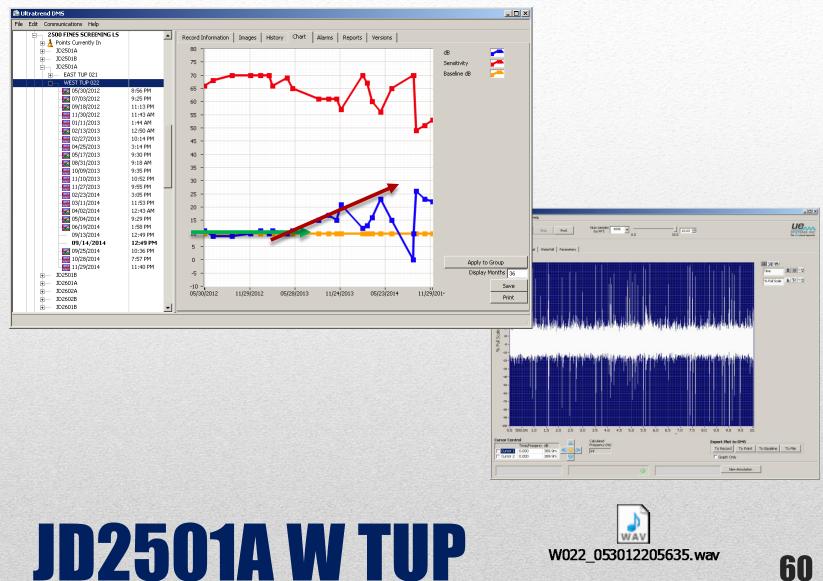
#### SUCCESS.....

Before / After Replacement
