# TIMKEN

## BEARING DAMAGE ANALYSIS REFERENCE GUIDE

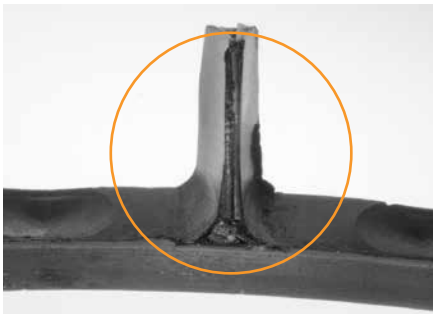
*Fine particle contamination entered this spherical roller bearing and generated wear between the cage surfaces, rollers and races.*

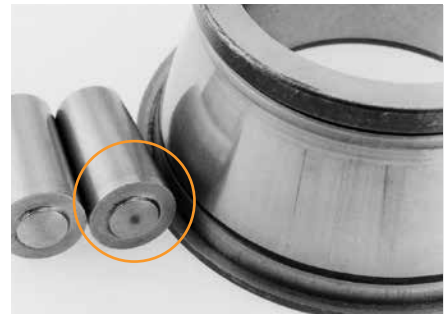
*Fine particle contamination caused abrasive wear on this tapered roller bearing.*

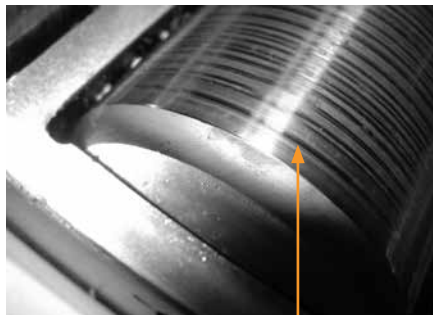
*Circumferential grooving on rollers.*

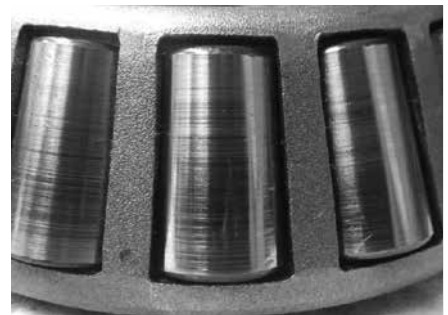
*Circumferential grooving.*

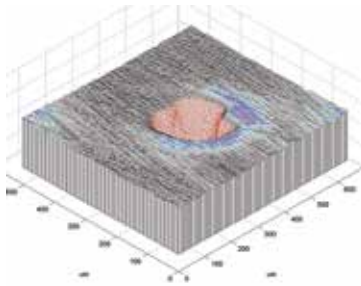
*This photo, taken with a microscope, shows a debris contamination bruise on a bearing race. A corresponding surface map of the dent is shown to the right.*

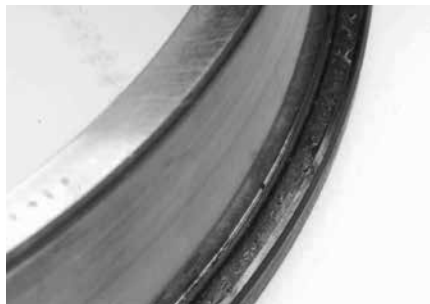
*Level 2 – Advanced rib scoring is due to inadequate lubricant film.*

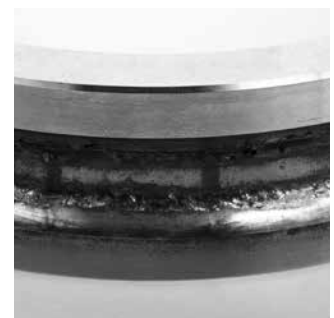
*Fatigue spalling from excessive preload.*

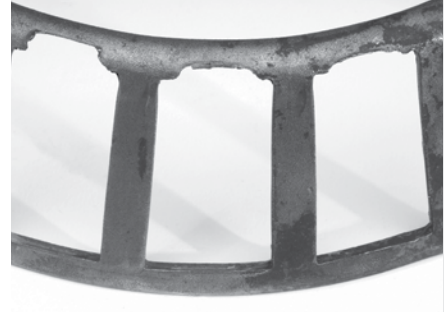
*Heavy wear in the small end of the cage pockets is typical of excessive endplay.*

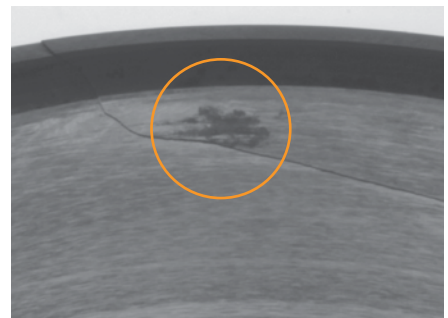
*This ball bearing inner ring fracture resulted from installation on top of a metal contaminant or raised metal nick.*

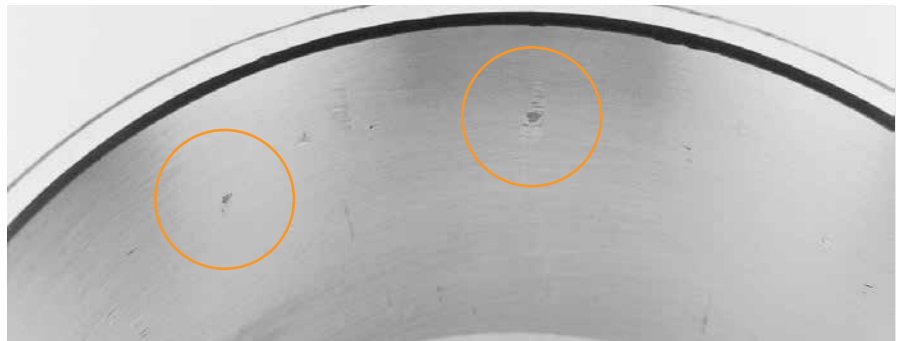
*Tapered roller spaced nicking was caused by the roller edges hitting the race during installation. These nicks/dents have raised edges that can lead to excessive noise, vibration or act as points of stress concentration.*

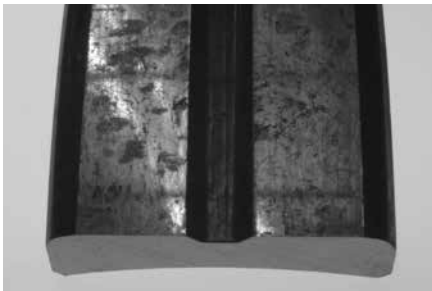
*A worn-out housing caused this bearing to lose fit and fret (move) during service. As a result, metal tearing and wear occurred on this spherical outer ring.*

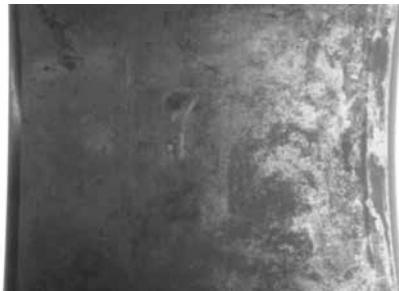
*Classic fretting corrosion from poor fitting practice is depicted here. Relative movement under load between the bearing and its seat caused this worn and corroded condition.*

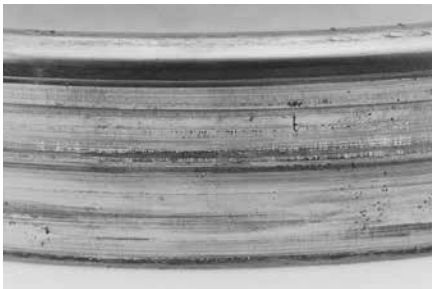
*A loose outer ring fit in a rotating wheel hub (typically tight) caused this bearing race damage.*

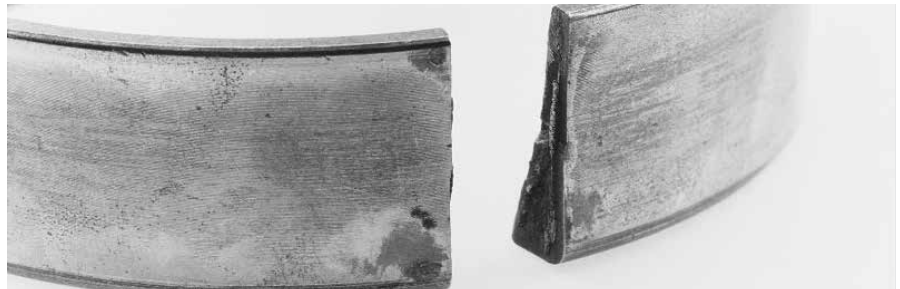
*Cracked outer ring in a wheel hub. The outer ring turns and wears the outer ring seat so the fit becomes more loose. Then the outer ring starts to stretch or roll out. Wear and stretching continues to the point where the metal reaches its breaking point and the outer ring cracks open.*

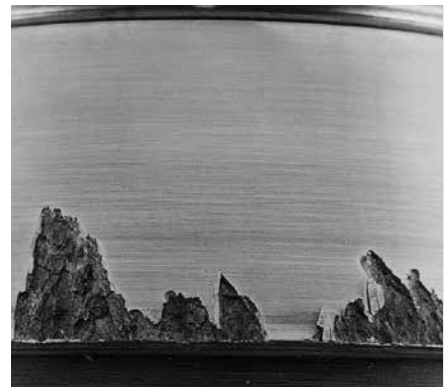
*Geometric Stress Concentration (GSC) spalling.*

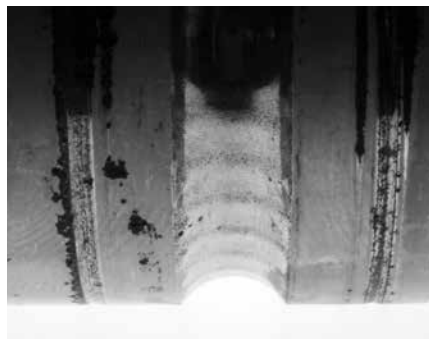
*Note shock loading caused brinell damage on this ball bearing inner ring.*

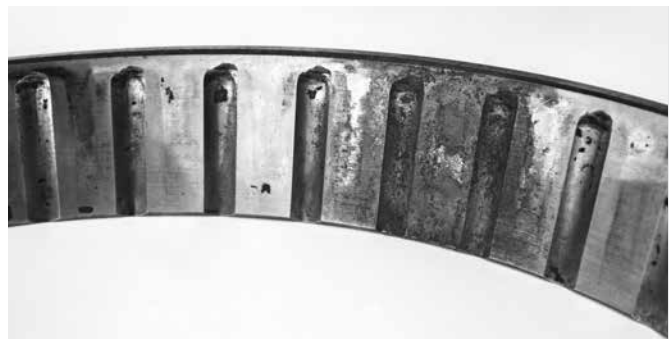
*Heavy false brinell on outer race.*
