# **Materials and Methods of Corrosion Control of Reinforced and Prestressed Concrete**

# Materials and Methods for Corrosion Control of Reinforced and Prestressed Concrete Structures in New Construction

PUBLICATION NO. 00-081

AUGUST 2000

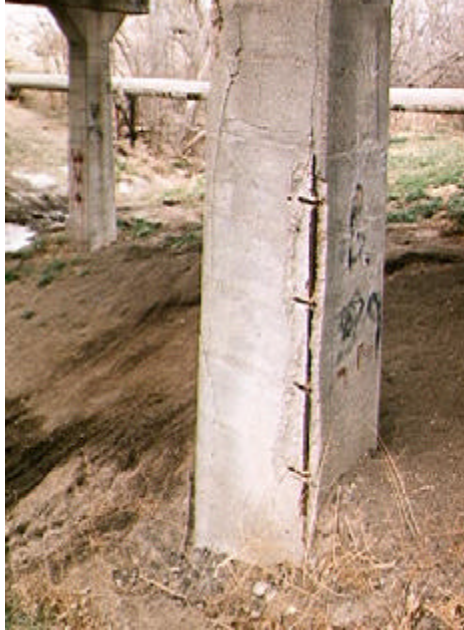
**Figure 1. Corrosion-induced deterioration on a bridge column.**

more than \$20 billion and to be increasing at \$500 million per year.<sup>(1)</sup> The primary cause of this deterioration (cracking, delamination, and spalling) is the corrosion of steel reinforcing bars due to chlorides. The two main sources of chlorides are deicing chemicals and seawater. The bare pavement policies of many highway agencies for winter snow and ice removal have resulted in extensive use of salt-based deicing chemicals. The most common chemical used has been sodium chloride. Many bridges have also been built in coastal areas and are exposed to seawater.
