## Article

# Research on the Corrosion Behavior of Q235 Pipeline Steel in an Atmospheric Environment through Experiment

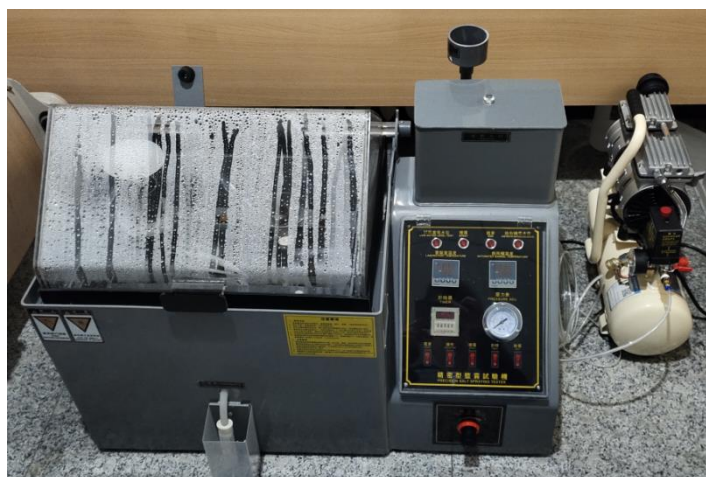
**Figure 1.** Salt spray tester with air compressor.

The samples used for testing were passivated Q235 low-carbon steel with the chemical composition provided in Table 1. The sample production process and test procedure were as follows: the Q235 low carbon steel pipe was cut into 15 mm × 20 mm × 2 mm samples with a wire cutting machine, and the method of cyclic cleaning was adopted to ensure the uniformity of pickling and passivation treatment. The sample was placed in the pipeline cleaning tank, and the temperature was 42 °C for the pickling solution (its main components are hydrochloric acid, oxalic acid, and urotropine corrosion inhibitor) in the tank for 3.8 h of pickling treatment. After neutralizing the pickling solution, the passivation solution at 25 °C (the main component of which is a mixed solution of sodium nitrite and a passivator accelerator) was passed into the pipeline cleaning tank for 0.5 h passivation treatment. After passivation, the surface of the qualified sample should be free of rust and evenly covered with a dense dark black passivation film. The treated specimens were numbered, dried, and weighed on an electronic scale, with the results achieving an accuracy of 0.1 mg. The weighed test pieces were placed in a salt spray tester, as shown in Figure 1.

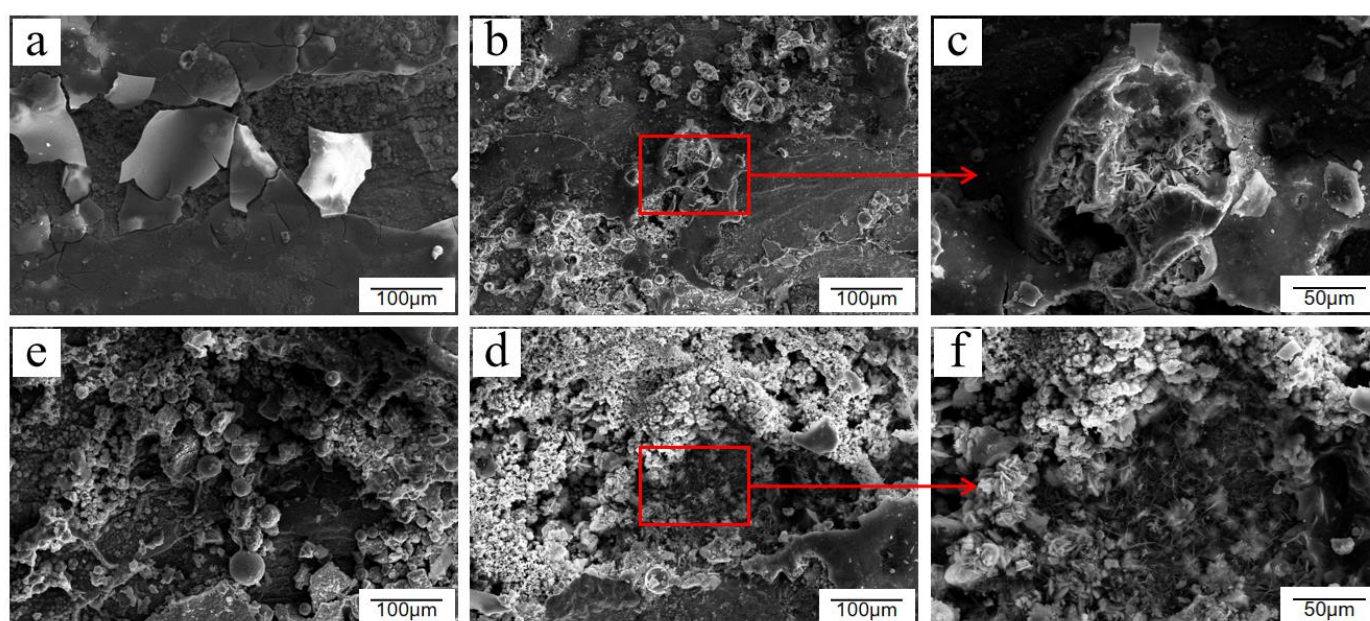
**Figure 2.** Several corrosion product morphologies of Q235 low-carbon steel under atmospheric conditions: (a) membranous, (b) needlelike, (c) needle enlargement, (d) crystal cluster, (e) crystal-like, and (f) crystal enlargement.

In general, the corrosion of Q235 low-carbon steel without passivation treatment in the atmospheric environment is divided into three stages. The first stage is surface hydroxylation, in which a thin layer of oxide or hydroxyl oxide is formed on the surface of carbon steel within a short period. The second stage is when the atmosphere acts as a thin liquid film attached onto the surface of the tube wall, in which its constituents are dissolved, leading to the transformation of the thin layer of oxides or hydroxyl oxides into green rust. The third stage is the gradual increase in the number and size of the nuclei of the products and the transformation of green rust into a yellow-brown friable layer of oxides and hydroxides; thus, the corrosion products consist mostly of  $\alpha$ -FeOOH,  $\gamma$ -FeOOH, and  $\gamma$ -Fe<sub>2</sub>O<sub>3</sub>. The corrosion product morphology is divided into three types: membranous, crystal-like, and crystal cluster-like, as shown in Figure 2a,d,e, respectively. Goethite ( $\alpha$ -FeOOH) and lepidocrocite ( $\gamma$ -FeOOH) occasionally appear in the form of fibrous or needle-like aggregates during the corrosion process. These aggregates grow and rupture to form the three aforementioned forms of corrosion products. The corrosion products on the surface of Q235 low-carbon steel were randomly scattered and distributed with the corrosion degree and corrosion depth, as shown in Figure 2b,c,f.

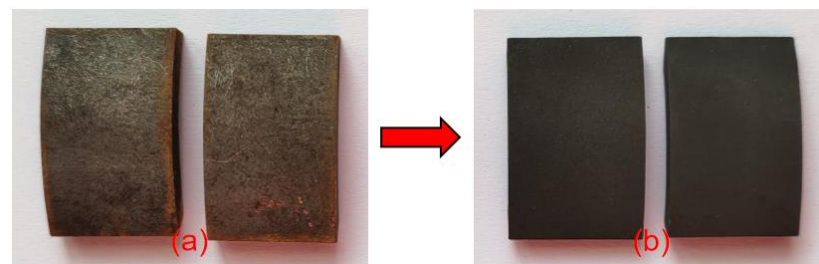
**Figure 3.** Comparison of samples before and after passivation: (a) before passivation and (b) after passivation.

The vast majority of metals will corrode spontaneously in the general environment. The purpose of passivation is to form a uniform and dense oxide film on a metal's surface via treatment with strong oxidants, reducing the surface activity of a metal to enhance its corrosion resistance. Before a metal is passivated, a pickling process is generally performed. After the pickling passivation process, surface rust marks on a test piece disappeared and the metallic silver-white surface was gradually covered by a black metal oxide, forming a dense oxide film, as shown in Figure 3. The observation of the passivated samples under

an electron microscope revealed that large areas of flat and dense metal oxides replaced the original Q235 steel morphology, with a small number of raised or defective areas adversely affecting the formation of the passivated film, as shown in Figure 4a. There is also enough passivation product at the fracture, but compared with the passivation layer at the flat part, the color of the passivation layer at the fracture is lighter. This shows that the passivation product is affected by the ridges at the fracture, and the aggregation is relatively fluffy, which also lays the groundwork for the first rupture of the passivation film at the fracture in the subsequent salt spray experiment, as shown in Figure 4b. In various industries, multiple standards have been established for the thickness of passivation films on low-carbon steel, but generally, a maximum of 10  $\mu\text{m}$  should not be exceeded.

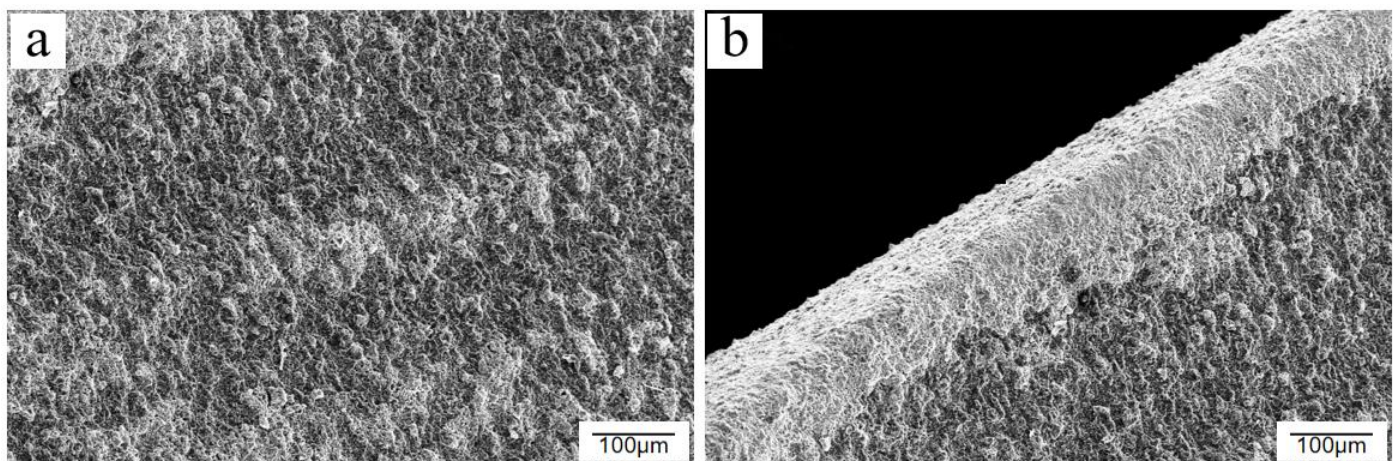
**Figure 4.** Comparison of passivation effects on different regions of the sample surface: (a) flat passivated layer and (b) passivated layer at fracture.

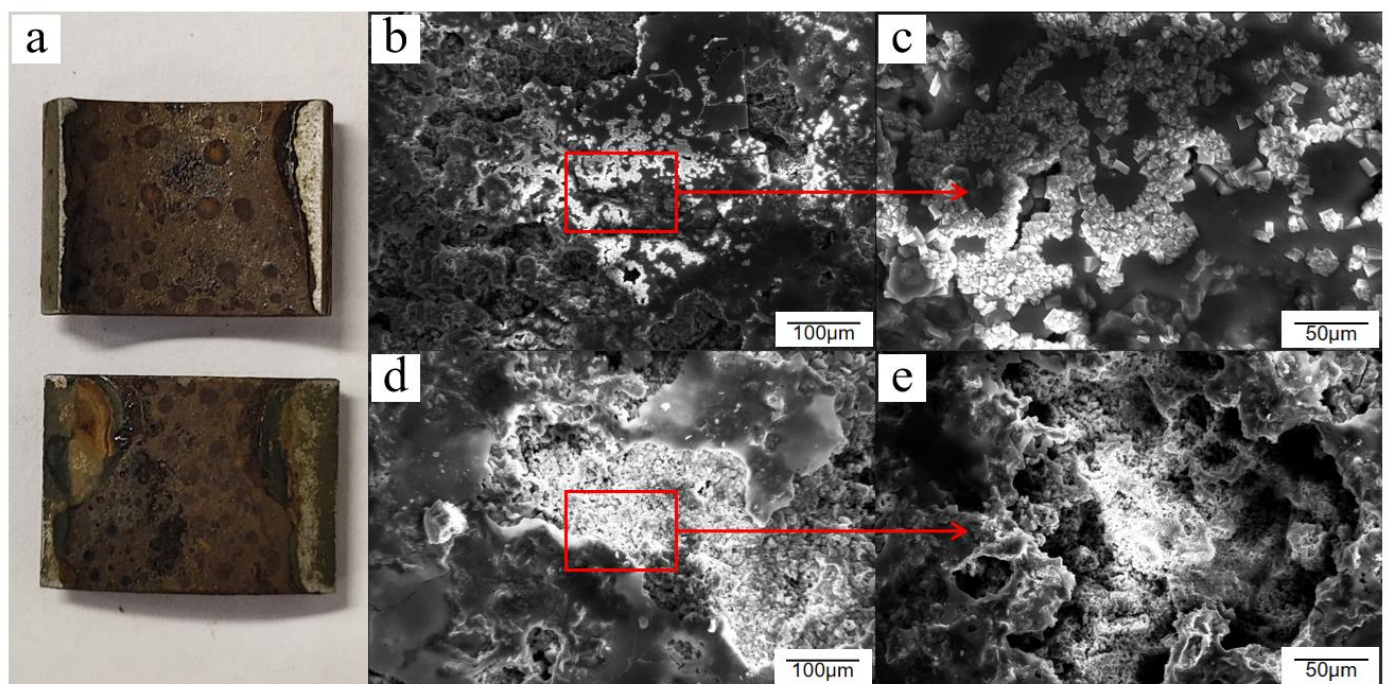
**Figure 5.** Macroscopic and microscopic morphology of Q235 low-carbon steel after 4 days of exposure in the cyclic salt spray accelerated corrosion test: (a) macroscopic appearance, (b) rupture area, (c) precipitation of crystals, (d) weak area, and (e) deep rupture.

4 days, the black passivation film on the surface of Q235 low-carbon steel began to lighten in color and rust spots appeared. The corrosion process began transitioning from a passivation layer to a substrate rust layer. The passivation film broke at the fracture, revealing the original substrate form. From a microscopic point of view, the passivation film was not yet broken in the vast majority of the areas and still had some resistance to corrosion. However, some areas exhibited serious corrosion features, such as etch pits and rust spots, which were scattered and distributed. After magnification, the rupture residue of the passivation film and the newly generated corrosion products in the corrosion pits were mixed together and could not be easily distinguished. The corrosion depth was large. In addition, crystalline behavior was observed within the vicinity of the rust spots and pits, which consisted mostly of sodium chloride crystals that remained after cleaning. Combined with atmospheric moisture, the residual sodium chloride crystals will continue to cause damage to the passivation film, as shown in Figure 5.

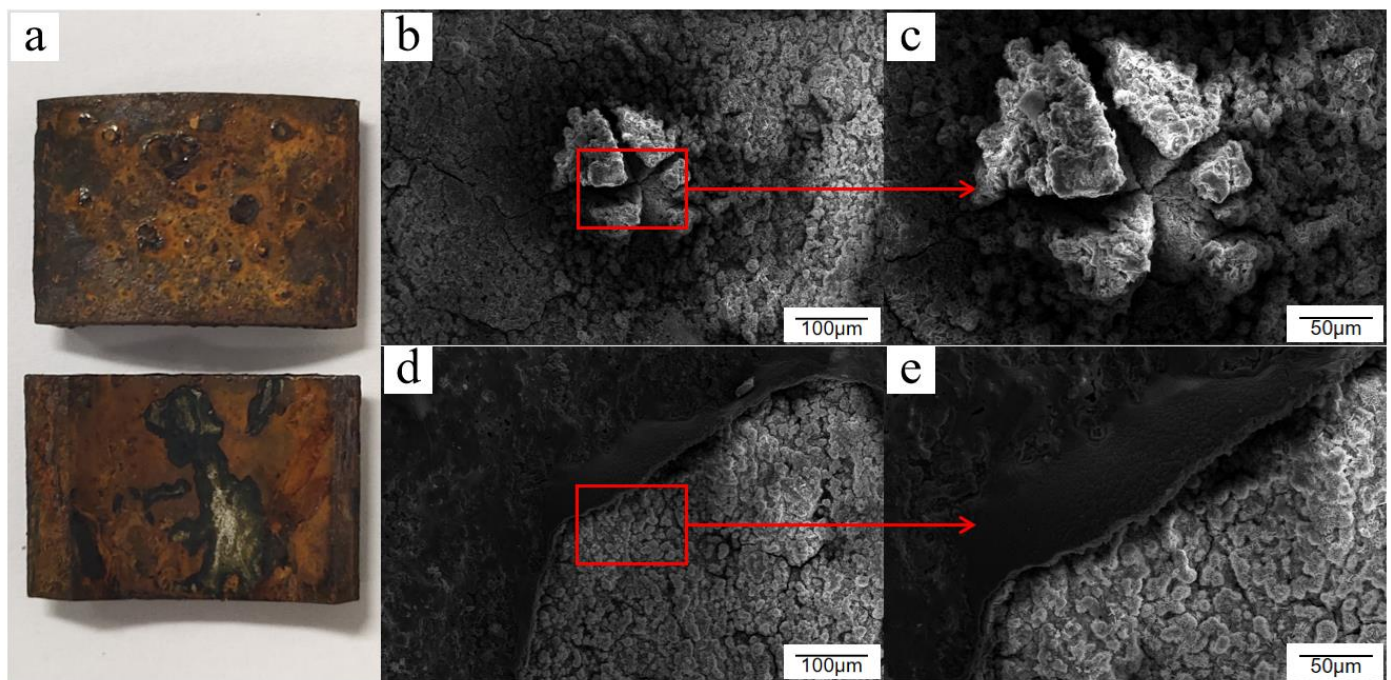
**Figure 6.** Macroscopic and microscopic morphology of Q235 low-carbon steel after 8 days of exposure in the cyclic salt spray accelerated corrosion test: (a) macroscopic appearance, (b) ruptured bulge, (c) enlarged drawing, (d) cracked edge, and (e) enlarged drawing.

From a macroscopic point of view, the majority of the black passivation film on the surface of Q235 low-carbon steel was replaced with a yellow-brown rust layer after 8 days of salt spray corrosion. The passivation film fell off over a large area, and the traces of passivation treatment were difficult to see, with local areas of granular corrosion products and the bulging phenomenon. From a microscopic point of view, the overall surface morphology of Q235 low-carbon steel was in the stage of passivation film breakage and shedding, with the growth of new rust products. Passivation film rupture was largely due to the combination of the passivation film residues and the new growth of rust products, constituting a mixed rust layer. Chloride ions and other corrosive media occurred under the loosening of cracking. Then, the corrosion product continued to grow and bulge, causing the passivation film to fall off, as shown by the bulge at the edge of the ruptured passivation film. In addition, the passivation film rupture area was littered with crystal clusters of corrosion products that were rich in needle-like morphological surface, which is the major feature of Q235 low-carbon steel surface micromorphology during this stage, as shown in Figure 6.

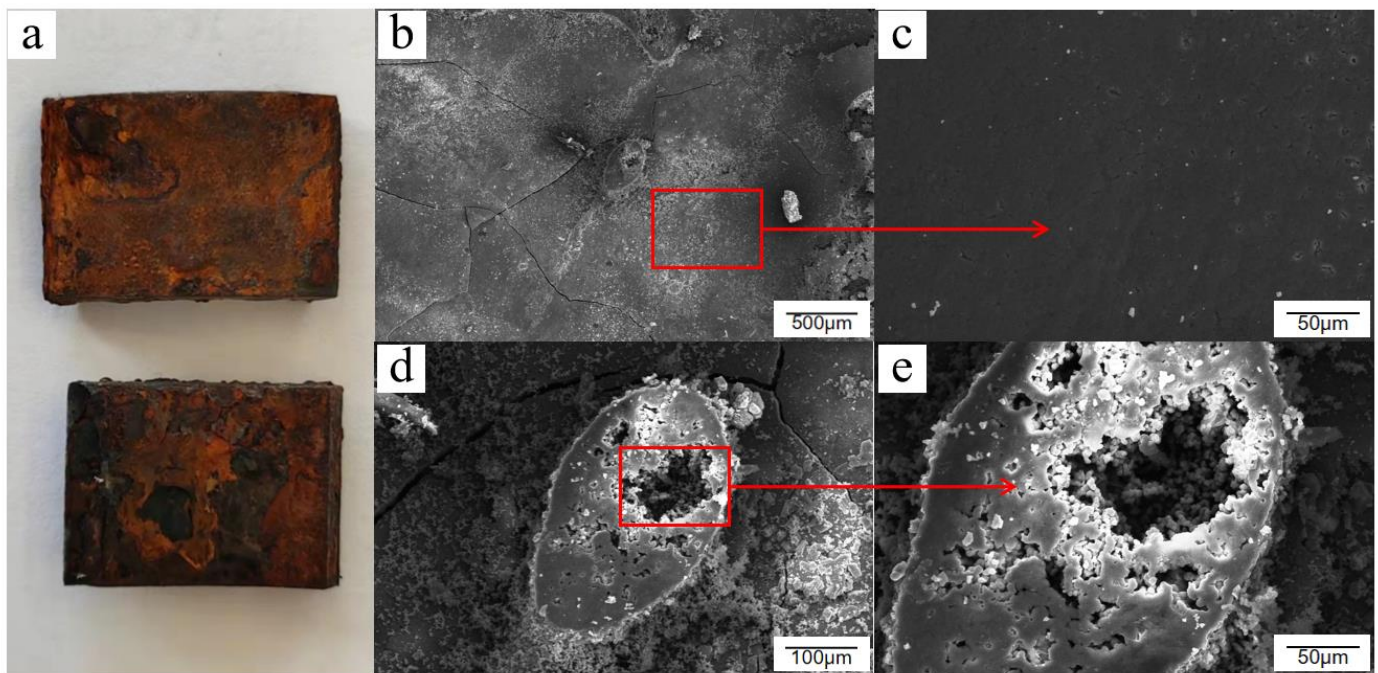
**Figure 7.** Macroscopic and microscopic morphology of Q235 low-carbon steel after 12 days of exposure in the cyclic salt spray accelerated corrosion test: (a) macroscopic appearance, (b) overall appearance, (c) flat rust layer, (d) rust cracked protrusion, and (e) internal corrosion growth.

The rust layer on the surface of Q235 low-carbon steel was not necessarily uneven and disorganized. By the time the salt spray test reached 12 days, the surface of the sample piece was completely replaced with a brownish rust product, which was darker in color compared with other periods. Its surface was flatter, with only small areas of slight defects. From a microscopic point of view, the residual passivation film was completely peeled off, and rust products were regenerated and extended onto the entire surface. A second flat corrosion layer was formed below the passivation film after stacking and agglomeration. This corrosion layer was denser than the other scattered rust traces. From the viewpoint of film formation of protective corrosion products, the corrosion layer is presumed as a “second protective layer” and, to a certain extent, it played a role in retarding corrosion and reducing the corrosion rate. However, the reduced corrosion rate does not mean that corrosion will not occur. Chloride ions and oxygen atoms will still penetrate and break through the corrosion layer and continue to exert a corrosive effect on the carbon steel substrate. The accumulation of newly generated corrosion products within the corrosion layer will again break through the corrosion layer and cause the surface to bulge and crack, as shown in Figure 7.

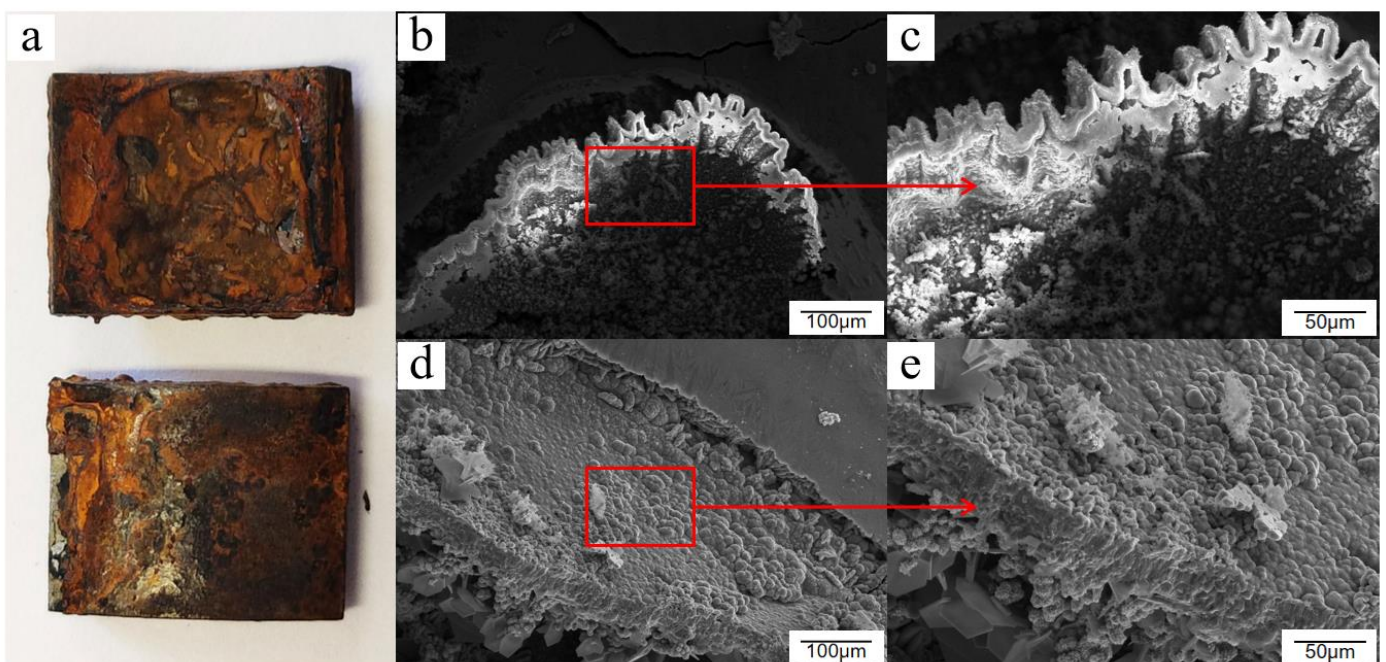
**Figure 8.** Macroscopic and microscopic morphology of Q235 low-carbon steel after 16 days of exposure in the cyclic salt spray accelerated corrosion test: (a) macroscopic appearance, (b) corrosion layer folds, (c) enlarged drawing, (d) corrosion product stacking up, and (e) enlarged drawing.

With the prolongation of exposure time, i.e., after the samples were placed in the salt spray environment for 16 days, large areas of folds and bulges appeared on the originally relatively flat rust layer. The color of the rust layer gradually deepened, and its thickness gradually increased, making the surface rust layer uneven in appearance. Using an electron microscope to magnify the characteristic area, the original flat carbon steel surface outside the corrosion layer was found to be either broken or covered, with various forms of corrosion products competing for growth. In the process of stacking and cascading, it continued to rise to a certain height after the fracture and the formation of “coral-like” folds. Considering that the protective layer formed in the previous phase is on the verge of falling off and failing, the corrosion rate is presumed to continue increasing, as shown in Figure 8.

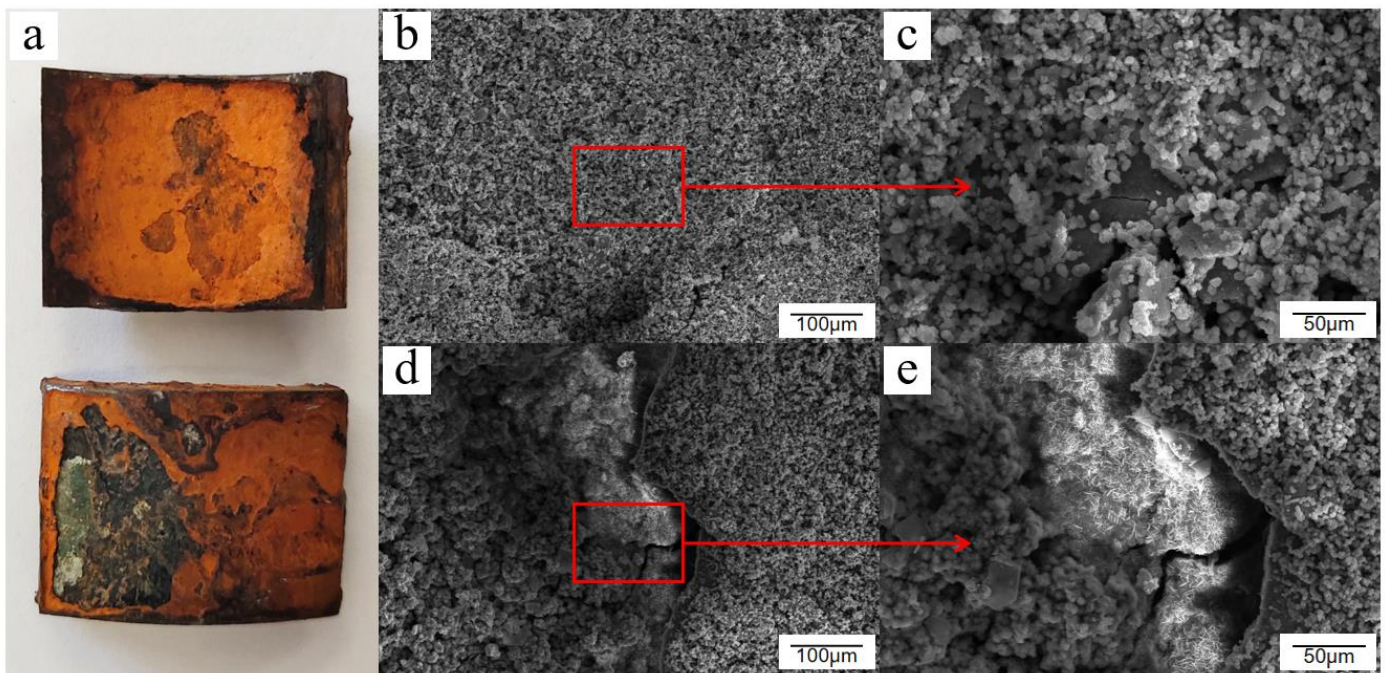
**Figure 9.** Macroscopic and microscopic morphology of Q235 low-carbon steel after 20 days of exposure in the cyclic salt spray accelerated corrosion test: (a) macroscopic appearance, (b) overall appearance, (c) loose corrosion products, (d) corrosion layer crack, and (e) corrosion intensifies.

After 20 days of cyclic salt spray accelerated corrosion testing, the surface rust products of Q235 low-carbon steel continued to accumulate and thicken until the rust layer began to fall off in a large area. The exposed base material under the erosion of chloride ions and other corrosive media continued to generate new corrosion products. The rust layer and

substrate interface exhibited more evident delamination cracks. From a microscopic point of view, the surface of Q235 low-carbon steel was completely covered by layers of newly generated thin and loose crystal cluster corrosion products, as shown by the corrosion layer joints where new needle-like rusting materials were still being generated. These materials were first stacked and connected to form a metal oxide skin, and then continuously stacked on top of this skin to form various types of corrosion products, as shown in Figure 9.

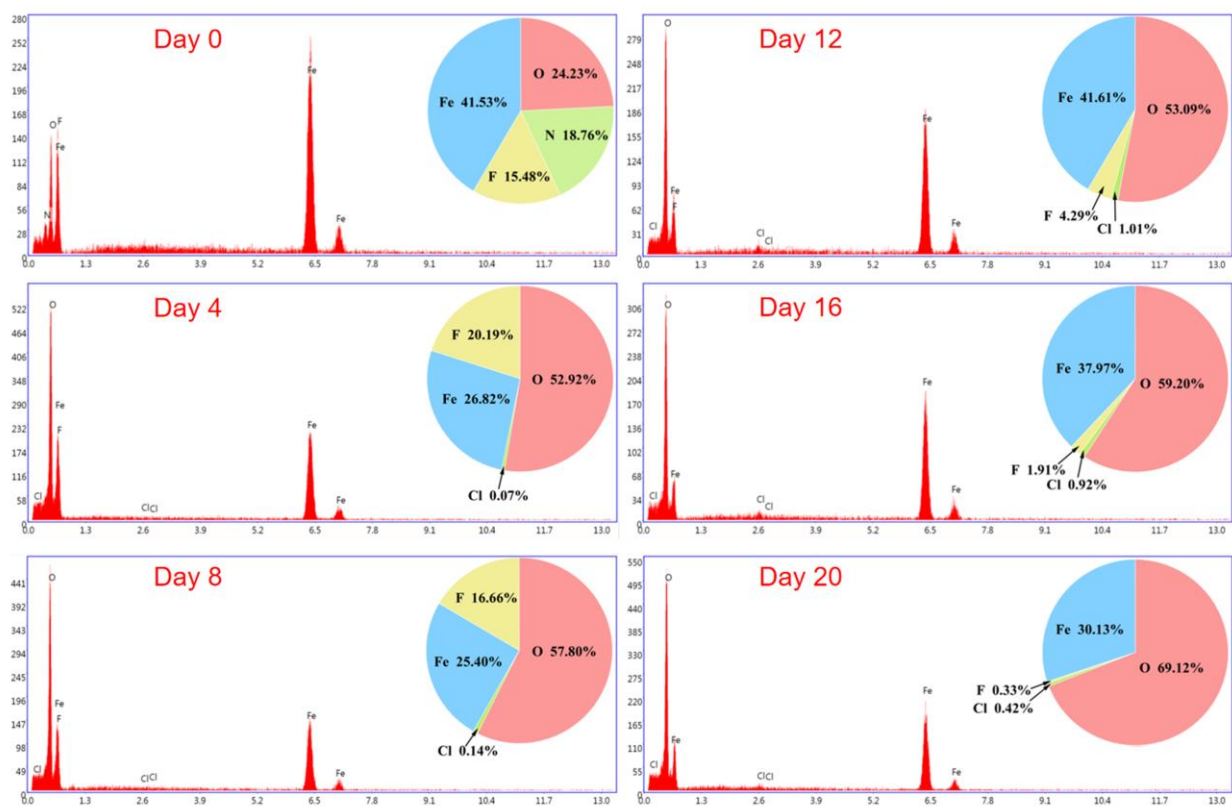
**Figure 10.** EDS spectra of the corrosion products of Q235 low-carbon steel after exposure to accelerated corrosive environments at different times.

The EDS energy spectrum of corrosion products and the change in the atomic content of each element with exposure time are shown in Figures 10 and 11, respectively. Before the experiment started, because the surface of the Q235 low-carbon steel was covered with a uniform and dense passivation film, the content of nitrogen and fluorine atoms was relatively high. As the corrosion product of the passivation layer transitioned to the corrosion product of the base rust layer during the corrosion process, the passivation film began to corrode when the Q235 low-carbon steel sample was exposed to the salt spray environment for 0–4 days. Rust spots appeared on the surface, but the whole was not completely fractured, thus the proportion of fluorine atoms was relatively high. At 4–8 days of exposure, the passivation film on the sample surface was gradually covered by substrate rust. In some areas, the passivation film fell off with the substrate rust products, the fluorine atom content began to decrease, while the oxygen atoms began to increase. When exposed for 8–12 days, the residual passivation film was nearly completely removed, and a flat, dense matrix rust layer was formed. The fluorine atom content was significantly reduced, and the atomic fraction of iron oxides rose gradually with the thickening of the rust layer. When exposed for 12–16 days, the flat corrosion layer produced in the previous stage exerted a certain protective effect on the carbon steel substrate. Therefore, although the surface rust layer gradually deepened and thickened and the oxygen atom content increased, the rate of increase was relatively slow. At 16–20 days of exposure, the oxygen atom content rose considerably while the fluorine atom content decreased as the “second protective layer” failed and corrosion products continued to deepen and thicken. The reason for this phenomenon may be related to the local shedding of the corrosion layer after it thickened to a certain height, while the fluorine atom content was nearly negligible. Overall, the fluorine atom content tended to decrease from the start of the salt spray test and decreased at the fastest rate between 8 and 12 days, indicating that the passivation film exhibited an accelerated trend in the process of “from point to surface” rupture. Simultaneously, the oxygen atom content tended to increase, and then decrease, and then increase again, indicating that the passivation film on the surface of Q235 low-carbon steel and the “second protective layer” that formed after the passivation film broke down were fulfilling their expected protective role. In addition, the corrosion products contained a proportion of chlorine atoms, and this condition was mostly related to the deposition of the sprayed salt solution during the test.

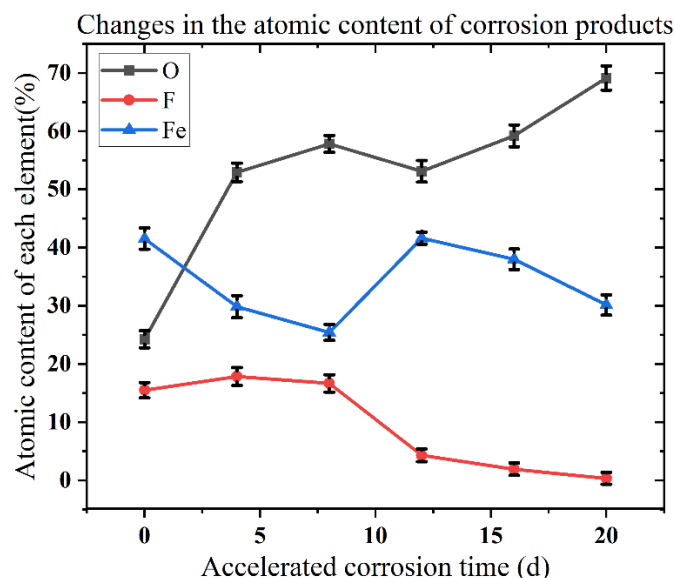
**Figure 11.** Changes in the elemental content of the corrosion products of Q235 low-carbon steel after different exposure times in accelerated corrosion environments.

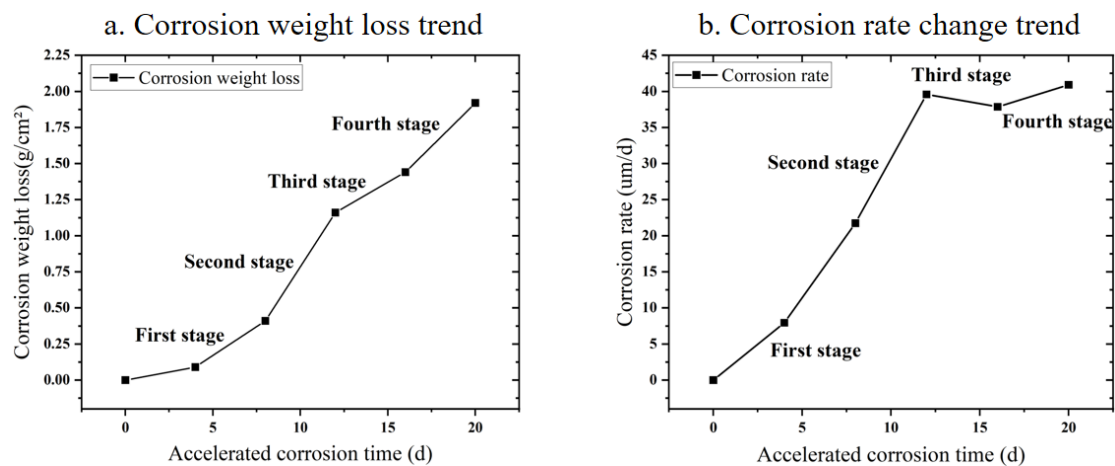
**Figure 12.** Corrosion kinetic analysis of Q235 low-carbon steel samples in an accelerated corrosive environment.

The corrosion weight loss and corrosion rate data of Q235 low carbon steel exposed to accelerated corrosion environment for different times are shown in Figure 12. By comparing the analysis of the data, the accelerated corrosion exposure process of Q235 low-carbon steel after passivation can be broadly divided into four stages. In stage 1 (0–8 days), corrosion weight loss tends to rise slowly and the corrosion rate increases at a slower rate. This scenario indicates that the passivation film forms a better protective effect on the substrate as the first corrosion-resistant layer during the early stage of corrosion. This phenomenon is related to the electrochemical protection mechanism of the passivation film. In the second stage (8–12 days), corrosion weight loss and the corrosion rate rapidly increased, demonstrating that, with the prolongation of exposure time, the substrate surface passivation film experienced comprehensive corrosion rupture. The loose rust layer was gradually peeled off, losing its protective effect. The substrate surface was exposed to hydrogen ions, chlorine ions, and other corrosive media. Electrochemical reaction resistance was rapidly reduced. In the third stage (12–16 days), the increasing trend of corrosion weight loss slowed down slightly, while the corrosion rate began to decline. This scenario was largely related to the gradual thickening of the rust layer and the increase in the proportion of stable  $\alpha$ -FeOOH components. The formation of the second corrosion-resistant layer after the passivation film gradually reduced corrosive media and substrate contact area. The electrochemical reaction resistance increased. In the fourth stage (16–20 days), corrosion weight loss accelerated and the corrosion rate increased again, indicating that the carbon steel matrix was eroded as the more stable  $\alpha$ -FeOOH rust layer thickened and fell off. At this moment, Q235 low-carbon steel had nearly no corrosion resistance.

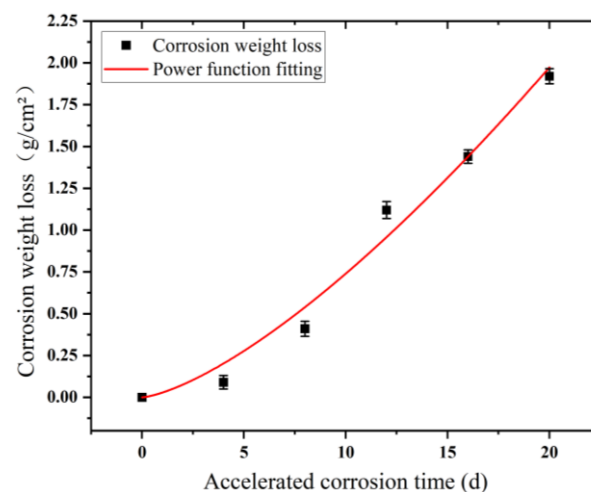
**Figure 13.** Corrosion weight loss fitting curves of Q235 low-carbon steel samples in accelerated corrosive environments.

In accordance with the trend of corrosion weight loss of Q235 low-carbon steel, the corrosion weight loss trend was fitted using Equation (1). The fitted curve and shape parameters are presented in Table 2 and Figure 13, respectively. Corrosion weight loss conformed to the power function change relationship, and the fitting degree reached as high as 0.976.

Q235 low-carbon steel has an *n* value greater than 1 during exposure, indicating a harsh environment for accelerated corrosion. Overall, Q235 low-carbon steel exhibits an accelerating corrosion process. The passivation film provides a good corrosion protective function during the early stage of corrosion. However, during the entire corrosion process, the passivation film falls off during the initial stage, and the surface rust layer on the substrate forms a protective effect, but is relatively weak. In the late stages of corrosion, the protective effect gradually appears. With the prolonged exposure time, the corrosion of Q235 low-carbon steel is likely to reach a relatively stable and slow stage, that is, the corrosion weight loss exponent *n* decreases below 1.
