Water Arabia 2011
CONFERENCE & EXHIBITION

Cleaning Clay from Fouled Membranes

Authors: Matthew Armstrong, Silvia Gallego, Fernando del Vigo, Stephen Chesters.

Genesys International Limited

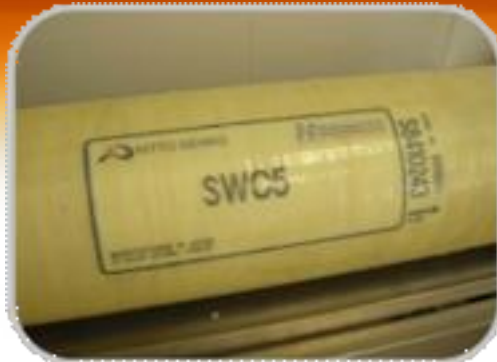
Hydranautics SWC5
Lead element first stage, first pass

Thin brown gelatinous deposit
Bacteria, fungi, iron, clay
(alumino-silicate)

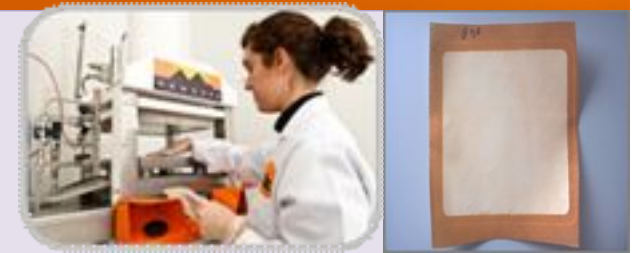
Cleaning test

Design specification 38.3 l/m ² h ± 15%		Flow Rate l/m ² h		
		Before	After	% Improvement
Clean 4	2% Genesol 703 at 35-40° C (2 hours)	28.12	39.3	39.7
Clean 1	Sodium hydroxide solution at 35-40° C (2 hours)	28.6	29.4	2.8
Clean 2	2% Genesol 40 alkaline cleaner at 35-40° C (2 hours)	29.4	32.38	10.2
Clean 3	2% Genesol 40 alkaline cleaner at 35-40° C (2 hours)	31.95	*	*
	300mg/l Genesol 30 biocide (1hour)	*	*	*
	2% Genesol 40 alkaline cleaner at 35-40° C (2 hours)	31.95	34.02	6.5
	3% Genesol 38 mild acid cleaner 25° C (2 hours)	34.02	22.21	-34.7
	2% Genesol 40 alkaline cleaner at 35-40° C (2 hours)	22.21	25.75	15.9
TOTAL		31.95	25.75	-19.4

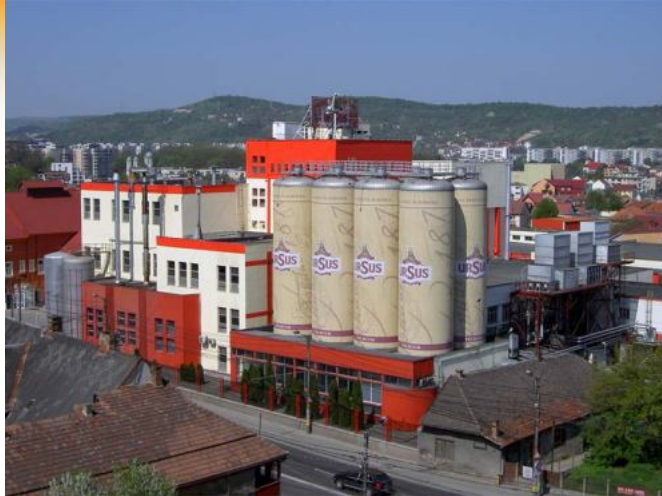
Ursus Brewery Buzau Romania

Nov 2008 permeate 50% of capacity

Membranes replaced after 18 months

Cleans carried out every 4-6 weeks

Cleans were taking 13 hours

Downtime was affecting production

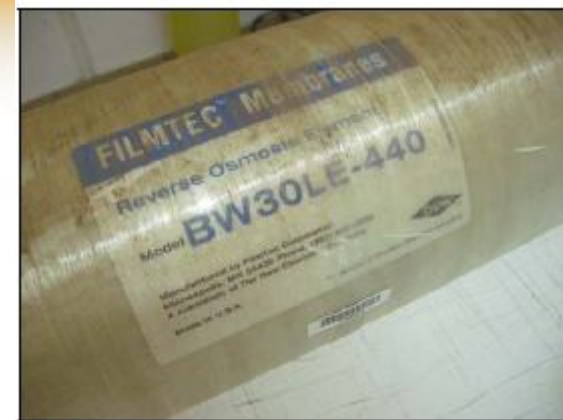
Dow Filmtec BW 30LE-440 last element
second stage

- Damage to casing
- Damage to ATD
- Dark brown inorganic deposit

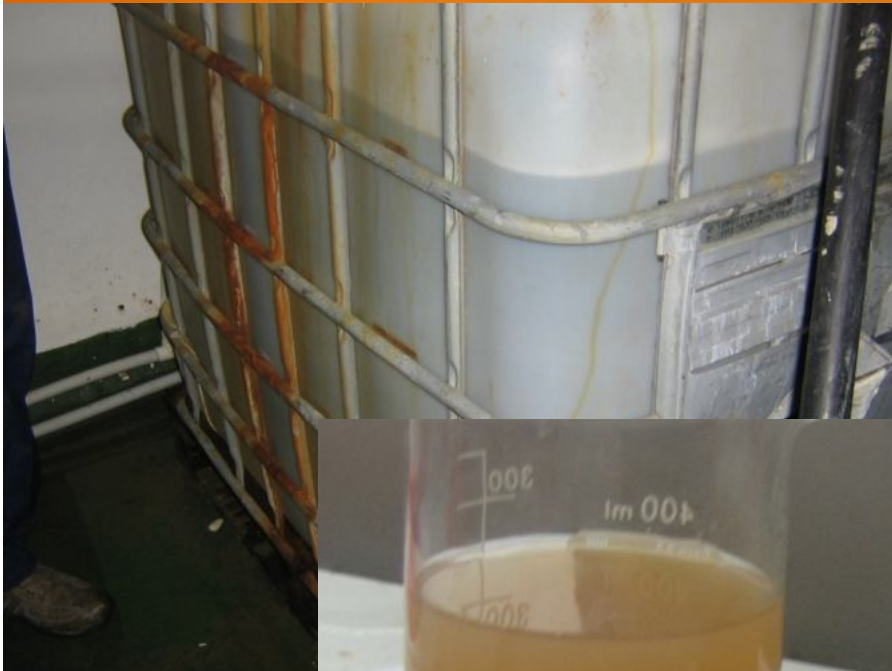
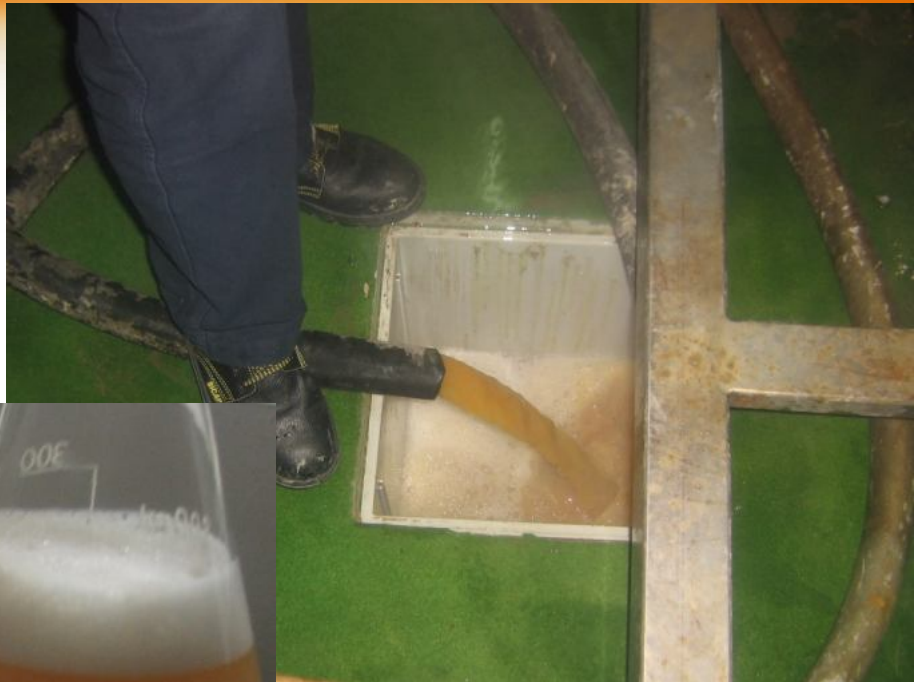
Rinsing after alkaline

Second Genesol 703 clean

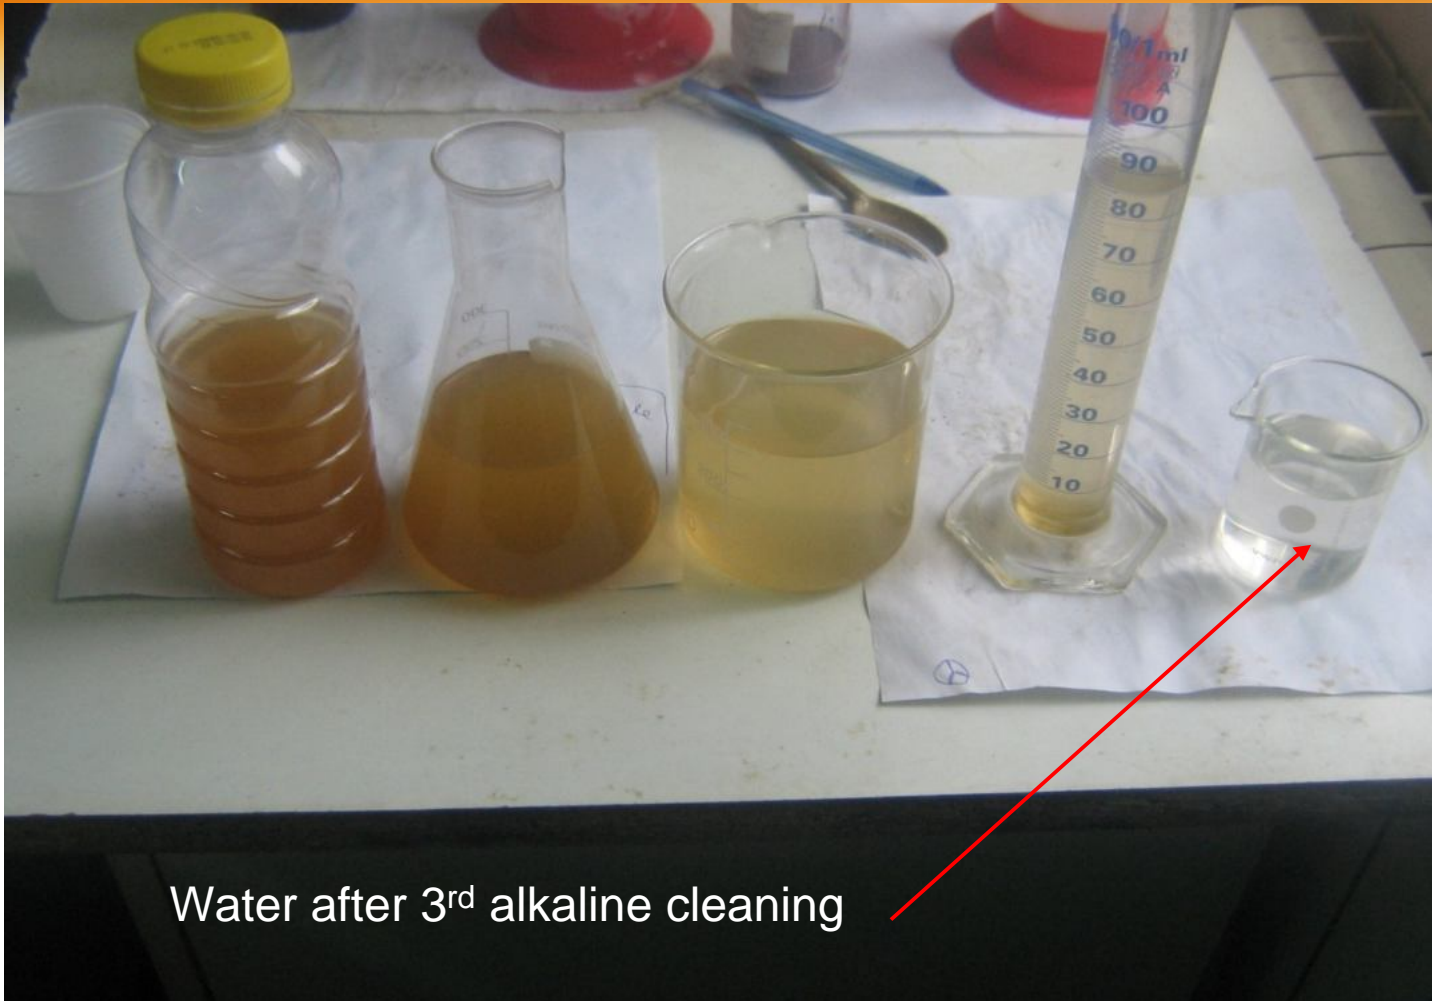
Second rinsing

Genesol 703 clean

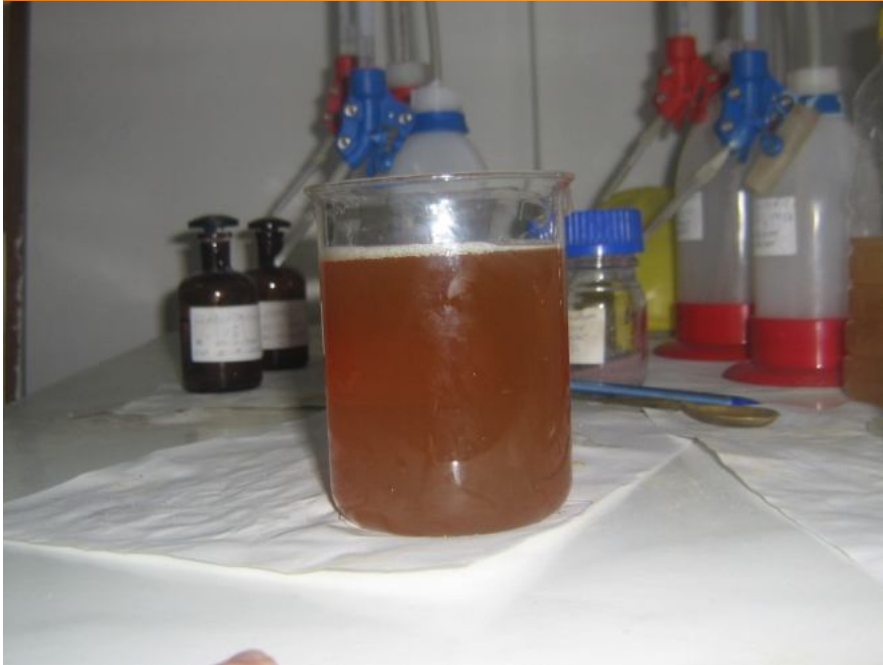
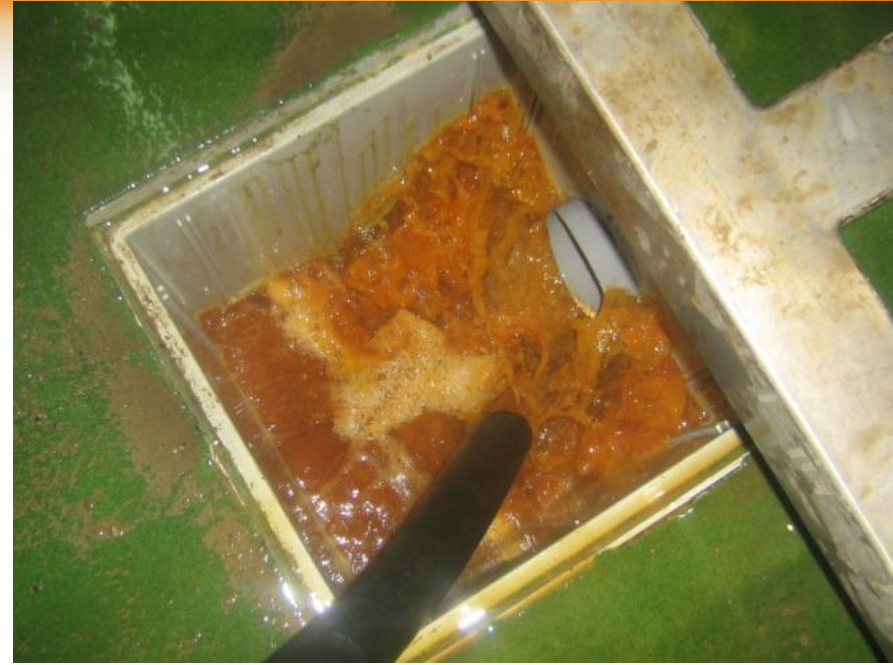
Clay removal

Water after 3rd alkaline cleaning

Genesol 38 Acidic clean

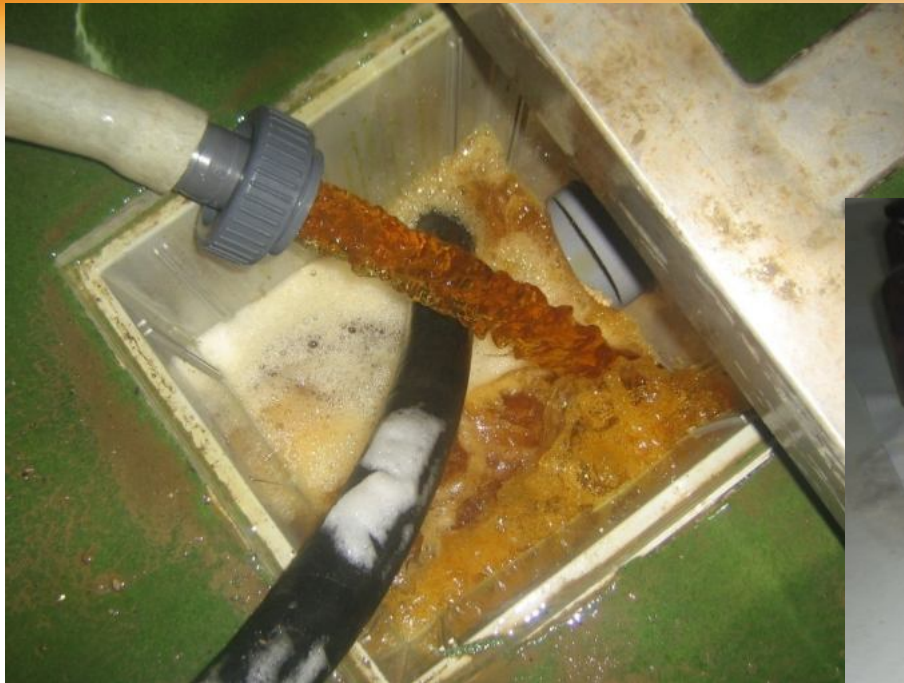
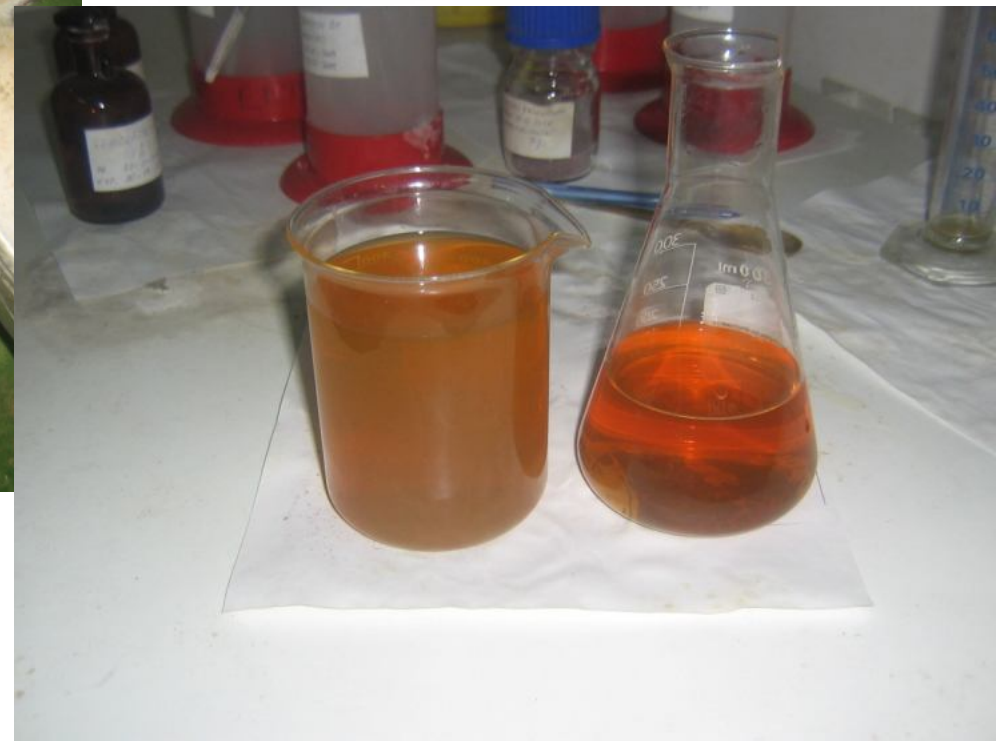
First acid cleaning iron removal pH 3.8

Genesol 38 acidic clean

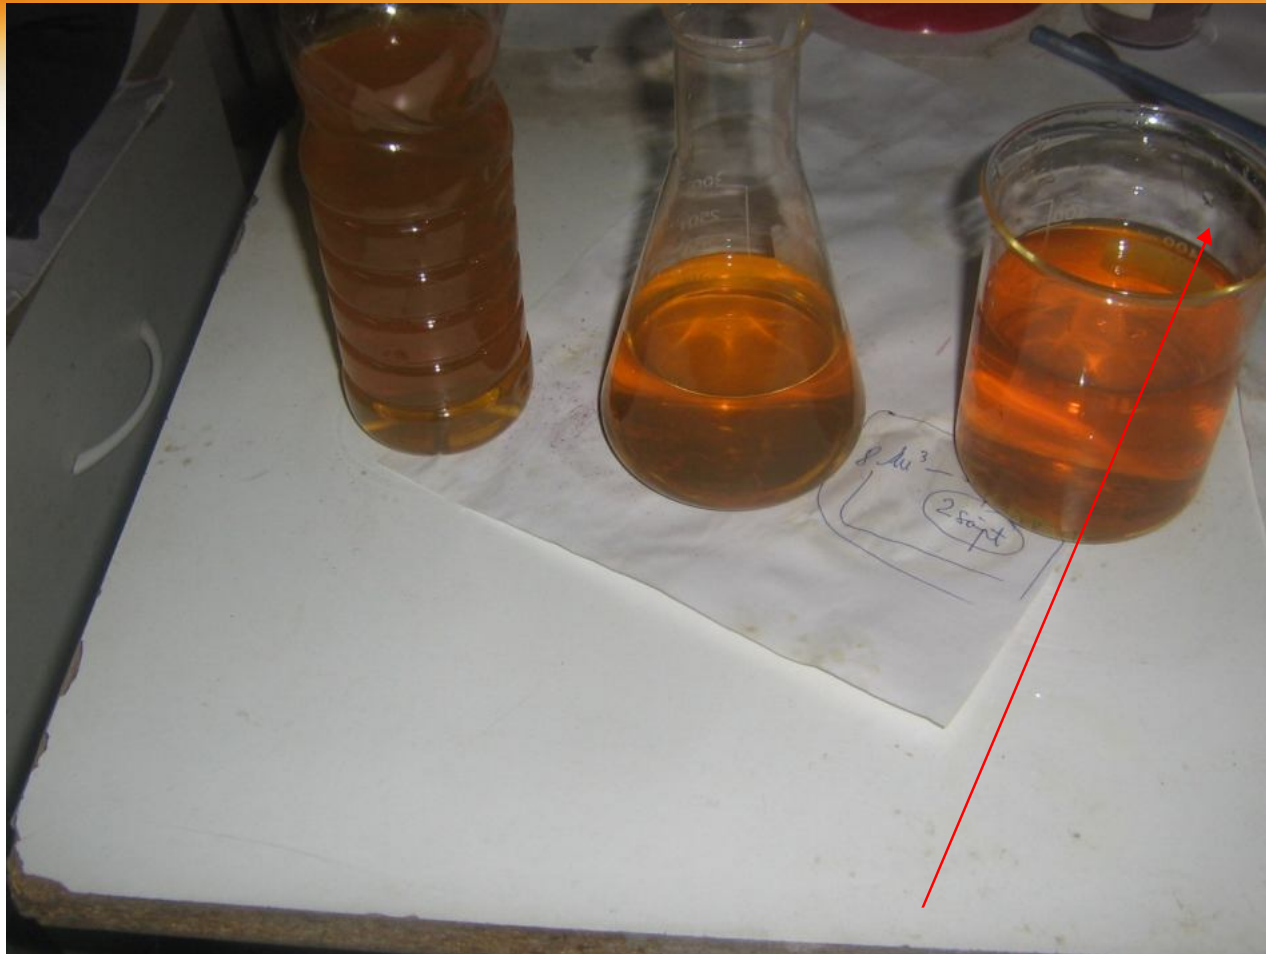
2nd acid cleaning

Genesol 38 acidic clean

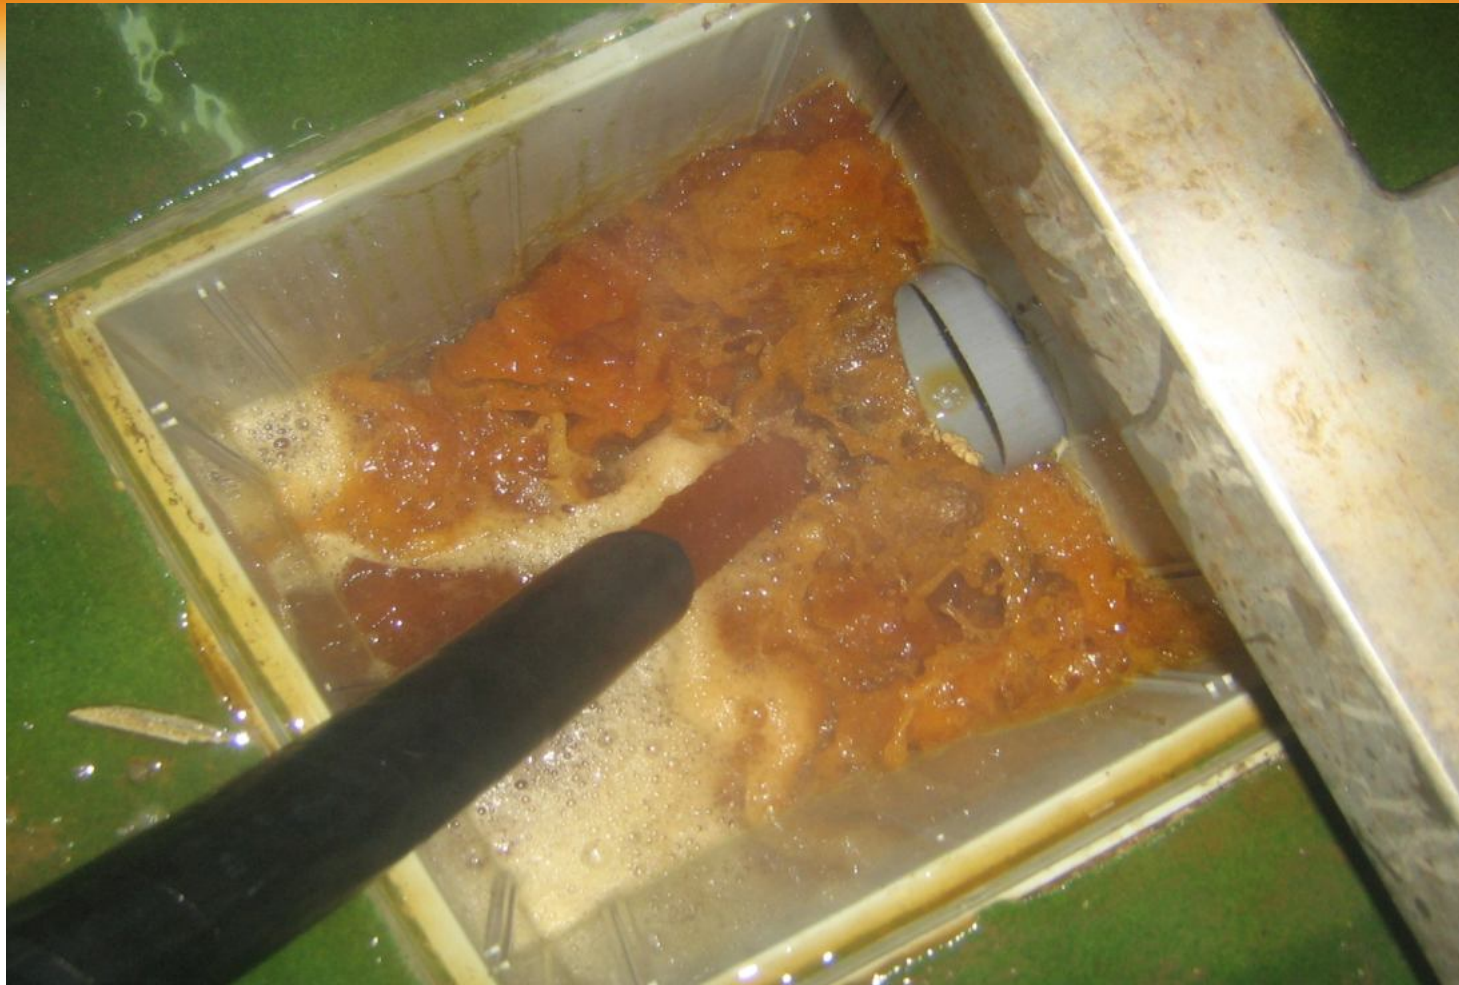
3rd acid clean and rinse

Genesol 38 acidic clean
